2022 California Battery Energy Storage System Disturbances

California Events: March 9 and April 6, 2022
Joint NERC and WECC Staff Report

September 2023

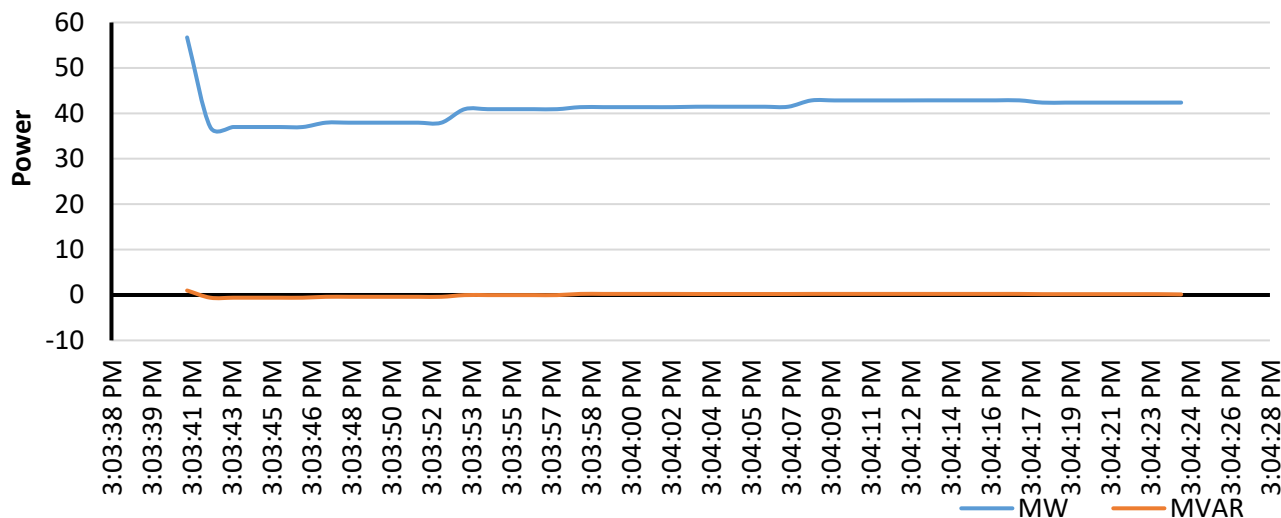
Figure A.1: Plant A Active and Reactive Power at POI on March 9

Plant A is a 66 MW facility connected to the 230 kV network that went into commercial operation in June 2021. The plant reduced output from 57 MW to 37 MW during the event (see [Figure A.1](#)). The plant consists of a total of 29 inverters; 15 inverters experienced instantaneous ac overcurrent tripping, and 12 inverters experienced unbalanced ac current tripping.

To mitigate these issues, the GO worked with the inverter original equipment manufacturer to perform software and configuration updates not only at this facility but proactively at other facilities that use the same inverter make and model.

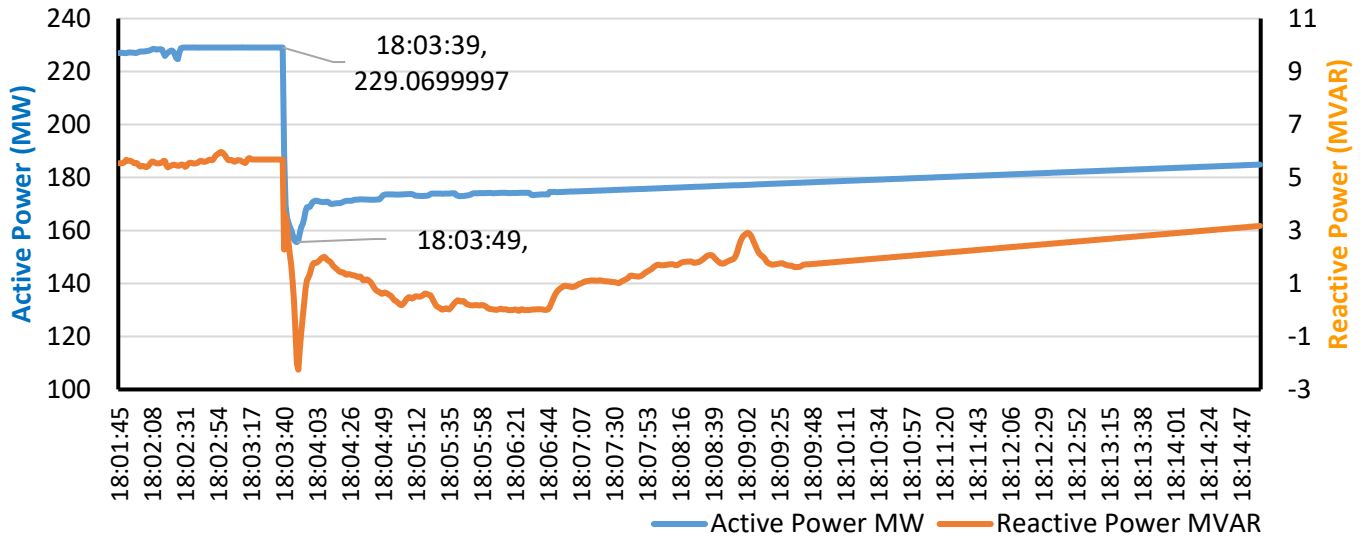
Figure A.2: Plant C Active and Reactive Power at POI on March 9

Plant C is a 250 MW facility connected to the 230 kV network that went into commercial operation in June 2021. The plant reduced output by 73 MW during the event (see [Figure A.2](#)). The plant consists of a total of 88 inverters. Of these, 27 inverters experienced instantaneous ac overcurrent tripping, and 35 inverters experienced unbalanced ac current tripping. GO was unable to provide any useful information regarding the cause of tripping from 12 additional inverters that reduced power.

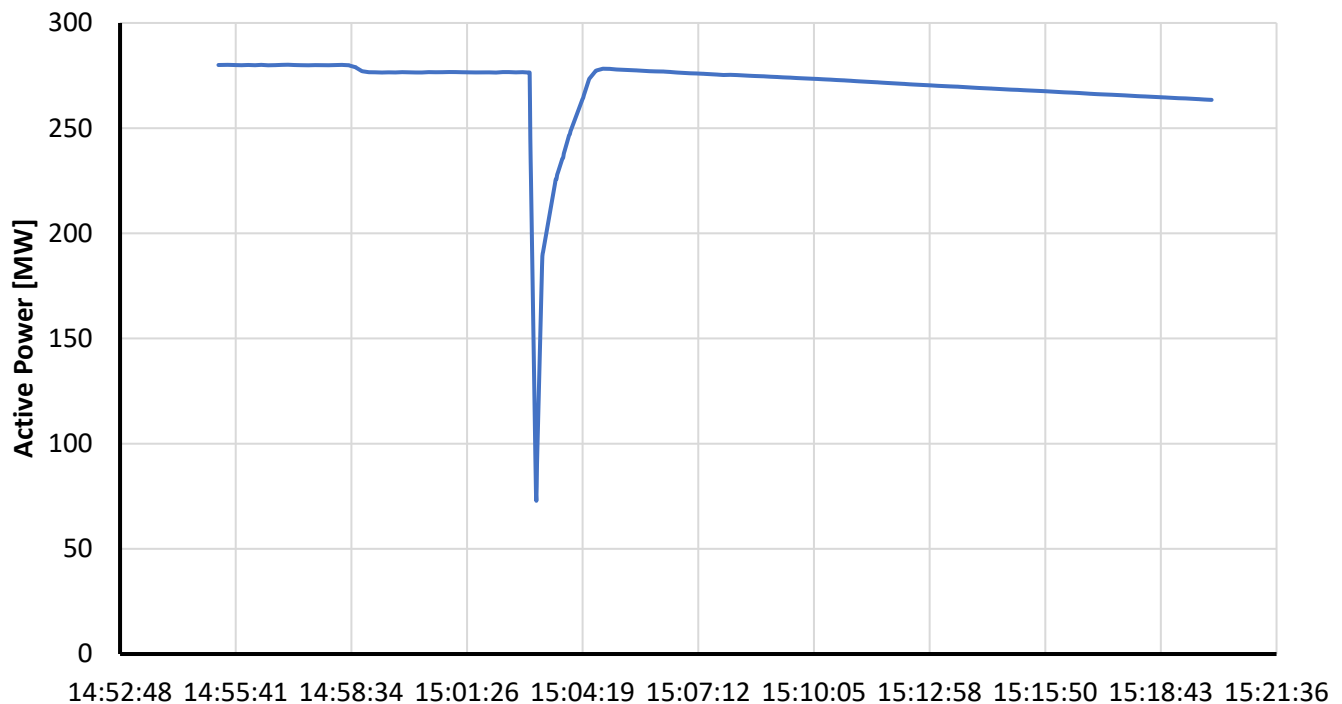
Figure B.1: Plant E Active Power at POI on April 6

Plant E is a 300 MW facility connected to the 230 kV network that went into commercial operation in 2014. The plant experienced a 104 MW power reduction due to momentary cessation. It is an older facility where momentary cessation could not be disabled. Its power recovery has improved since the last event it was involved in. One inverter tripped on dc overcurrent. See [Figure B.1](#).

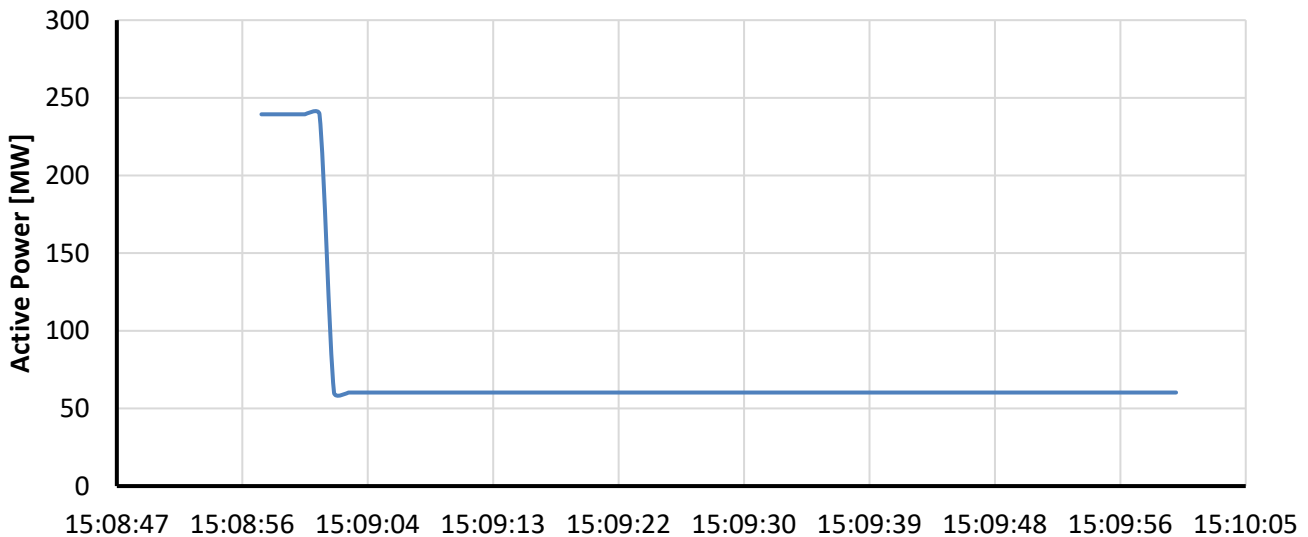
Figure B.3: Plant G Active Power at POI on April 6

Plant G is a 250 MW facility connected to the 230kV network that went into commercial operation in 2016. During the event, the plant output dropped from 239 MW to 60 MW due to 192 inverters tripping on low line-to-line voltage and 2 inverters of a different manufacturer tripping for unknown reasons as the inverters did not record fault codes. A few months prior to the event, the inverter trip settings had been revised from being set directly on PRC-024 no-trip boundaries, but the inverter still tripped. See [Figure B.3](#).

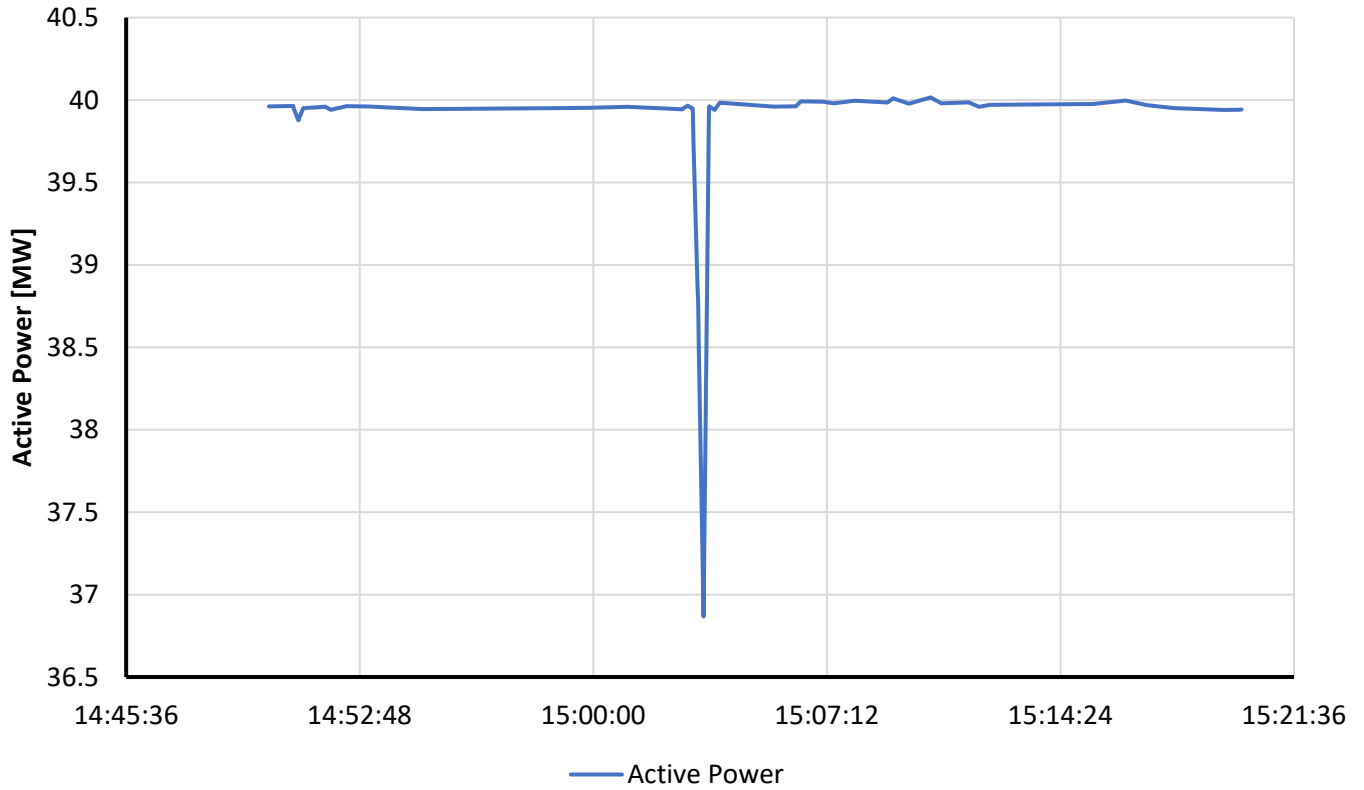
Figure B.6: Plant K Active Power at POI on April 6

Plant K is a 250 MW facility connected to the 230 kV network that went into commercial operation in 2014. During the event, the plant output dropped from 40 MW to 37 MW due to momentary cessation. No inverter tripping was reported. See [Figure B.6](#).
