# 2022 California Battery Energy Storage System Disturbances

California Events: March 9 and April 6, 2022  
Joint NERC and WECC Staff Report

September 2023

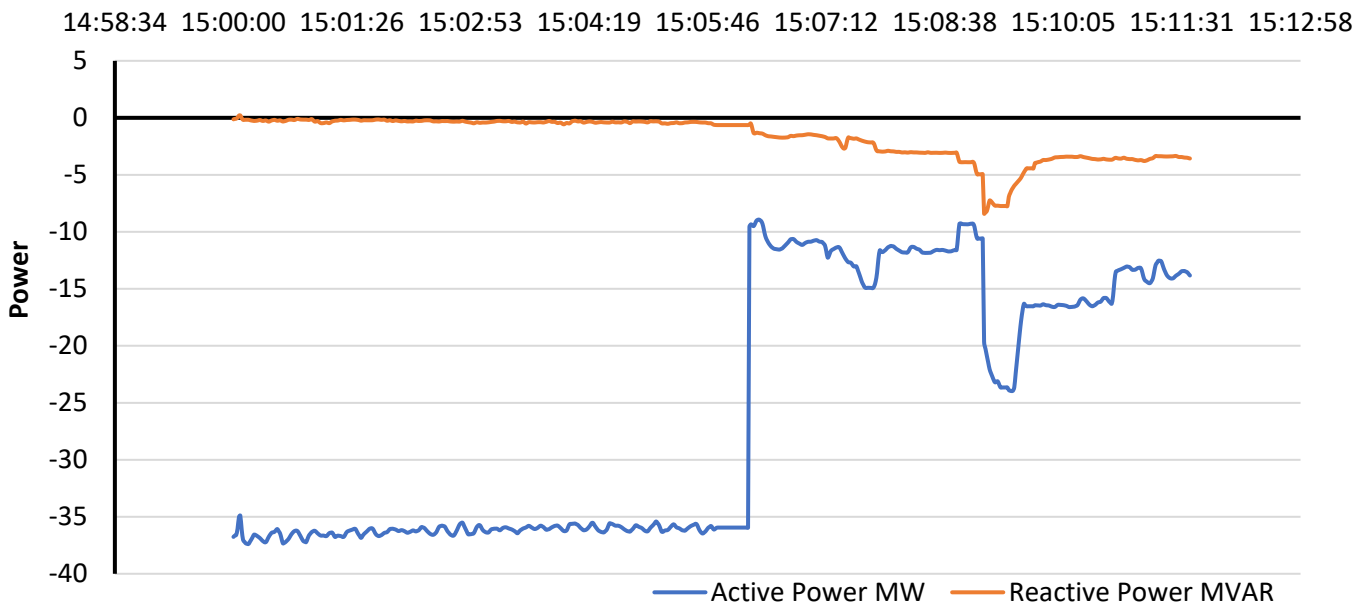
**Figure A.4: Plant B Active and Reactive Power at POI on April 6**

Plant B is a 115 MW facility connected to the 230 kV network that went into commercial operation in April 2021. The plant output dropped by 26 MW during the event from the pre-disturbance level of 36 MW (see [Figure A.4](#)). The plant consists of a total of 45 inverters. GO reported that five inverters tripped (three tripped on unbalanced ac current protection; cause of trip unknown for the rest). However, the loss of five inverters does not add up to the total 26 MW lost, suggesting that there is a data quality issue.

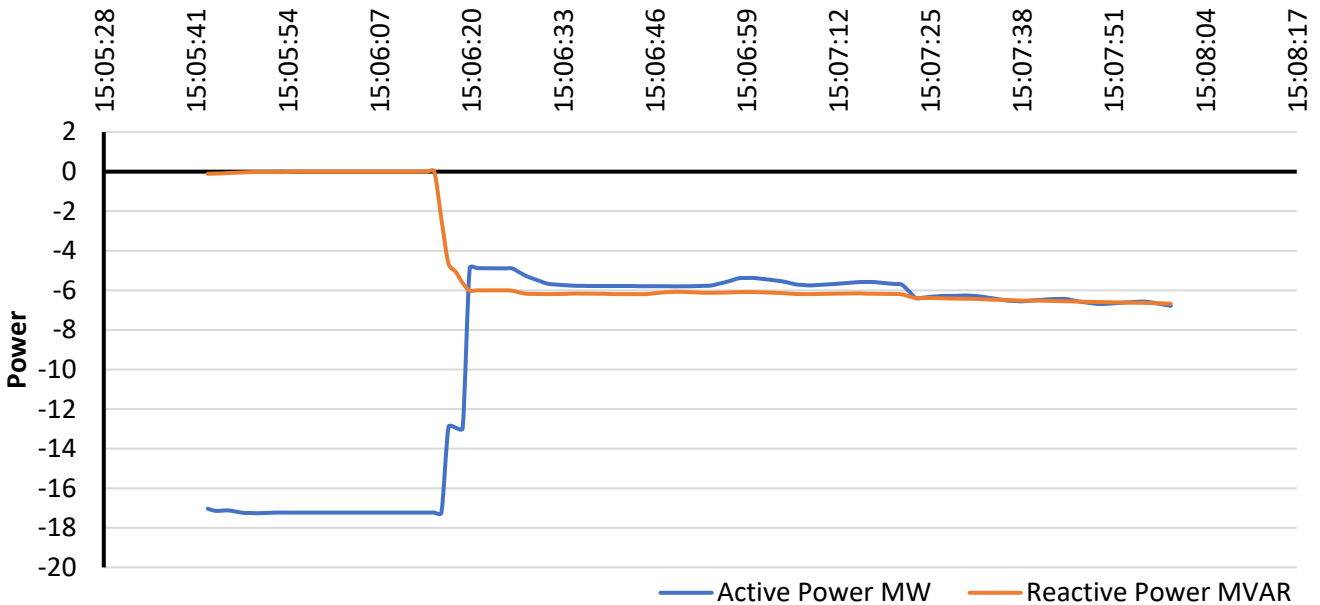
**Figure A.5: Plant C Active and Reactive Power at POI on April 6**

The GO reported there was no inverter fault and attributed the abnormal power response to the facility charging at a lower power level than the set point to manage the battery nearing its full state of charge. However, data from GO (Figure A.5) indicated that the facility metering was interrupted right around the disturbance due to the log recording the same value for a few seconds. When the recording resumed, the plant charging power level dropped, and the reactive power consumption increased simultaneously, suggesting that a few inverters were lost. The results are inconclusive.
