# **FEDERAL TRANSIT BUS TEST**

**Manufacturer: Micro Bird Inc. / Micro Bird USA LLC  
Model: Micro Bird G5**

**December 2025**

**Report Number: LTI-BT-R2025-03**

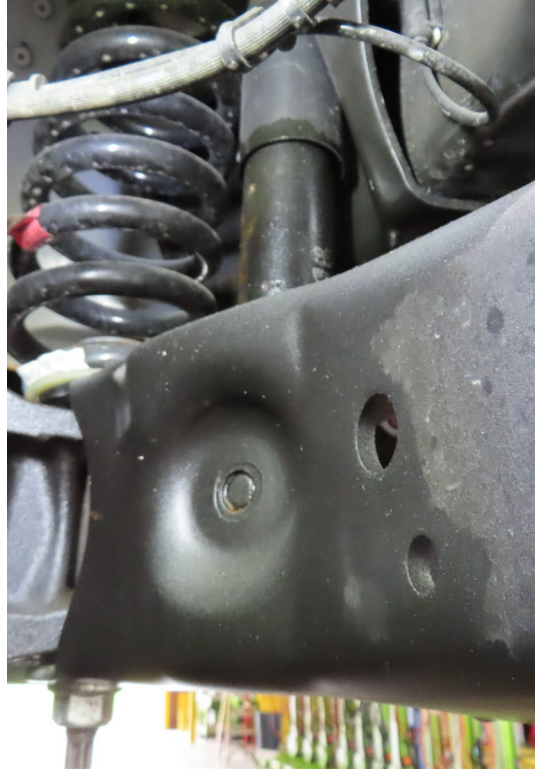
**FRONT, STREETSIDE SHOCK ABSORBER IS LEAKING  
(334 TEST MILES)**

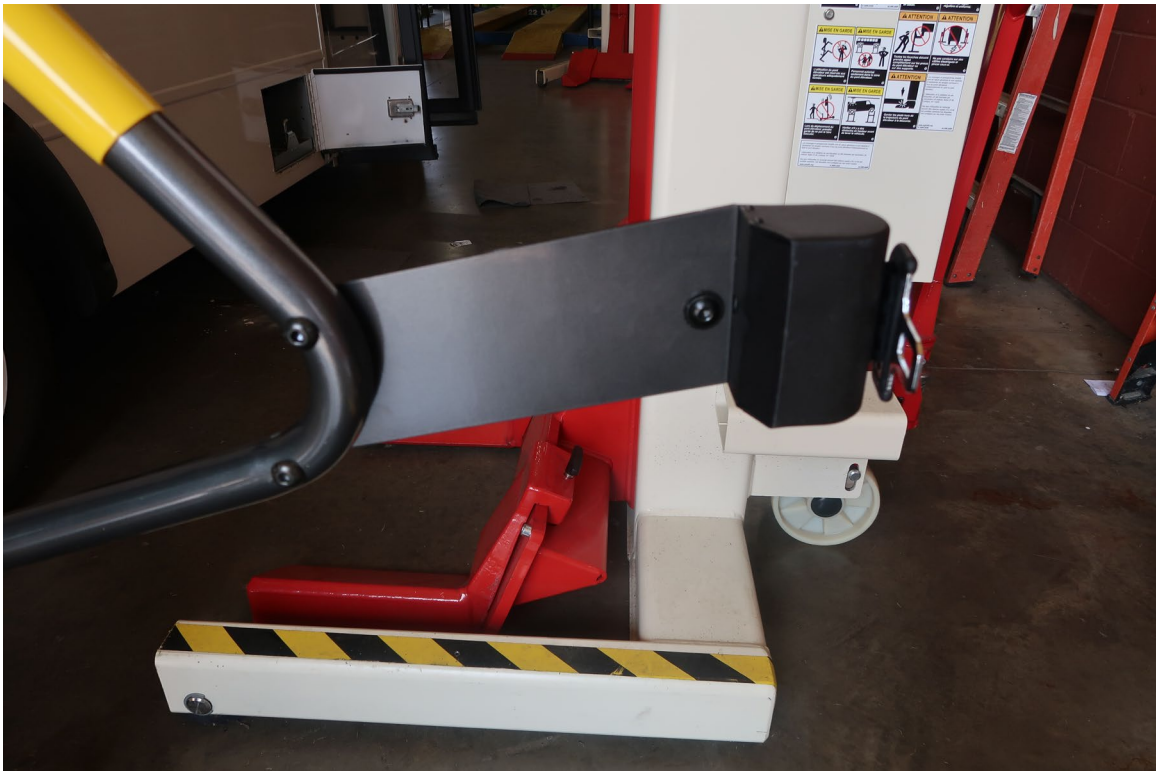
**SEATBELT BRACKET FOR ADA LIFT WAS REPLACED  
(1,815 TEST MILES)**

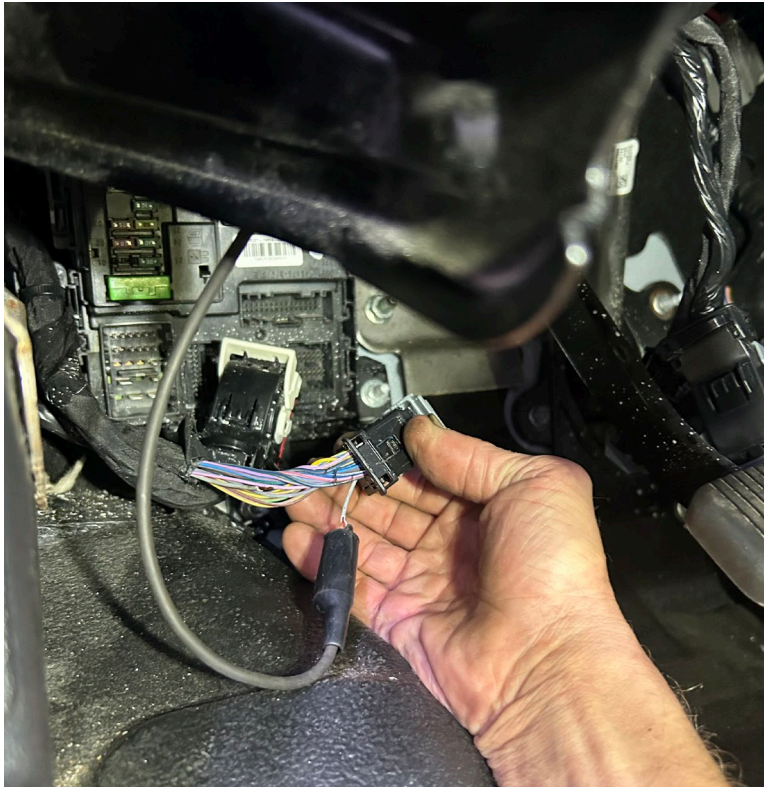
**BROKEN WIRE IN THE WIRING HARNESS  
(2,268 TEST MILES)**

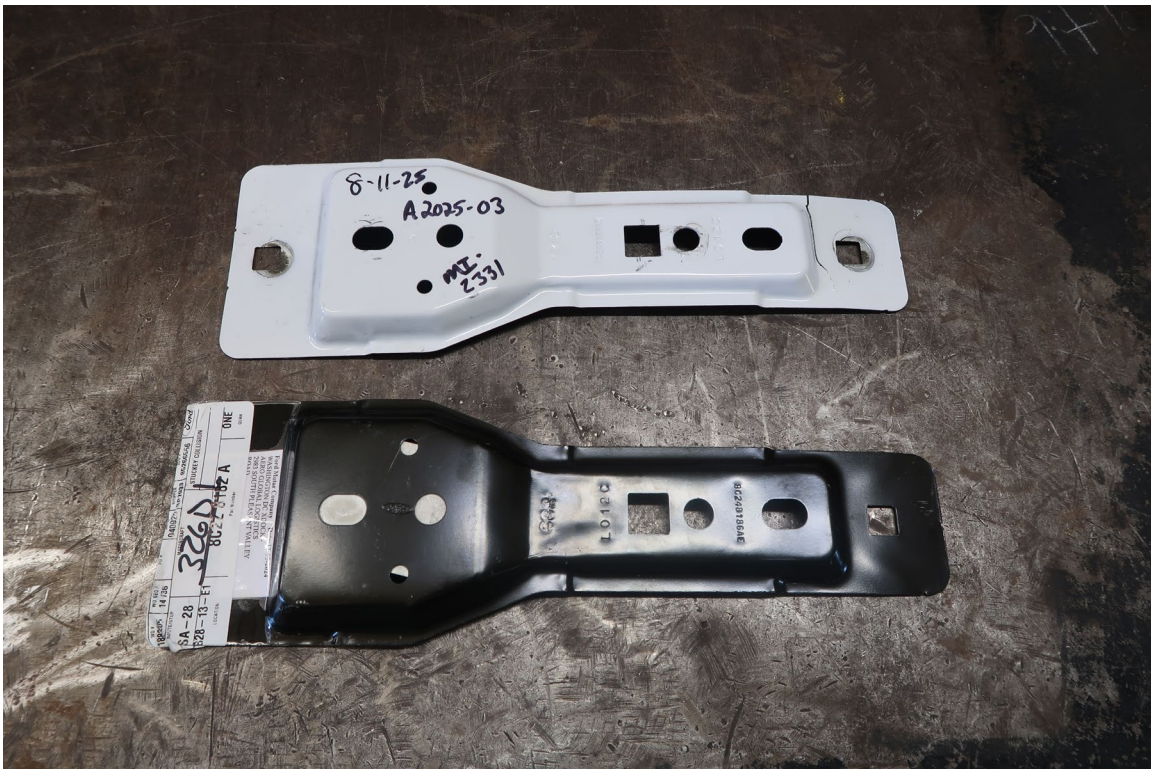
**STREETSIDE GRILLE SUPPORT BRACKET IS CRACKED  
(2,282 TEST MILES)**

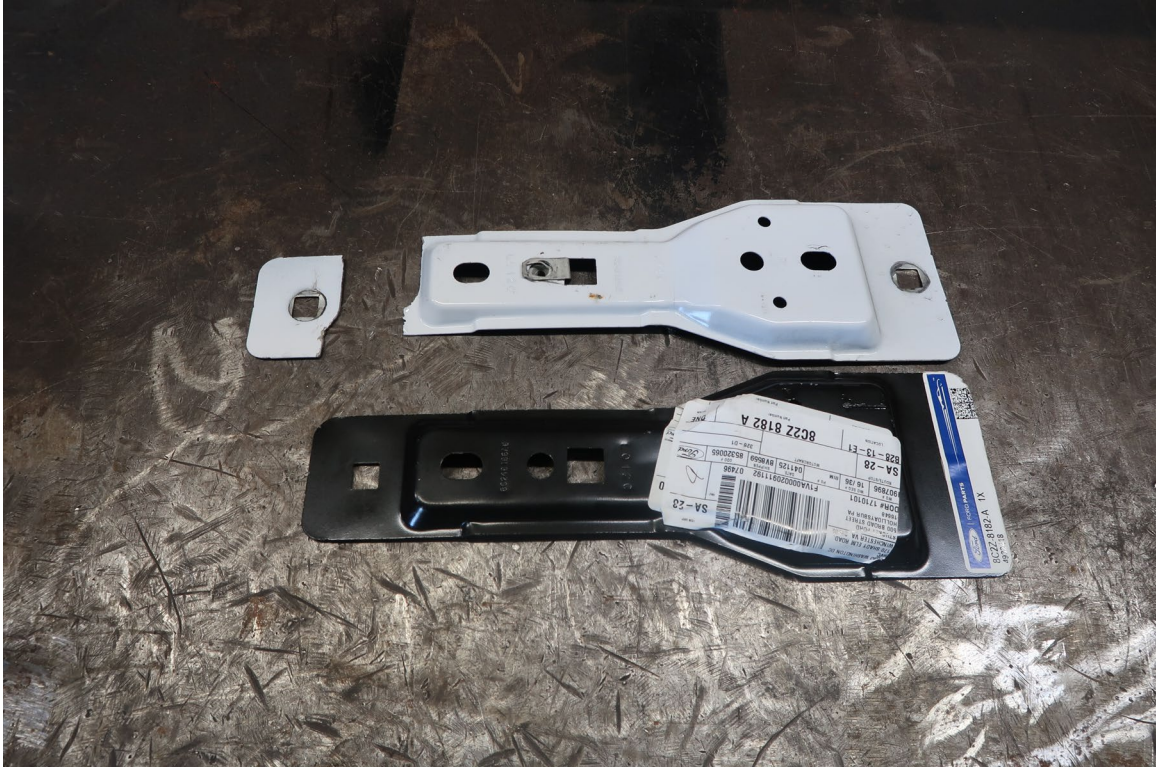
**CURBSIDE GRILLE SUPPORT BRACKET IS CRACKED  
(2,930 TEST MILES)**

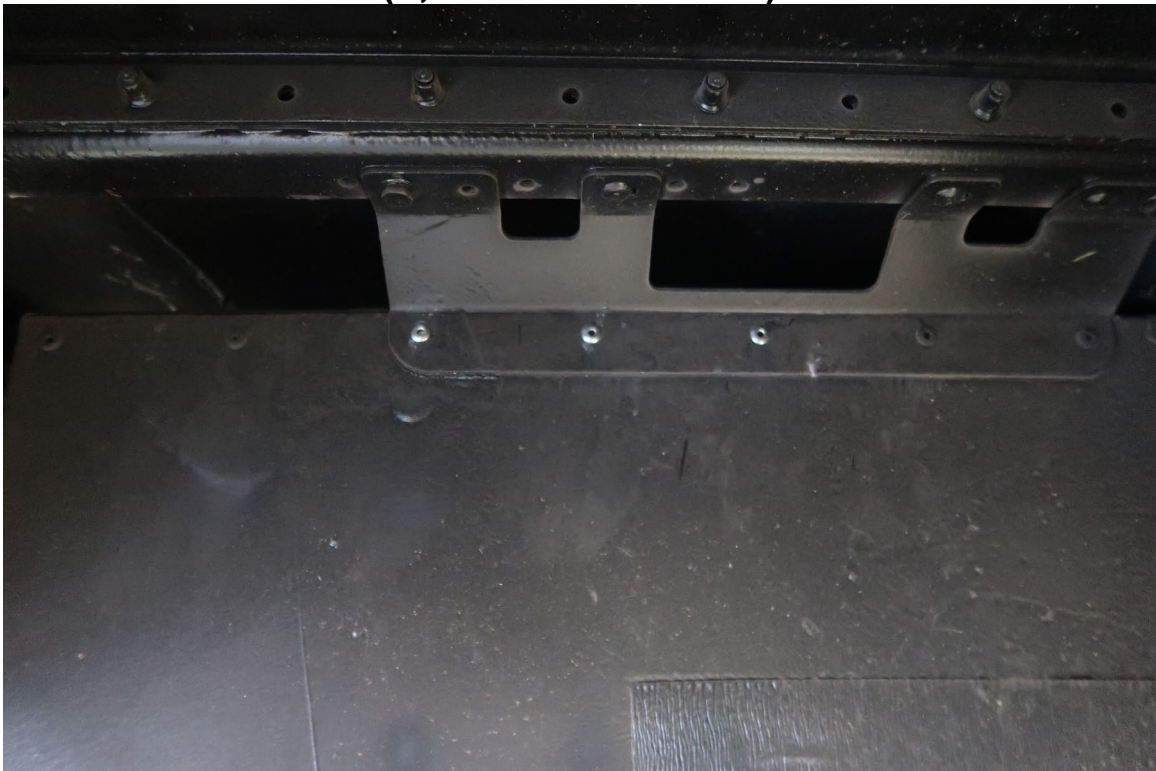
**THREE RIVETS REPLACED ON REAR SIDE OF  
12-VOLT AUXILIARY BATTERY BOX  
(2,930 TEST MILES)**

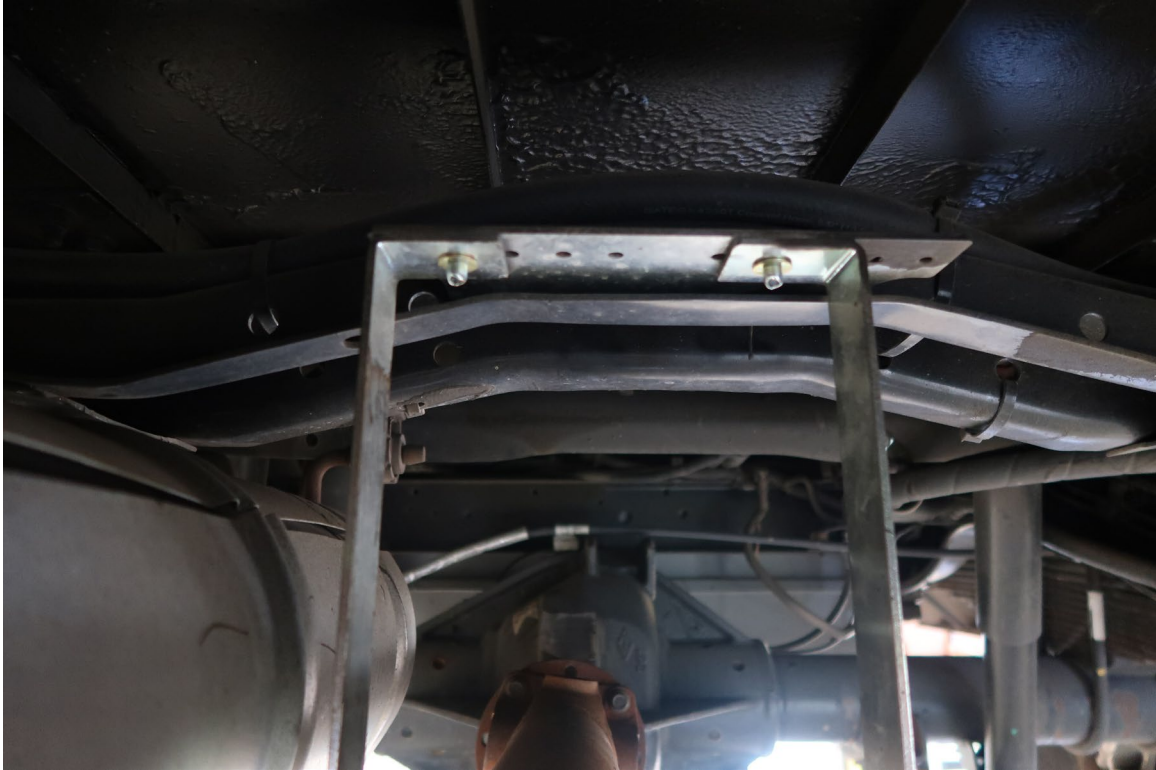
**RIVETS REPLACED ON THE REAR MOST DRIVESHAFT LOOP  
(2,930 TEST MILES)**

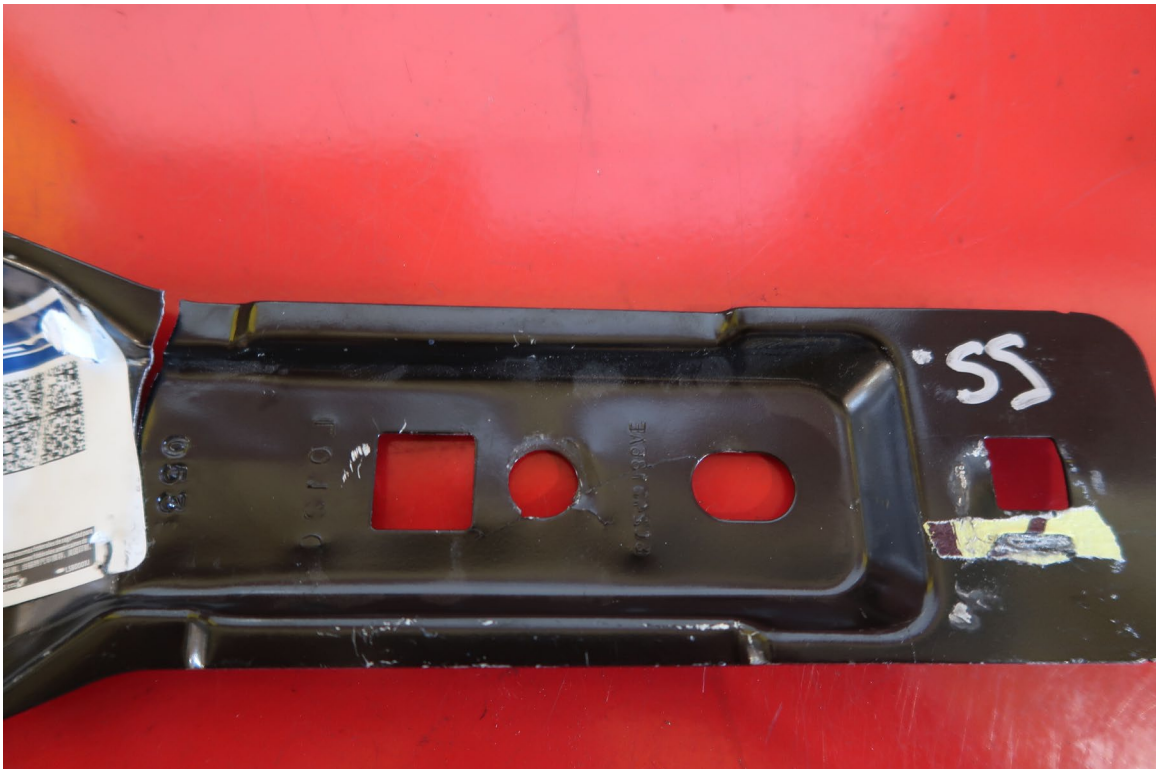
**STREETSIDE GRILLE SUPPORT BRACKET IS CRACKED  
(3,817 TEST MILES)**

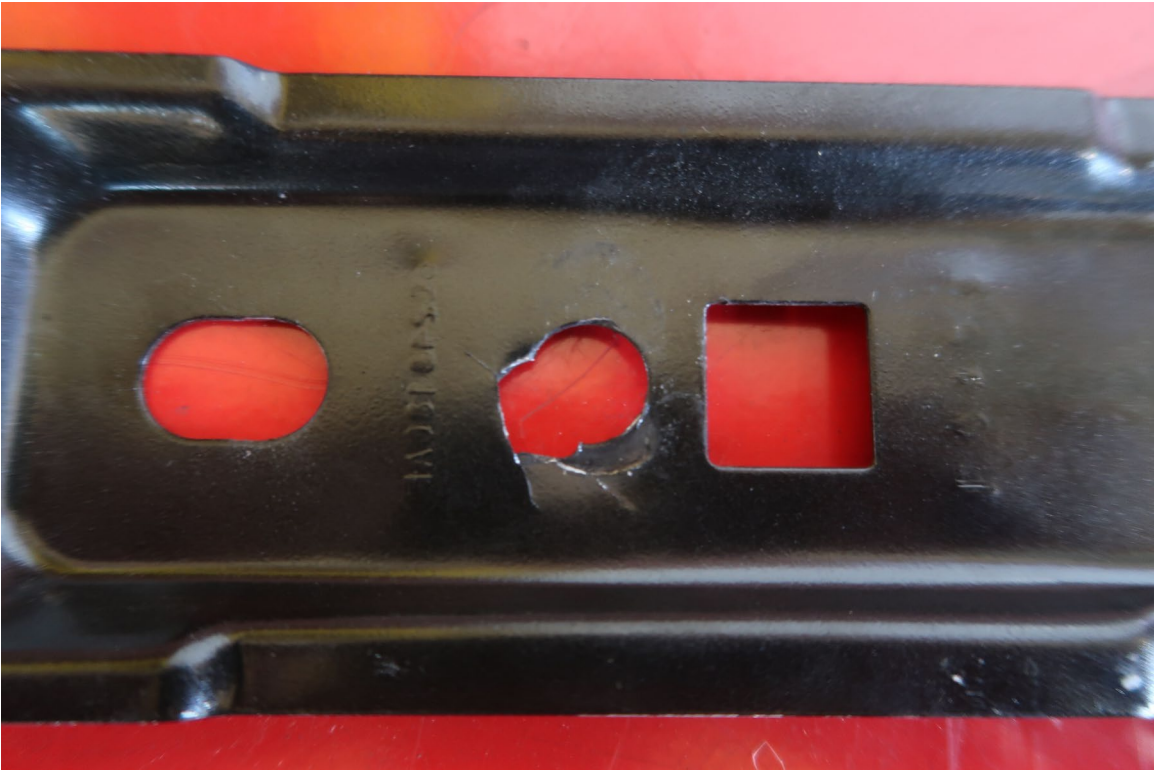
**CURBSIDE GRILLE SUPPORT BRACKET IS CRACKED  
(3,817 TEST MILES)**

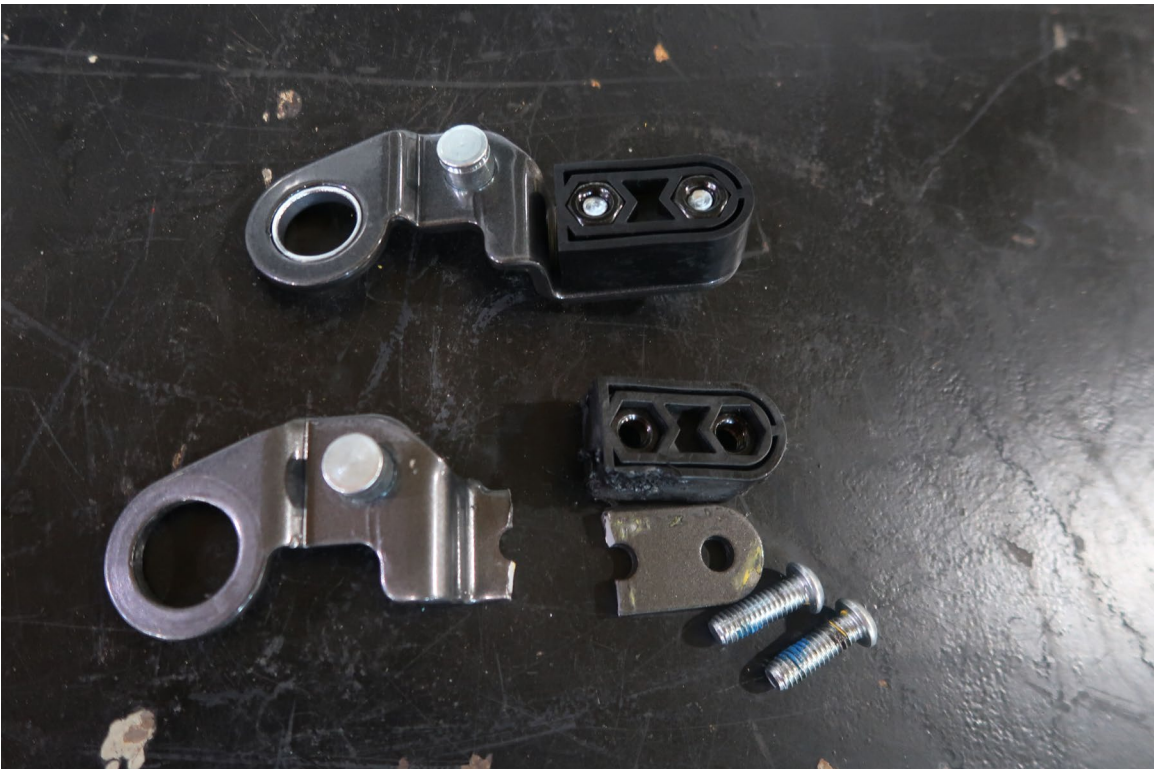
**CURBSIDE, REAR ADA LIFT INBOARD BARRIER BRACKET IS BROKEN  
(4,298 TEST MILES)**

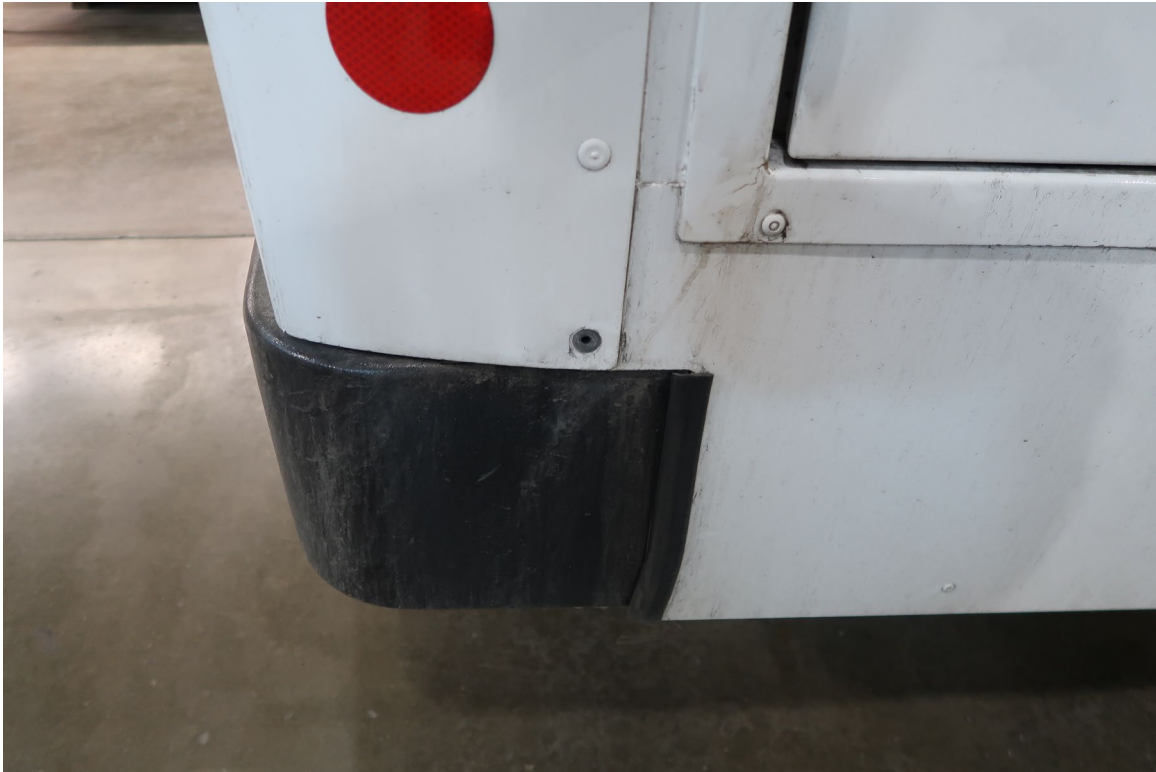
**BROKEN RIVET ON CURBSIDE REAR OF BUS  
(4,298 TEST MILES)**

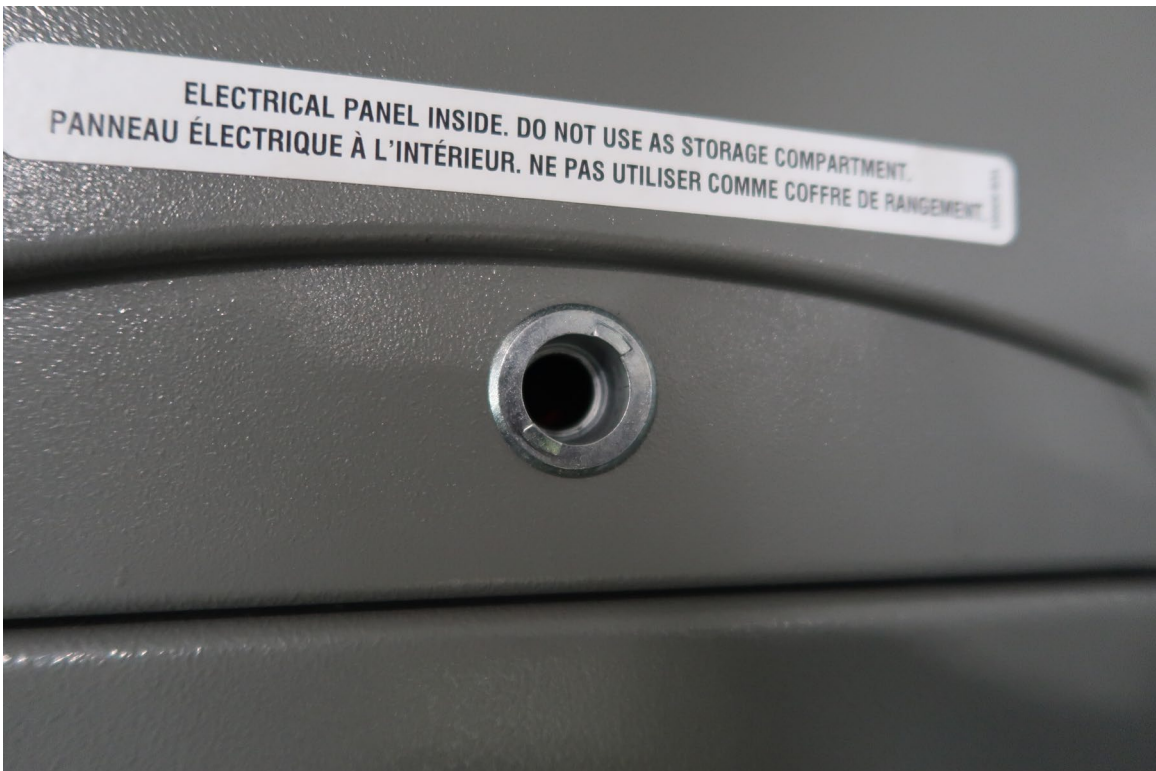
**MISSING LATCH ON FUSE PANEL LOCATED ABOVE DRIVER'S SEAT  
(4,298 TEST MILES)**

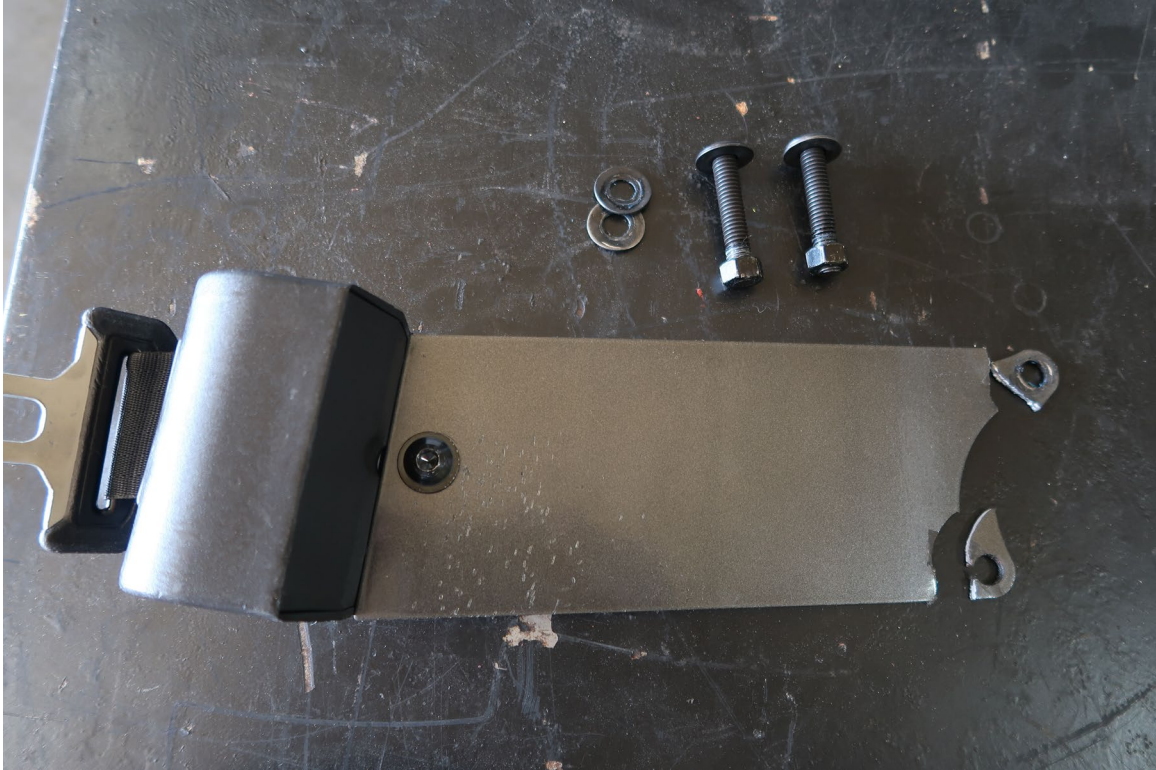
**SEATBELT BRACKET FOR ADA LIFT IS BROKEN  
(4,298 TEST MILES)**

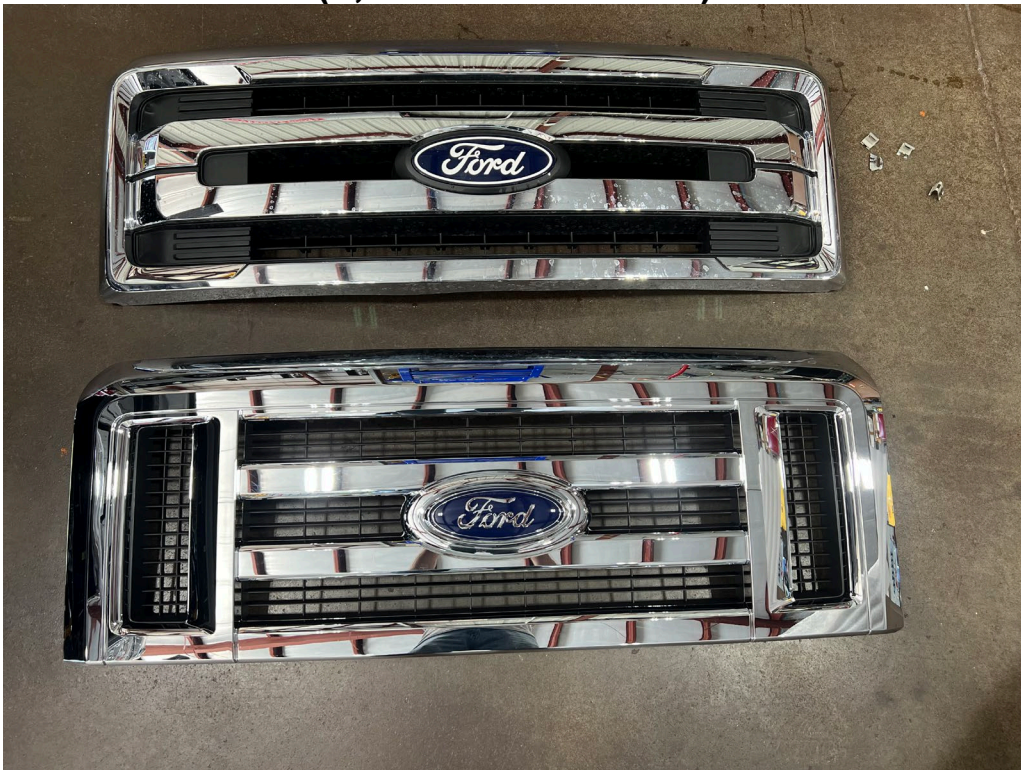
**GRILLE REPLACED; TOP IS ORIGINAL, BOTTOM IS REPLACEMENT  
(4,345 TEST MILES)**

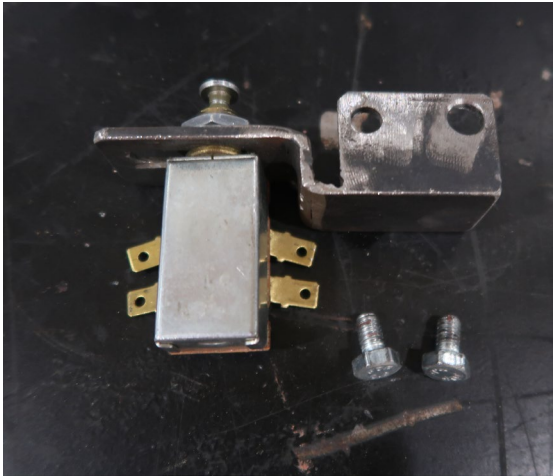
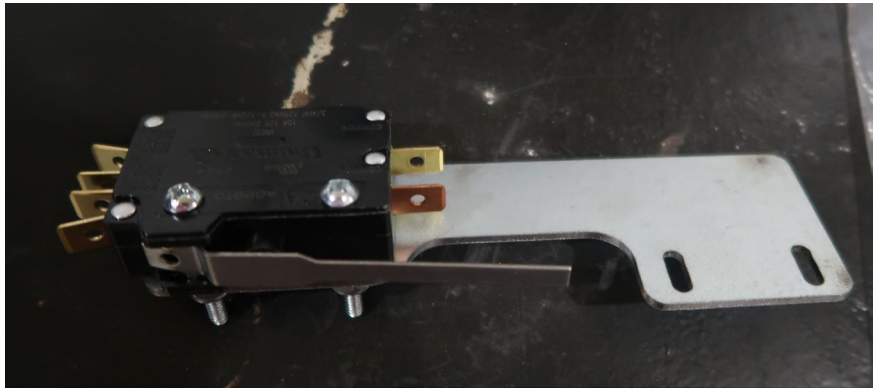
**ADA DOOR SWITCH REPLACED WITH MODIFIED VERSION;  
OLD SWITCH (LEFT), NEW SWITCH (RIGHT)  
(4,457 TEST MILES)**

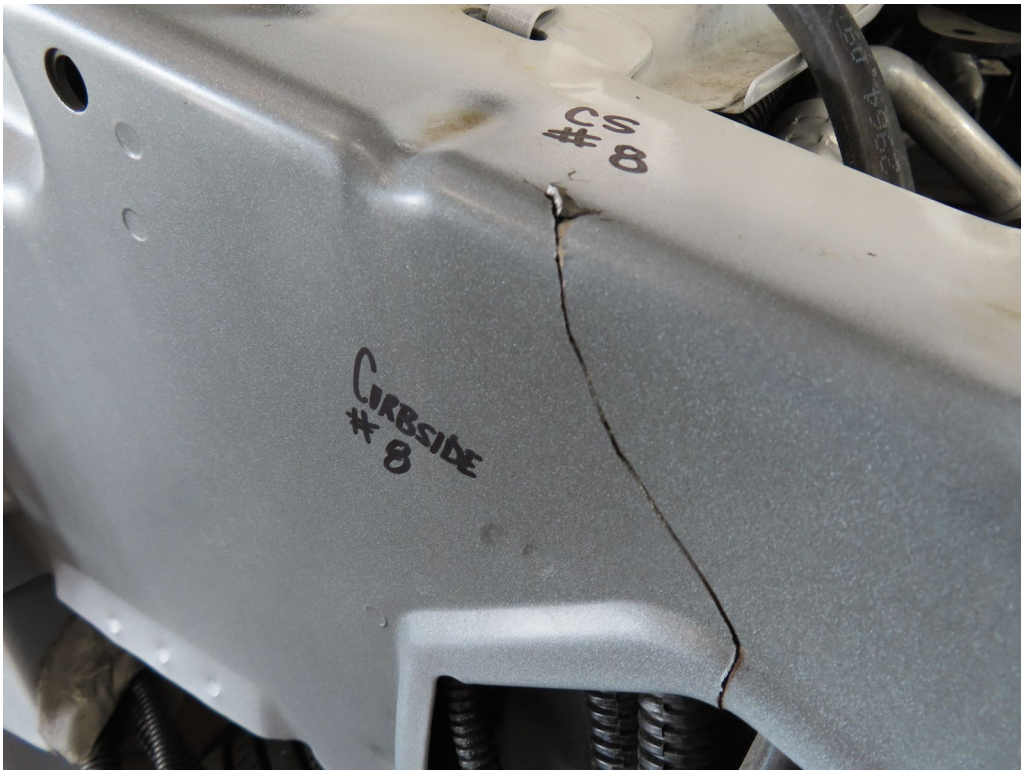
**CRACK #8 – CRACK IN CURBSIDE INNER FENDER  
(4,750 TEST MILES)**

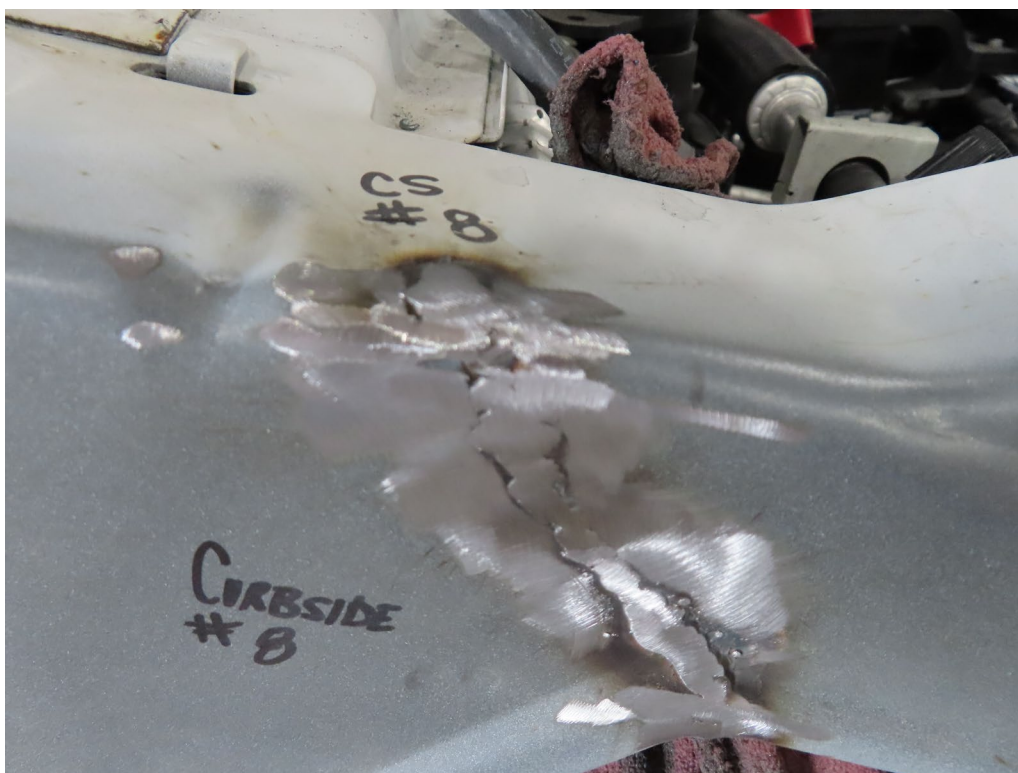
**CRACK #8 – WELDING REPAIR  
(4,750 TEST MILES)**

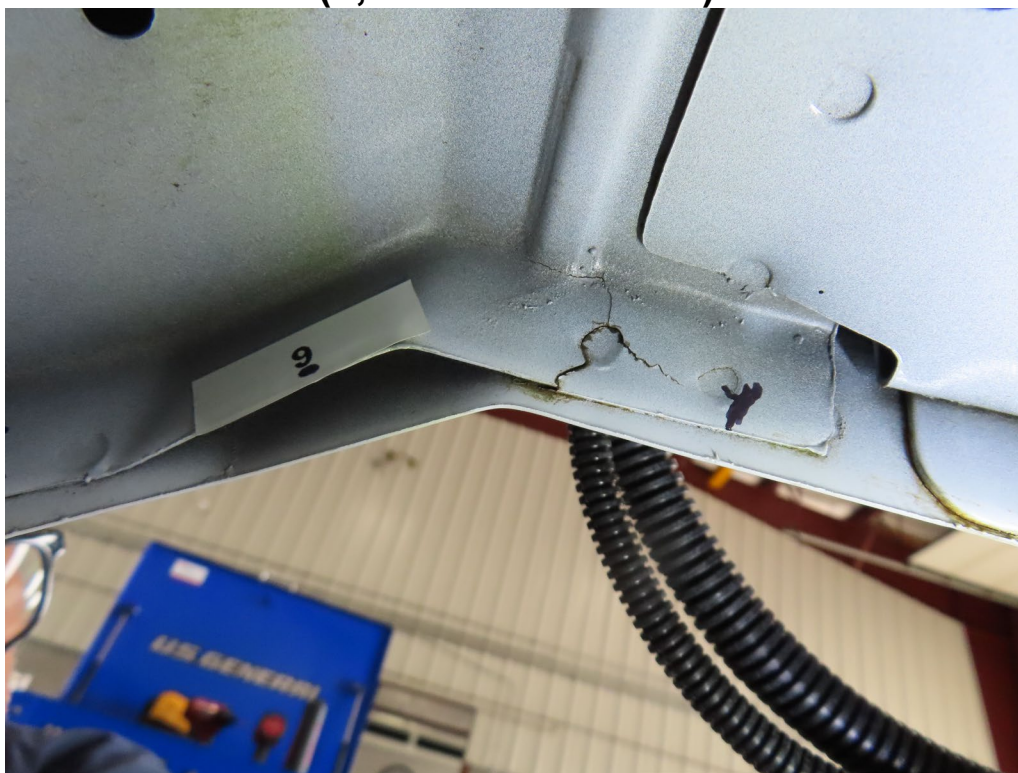
**CRACK #9 – CRACK IN INNER FENDER STRUCTURE ABOVE  
CURBSIDE FRONT TIRE  
(4,750) TEST MILES**

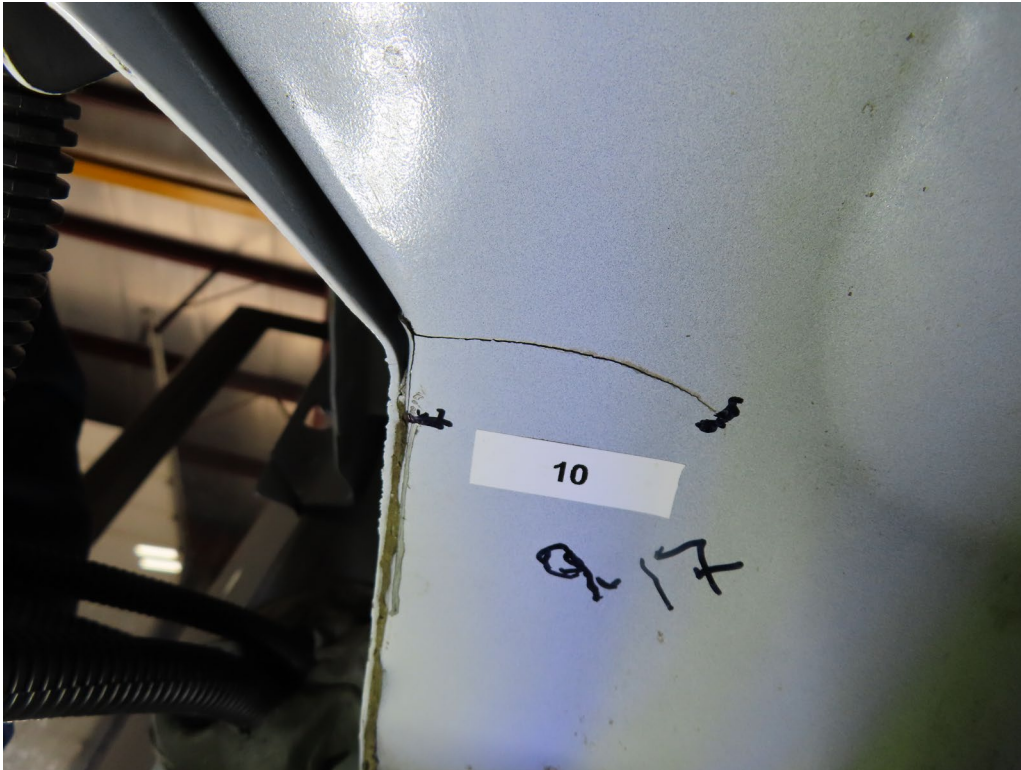
**CRACK #10 – CRACK IN INNER FENDER STRUCTURE ABOVE  
CURBSIDE FRONT TIRE  
(4,750 TEST MILES)**

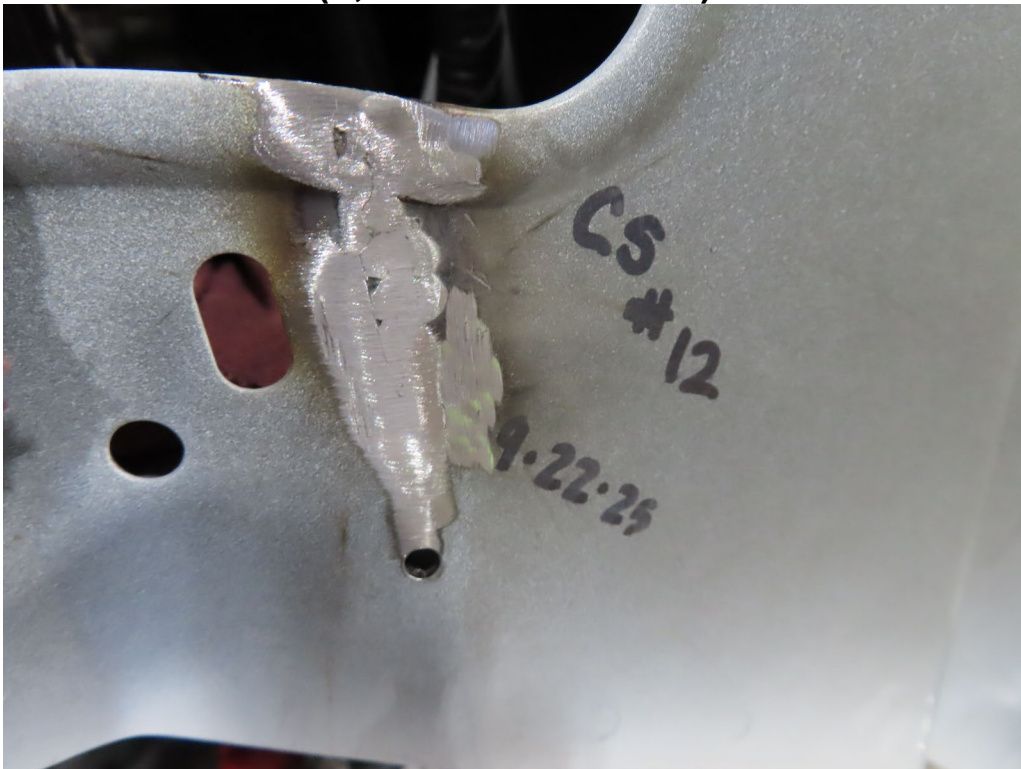
**CRACK #12 – WELDING REPAIR OF CRACK IN INNER FENDER  
(4,750 TEST MILES)**

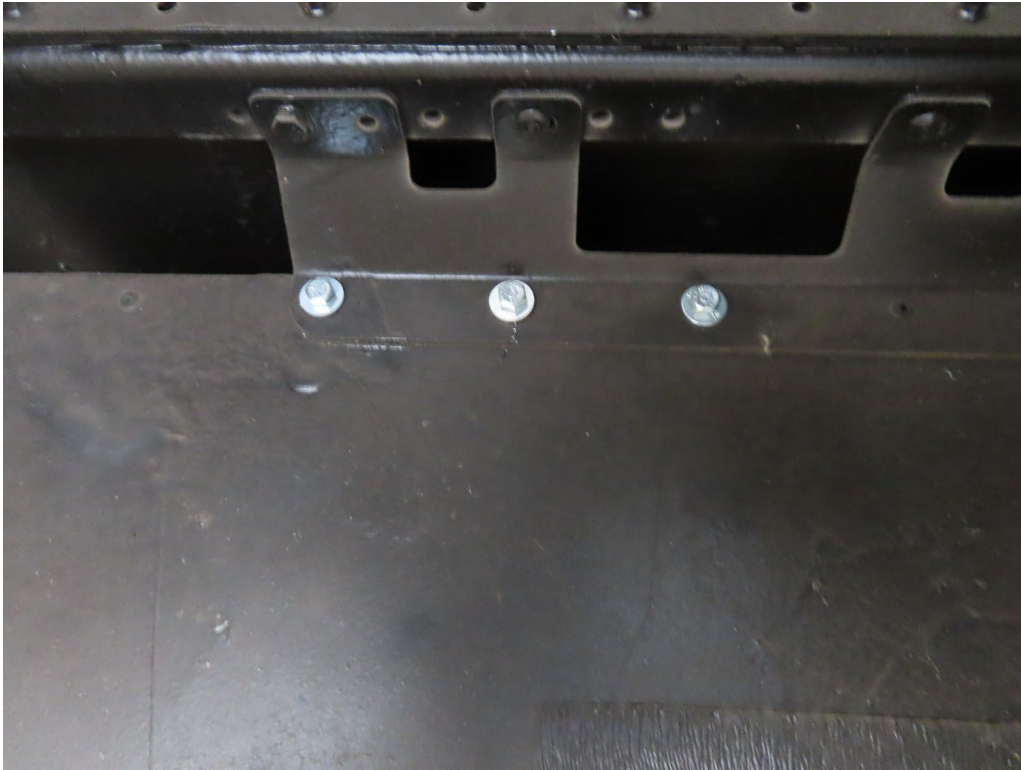
**12-VOLT AUXILIARY BATTERY BOX RIVETS REPLACED  
WITH BOLTS AND NYLOCK NUTS  
(4,750 TEST MILES)**

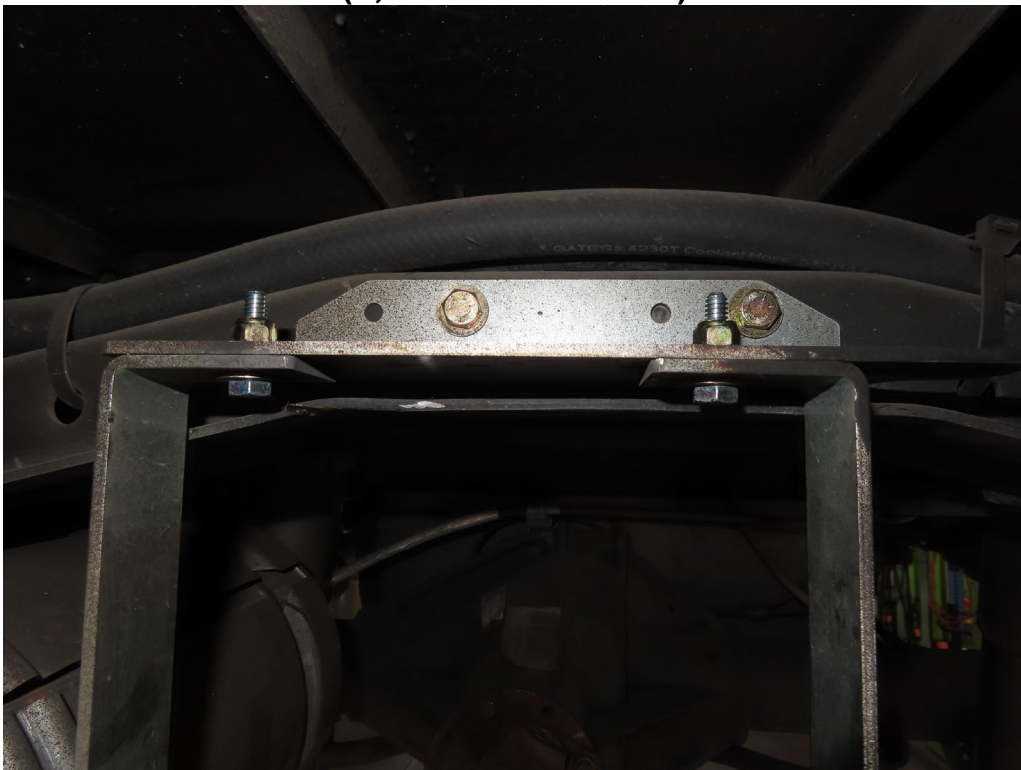
**RIVETS ON THE REAR MOST DRIVESHAFT LOOP REPLACED WITH BOLTS,  
WASHERS AND LOCK NUTS  
(5,512 TEST MILES)**

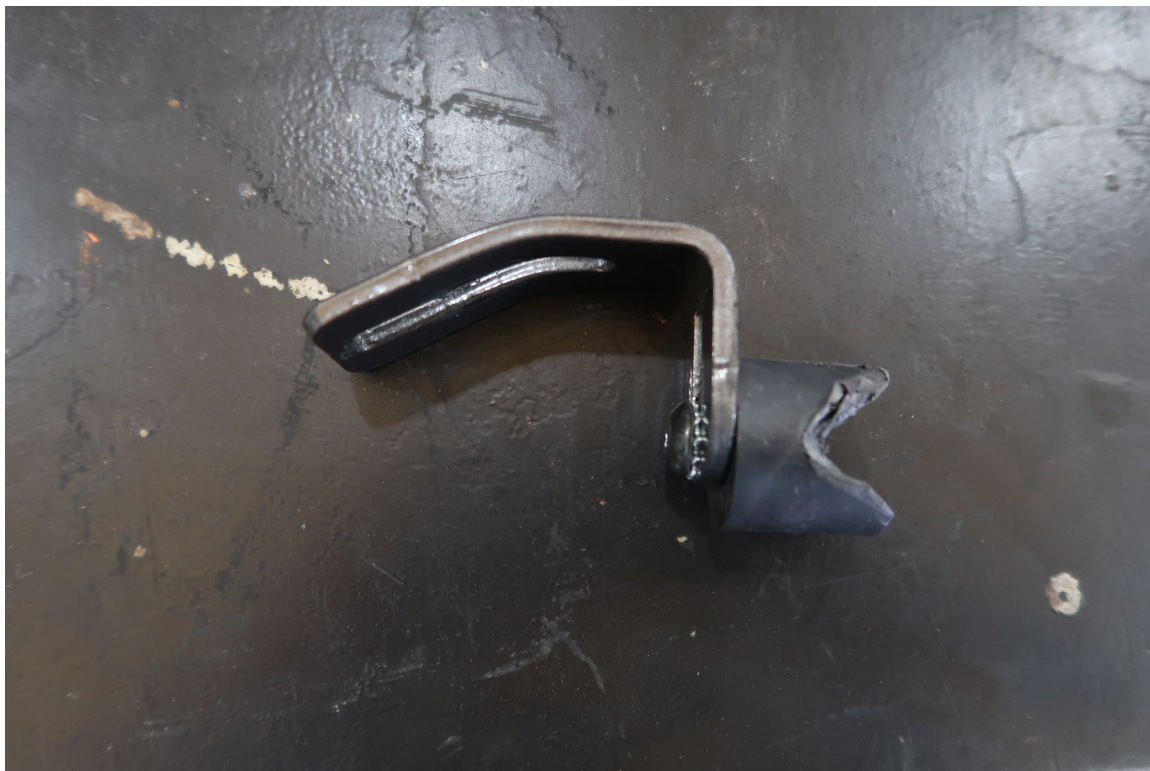
**ADA RAMP STOP BRACKET IS BROKEN  
(5,512 TEST MILES)**

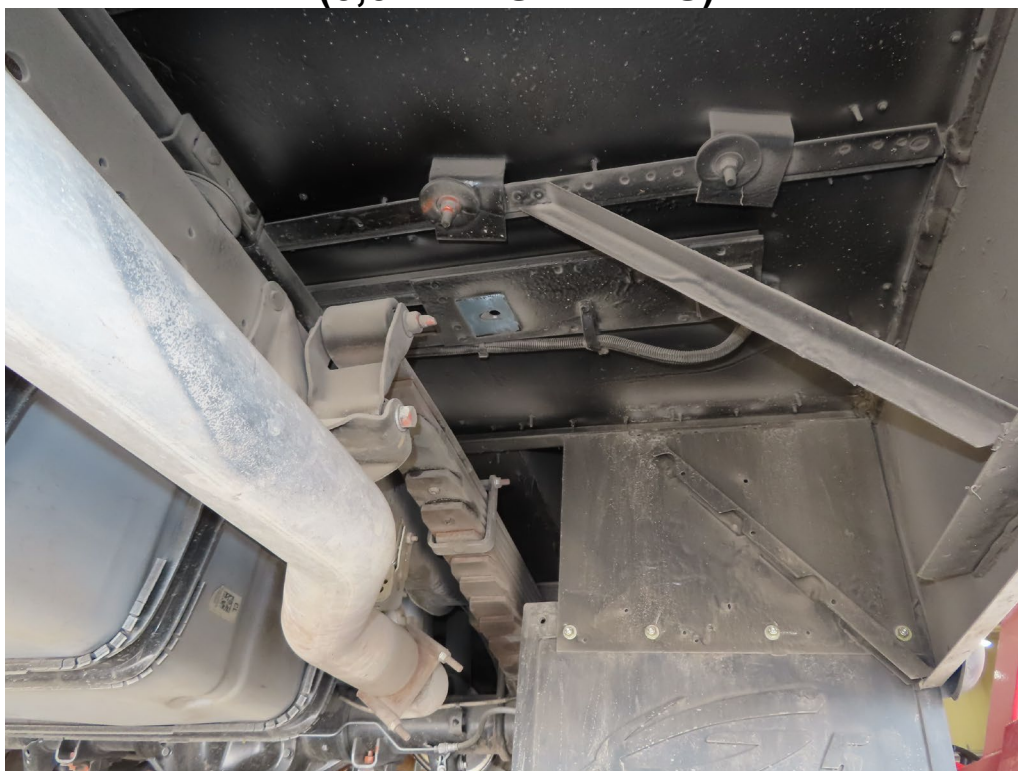
**ADA MOUNTING BOLT BROKE AND FELL OUT  
(6,008 TEST MILES)**

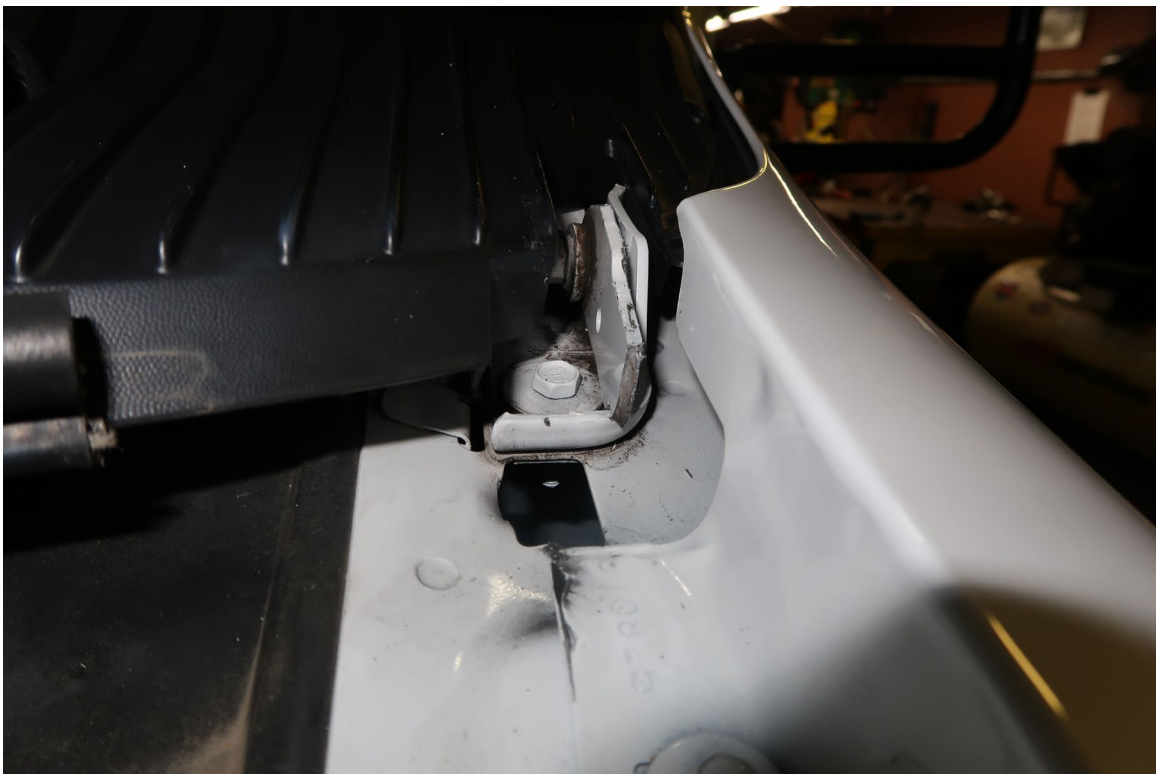
**STREETSIDE HOOD HINGE IS BROKEN  
(6,356 TEST MILES)**

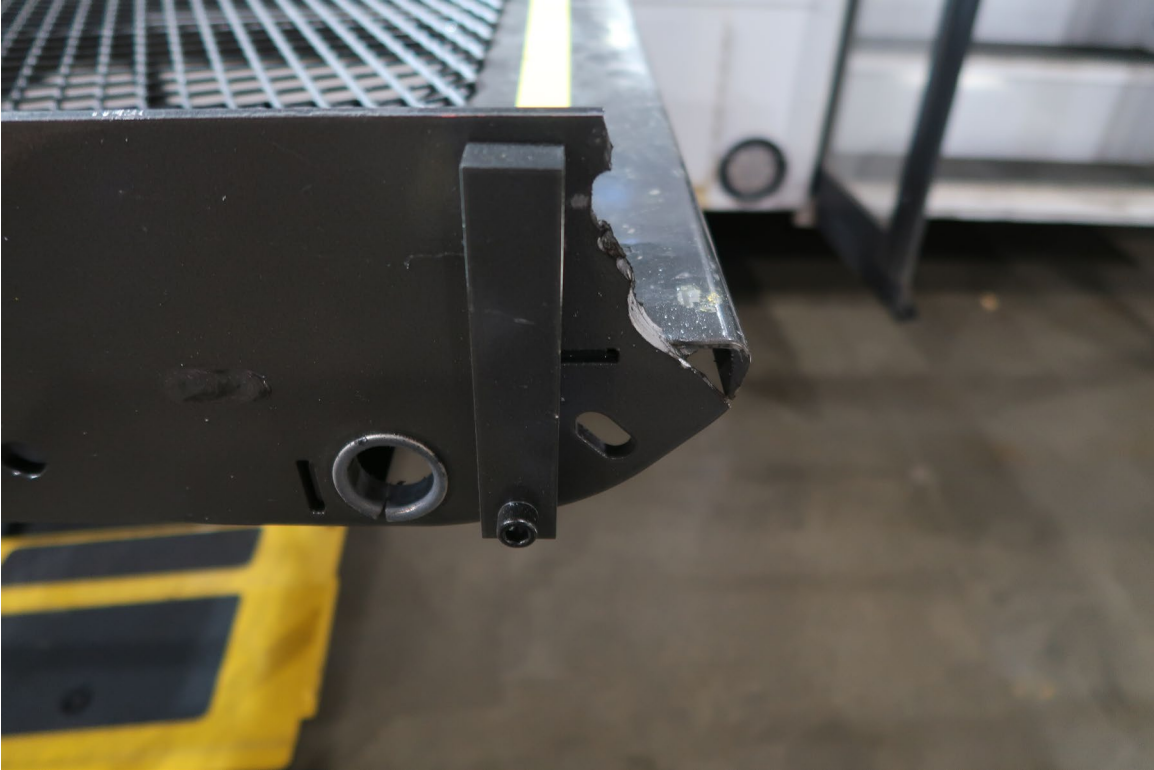
**WHEELCHAIR PLATFORM BROKEN WHERE THE INNER BARRIER ATTACHES  
(6,540 TEST MILES)**

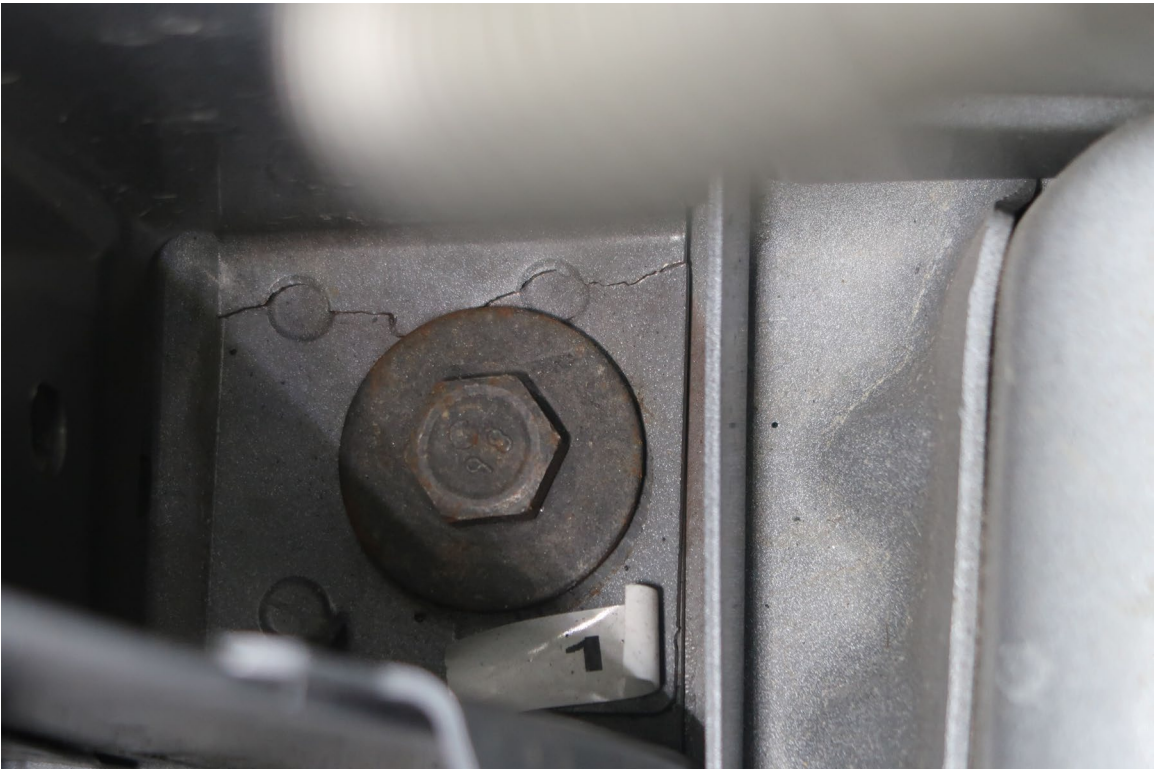
**CRACK #1; CRACK ON SPOT WELDS ON THE STREETSIDE CORE SUPPORT**
