# **FEDERAL TRANSIT BUS TEST**

**Manufacturer: Micro Bird Inc. / Micro Bird USA LLC  
Model: Micro Bird G5**

**December 2025**

**Report Number: LTI-BT-R2025-03**

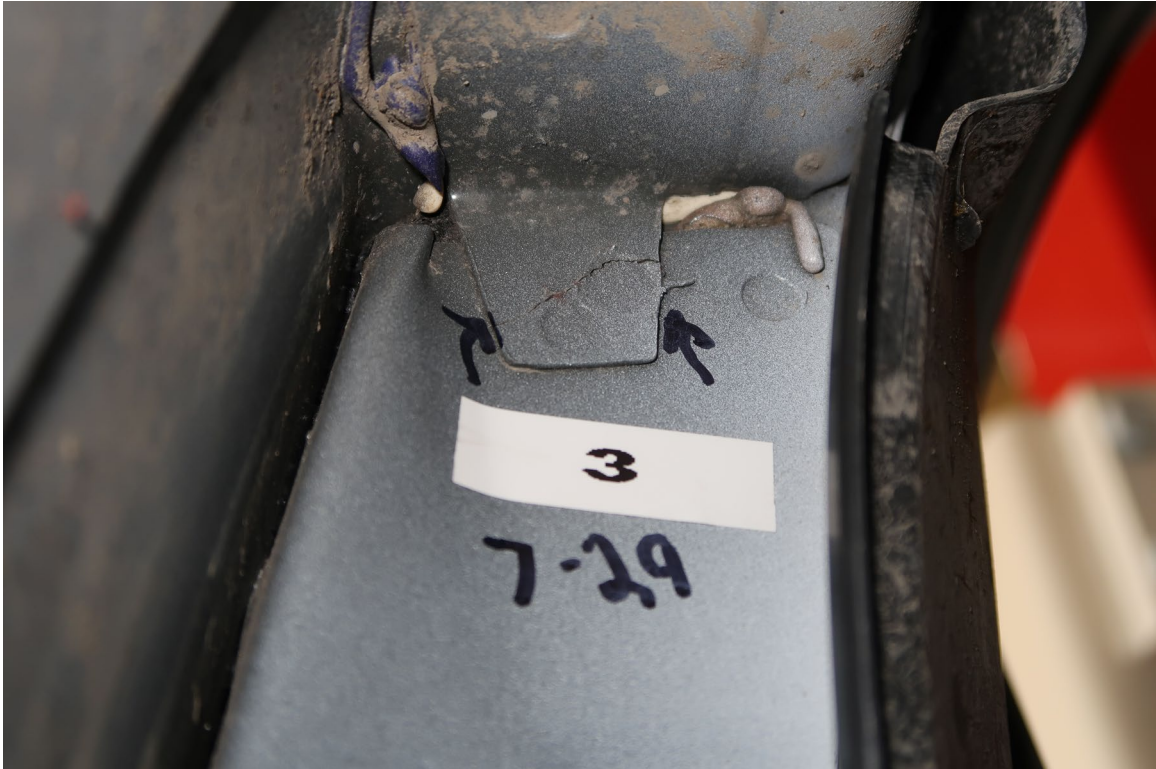
**CRACK #3; CRACK IN THE BODY UNDER THE STEP**

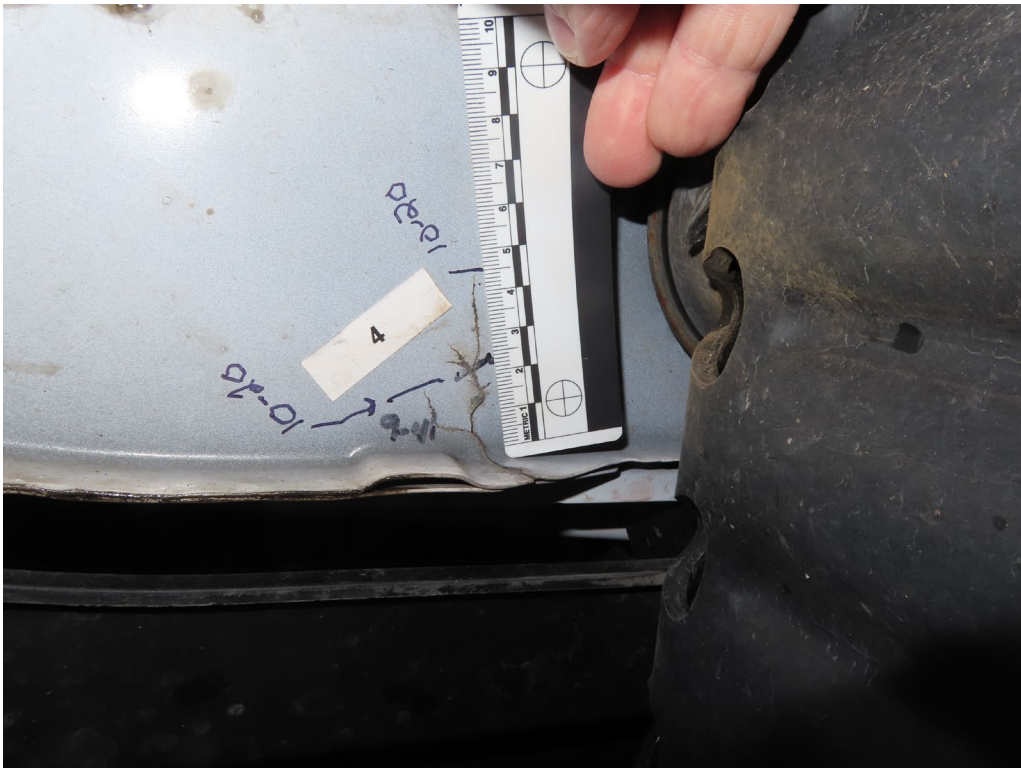
**CRACK #4; CRACK UNDER FRONT CORE SUPPORT ON STREETSIDE IN FRONT OF STREETSIDE FRONT WHEEL**

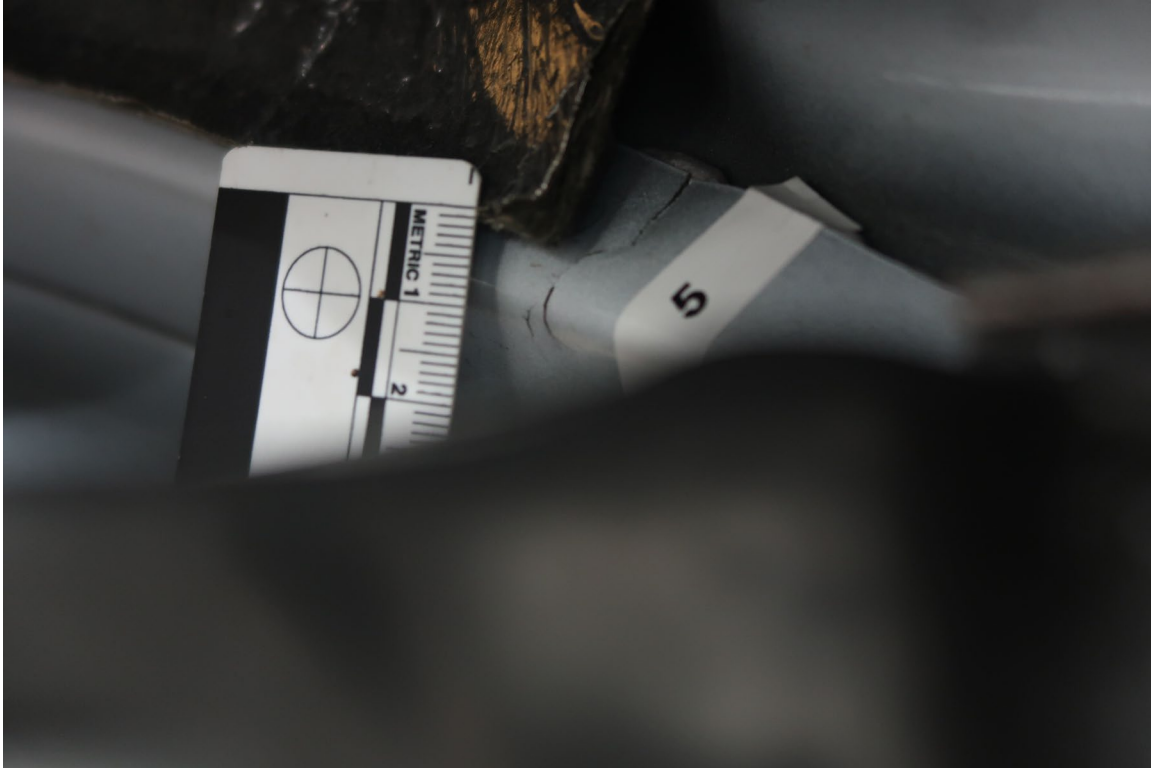
| DATE | TEST<br>MILES | SERVICE | ACTIVITY/OBSERVATIONS | DOWN<br>TIME | LABOR<br>HOURS |
|---|---|---|---|---|---|
| 10/20/25<br>(Cont.) | | | <p>#5 – Crack in the curbside inner fender structure in front of the curbside entrance doorsteps – 2 cm in length is now approximately 3 cm.</p> <p>#6 – Crack in the curbside inner fender structure in front of the curbside entrance doorsteps, near crack #5 – 1 cm in length – No change.</p> <p>#7 - Crack on curbside under the seal of the engine cover access. Cover needs to be removed to see the crack – 2 cm in length – No change.</p> <p>#8 - Crack on curbside inner fender under the hood in the engine compartment by the blower motor – crack has extended by 7 cm to 8 cm in length in total – Repaired – Cracked again, see crack #8.1.</p> <p>#8.1 – Crack on the curbside inner fender under the hood in the engine compartment by the blower motor, 8 cm in length – No change.</p> <p>#9 – Crack on curbside inner fender structure above the front tire – 4.5 cm in length – Repaired.</p> <p>#10 Crack on curbside inner fender structure above the front tire – 6.5 cm in length - Repaired.</p> <p>#11 – Crack on streetside inner fender structure above the frame rail near the power steering box – 2.5 cm in length – No change.</p> <p>#12 – Crack in inner fender below crack # 8. Found when the fender was removed for the repair of other cracks – Repaired – No change.</p> <p>#13 – Crack just below the corner of the windshield under the fender – can only be seen when the fender is removed.</p> | | |

**CRACK #5; CRACK IN CURBSIDE INNER FENDER STRUCTURE IN FRONT OF CURBSIDE FRONT ENTRANCE STEPS**

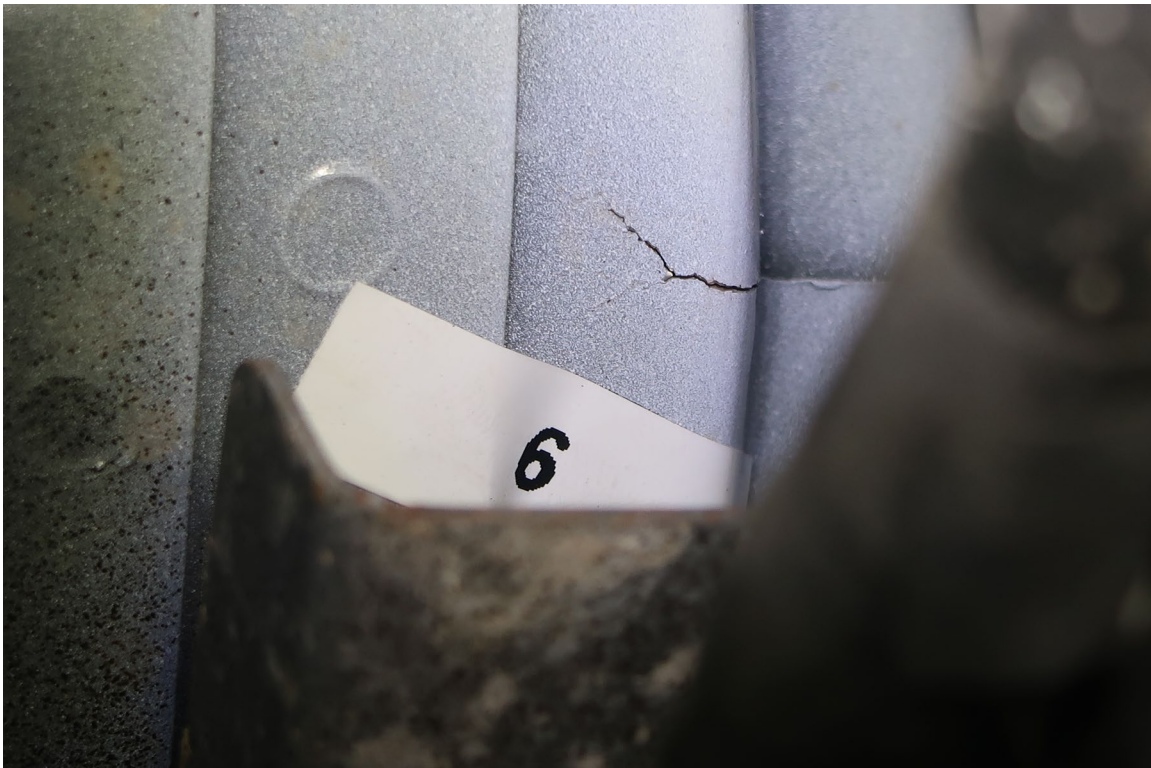
**CRACK #6; CRACK IN THE CURBSIDE INNER FENDER STRUCTURE IN FRONT OF THE CURBSIDE ENTRANCE DOORSTEPS**

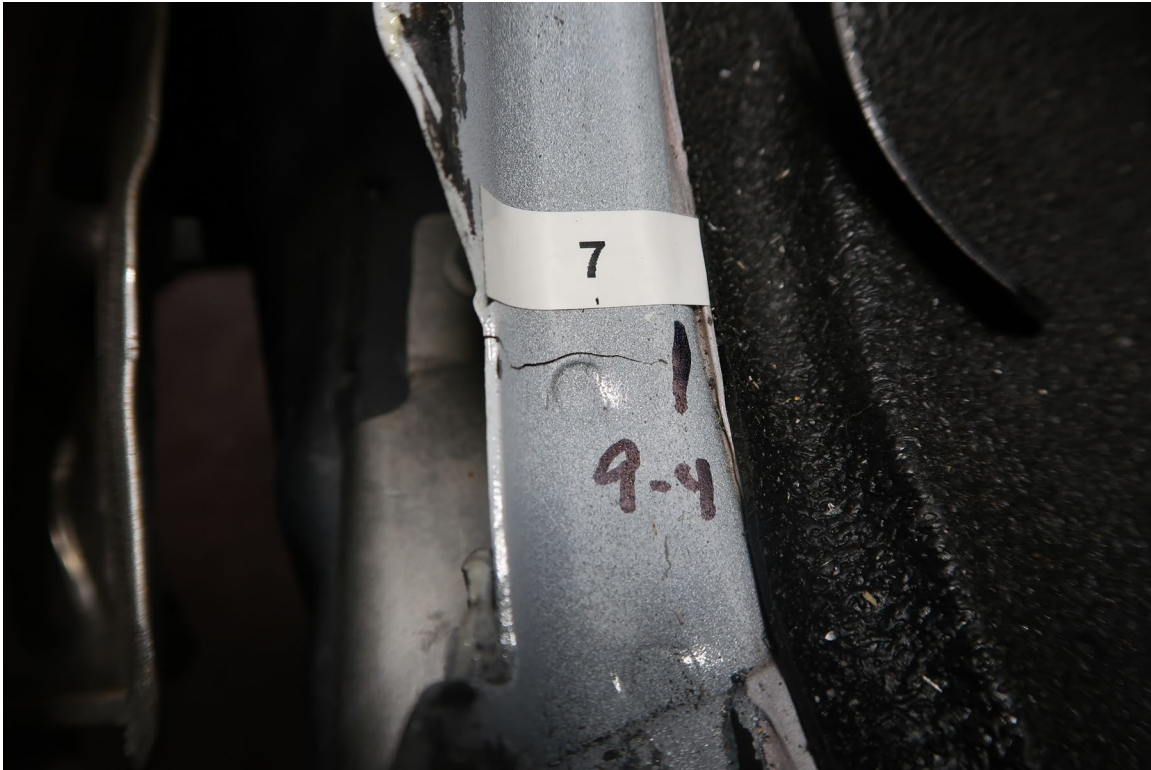
**CRACK #7; CRACK ON CURBSIDE UNDER THE SEAL OF THE ENGINE ACCESS COVER**

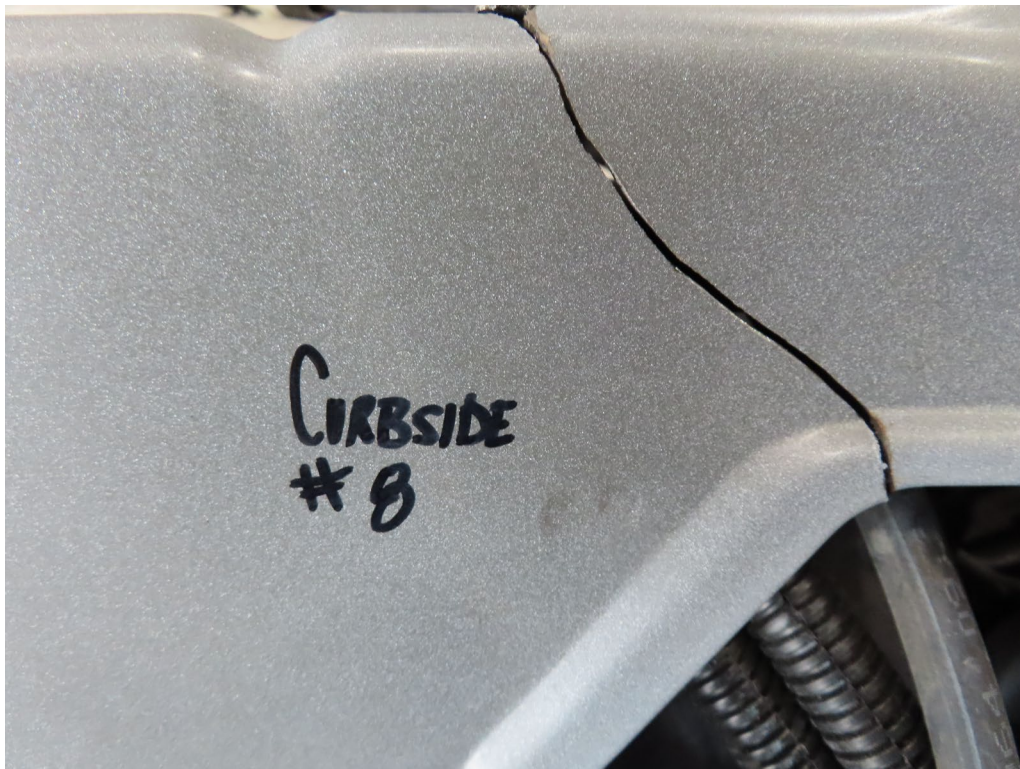
**CRACK #8; CRACK ON THE CURBSIDE INNER FENDER UNDER THE HOOD**

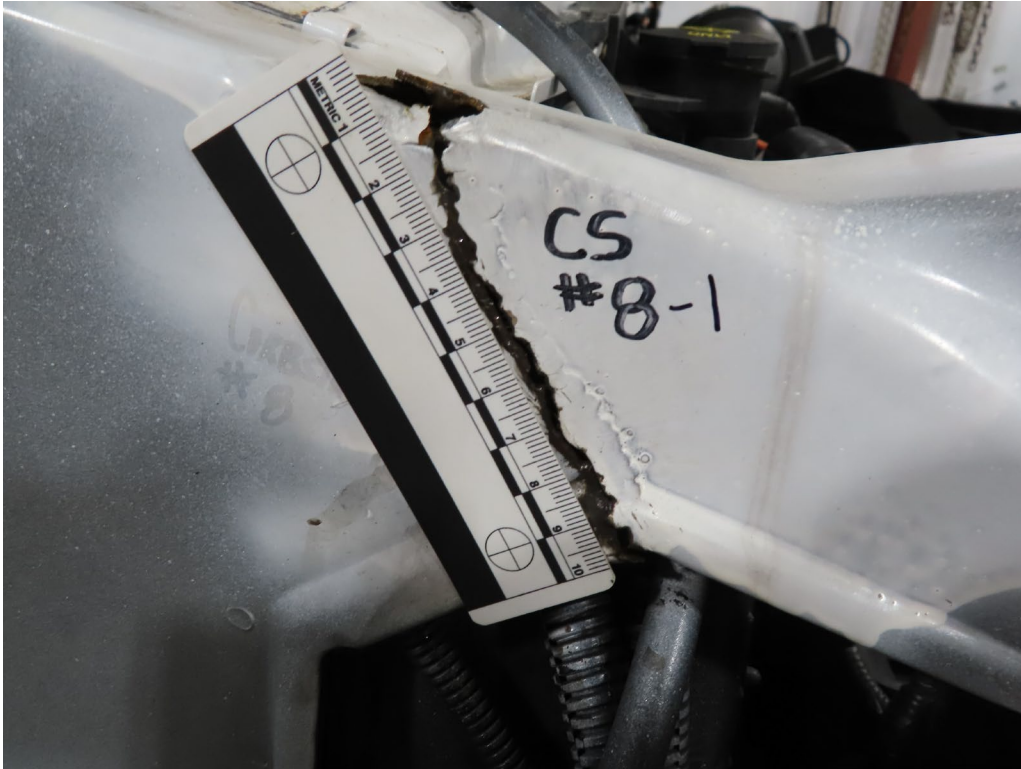
| DATE | TEST MILES | SERVICE | ACTIVITY/OBSERVATIONS | DOWN TIME | LABOR HOURS |
|---|---|---|---|---|---|
| 10/07/25<br>(Cont.) | | | <p>#8.1 – Crack on the curbside inner fender under the hood in the engine compartment by the blower motor, 8 cm in length.</p> <p>#9 – Crack on curbside inner fender structure above the front tire – 4.5 cm in length – Repaired.</p> <p>#10 Crack on curbside inner fender structure above the front tire – 6.5 cm in length - Repaired.</p> <p>#11 – Crack on streetside inner fender structure above the frame rail near the power steering box – 2.5 cm in length – No change.</p> <p>#12 – Crack in inner fender below crack # 8. Found when the fender was removed for the repair of other cracks - Repaired.</p> <p>#13 – Crack just below the corner of the windshield under the fender.</p> | | |

**CRACK #8-1; WELDED REPAIR OF CRACK #8 ON THE CURBSIDE INNER FENDER UNDER THE HOOD HAS CRACKED**

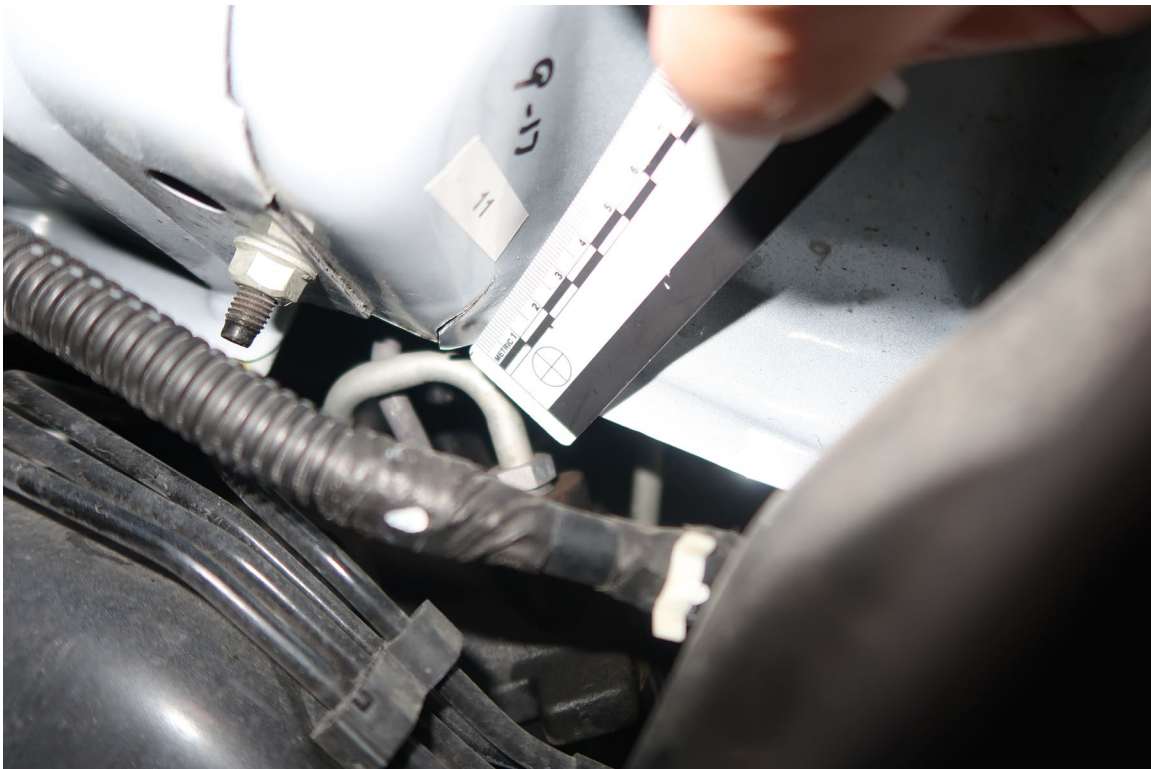
**CRACK #11; CRACK ON STREETSIDE INNER FENDER STRUCTURE ABOVE THE FRAME RAIL NEAR THE POWER STEERING BOX**

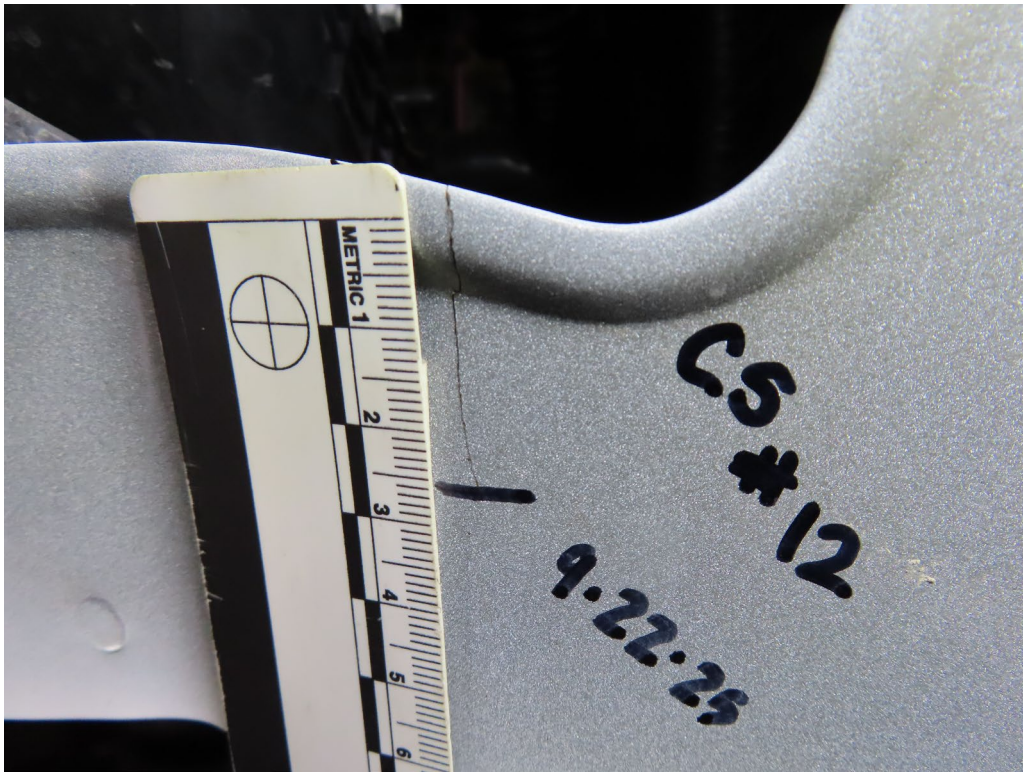
**CRACK #12; CRACK ON THE CURBSIDE INNER FENDER**

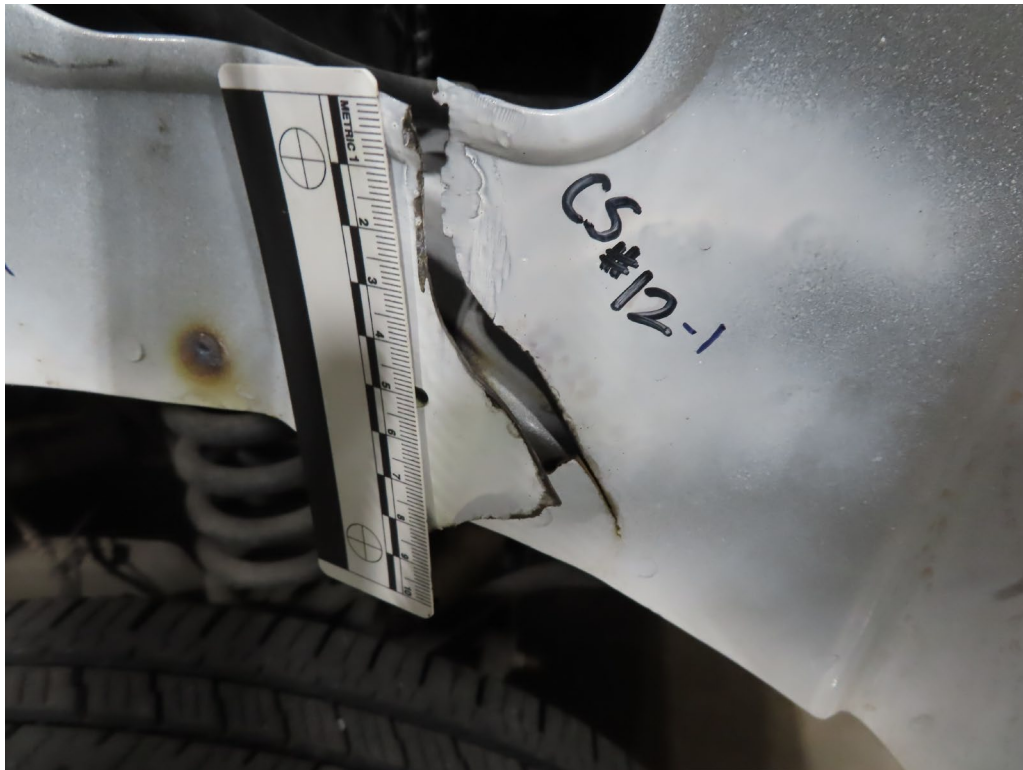
**CRACK #12-1; WELDED REPAIR OF CRACK #12 ON THE CURBSIDE INNER FENDER HAS CRACKED**

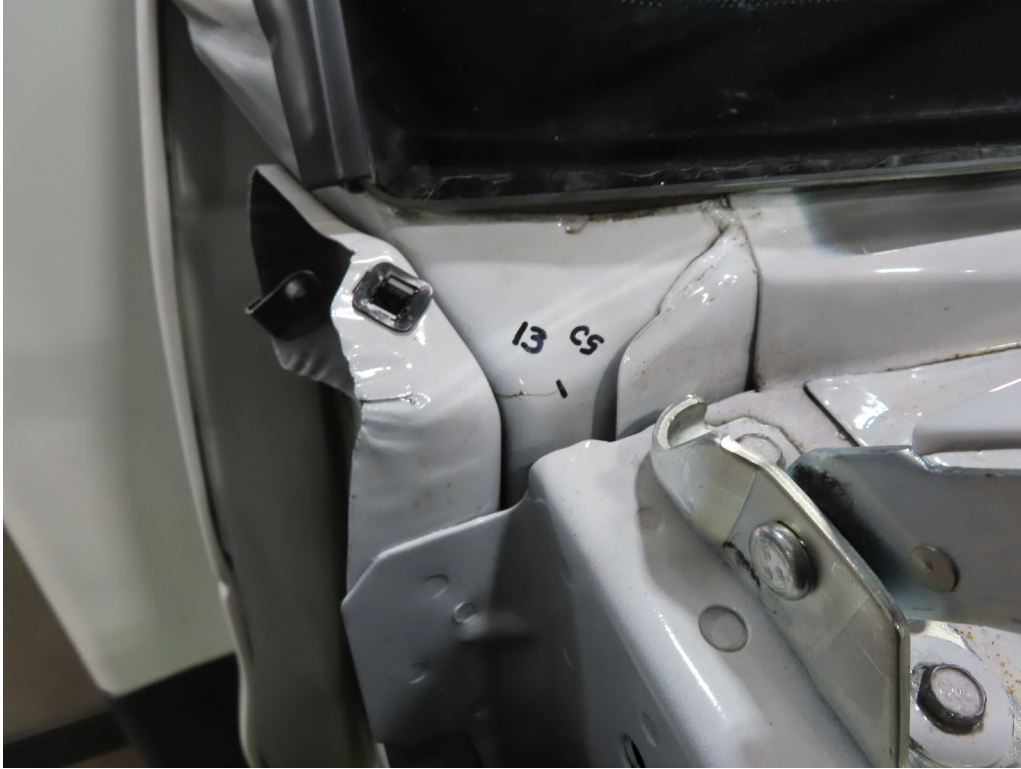
**CRACK #13; CRACK JUST BELOW THE CORNER OF THE WINDSHIELD UNDER THE FENDER**

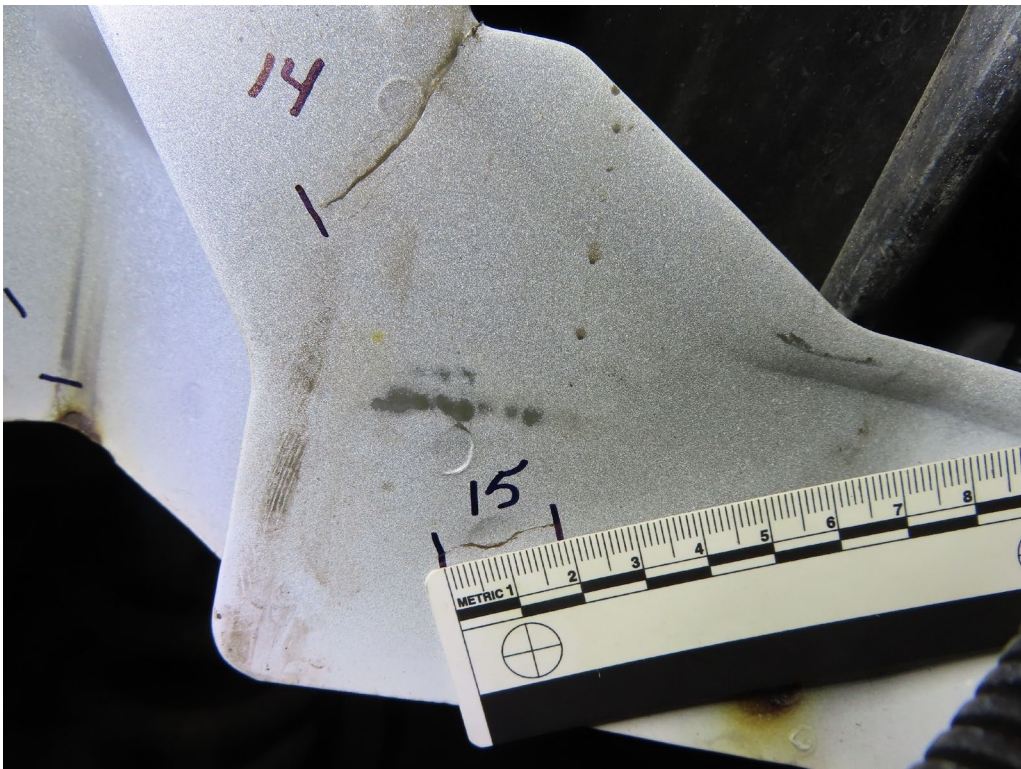
**CRACKS #14 & 15; CRACKS ON THE CURBSIDE INNER FENDER**

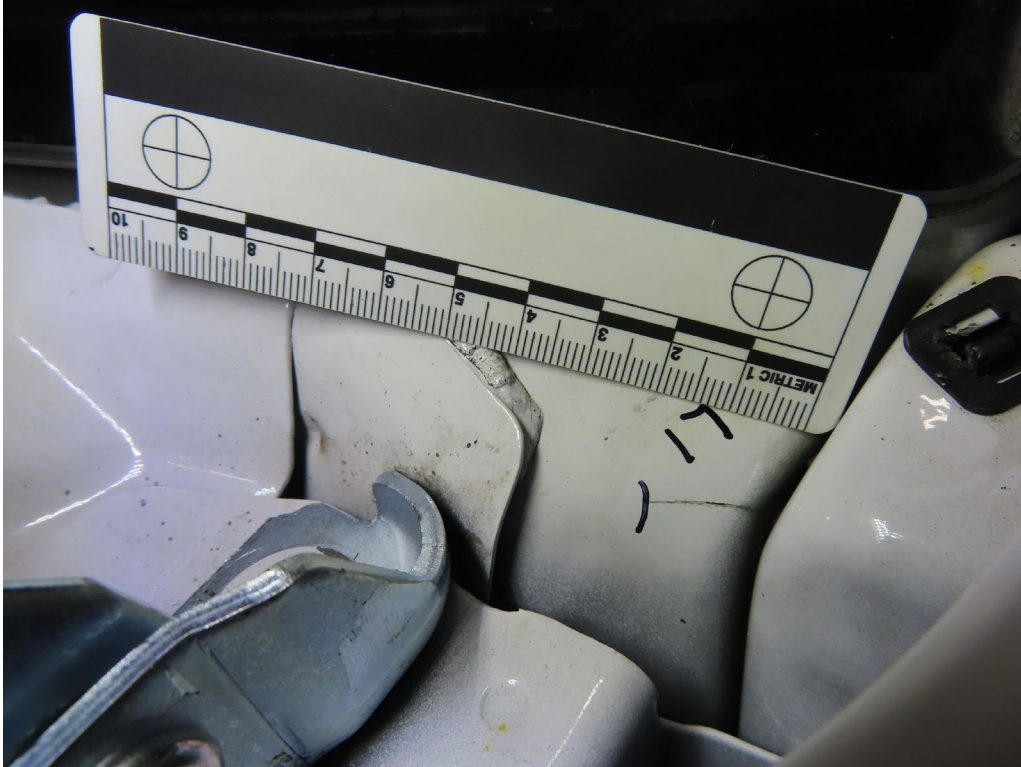
**CRACK #17; CRACK ON THE STREETSIDE BELOW THE WINDSHIELD ON THE BODY UNDER THE WIPER COWL**

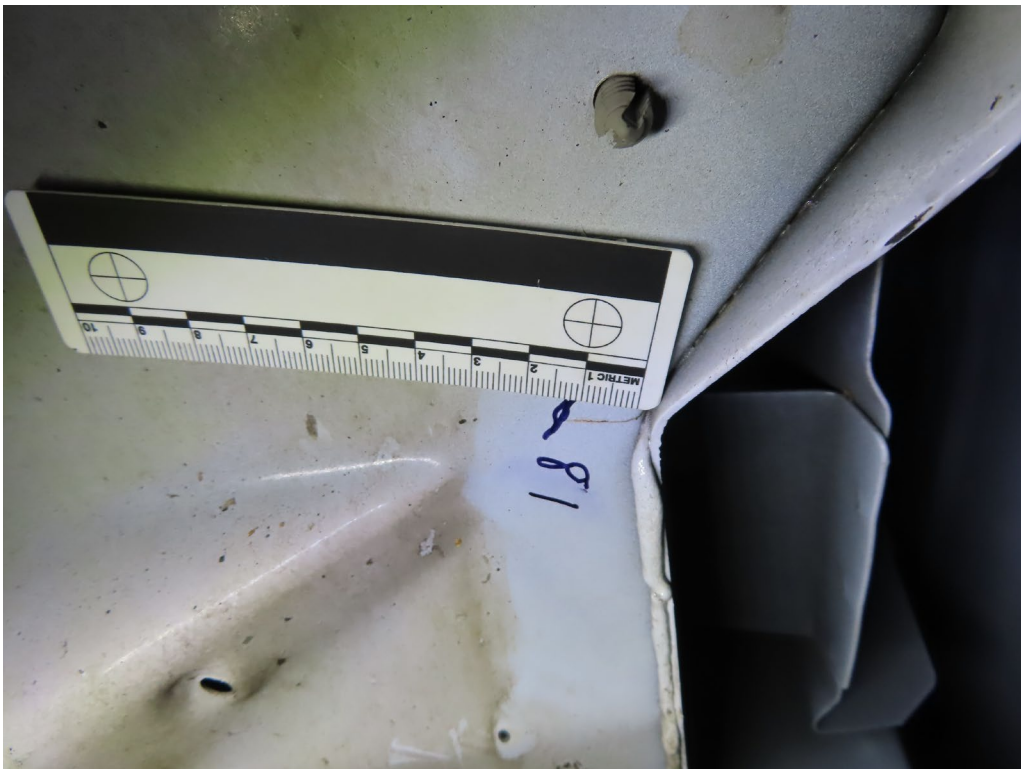
**CRACK #18; CRACK ON STREETSIDE INNER FENDER WELL BEHIND PLASTIC LINER ABOVE THE TIRE**

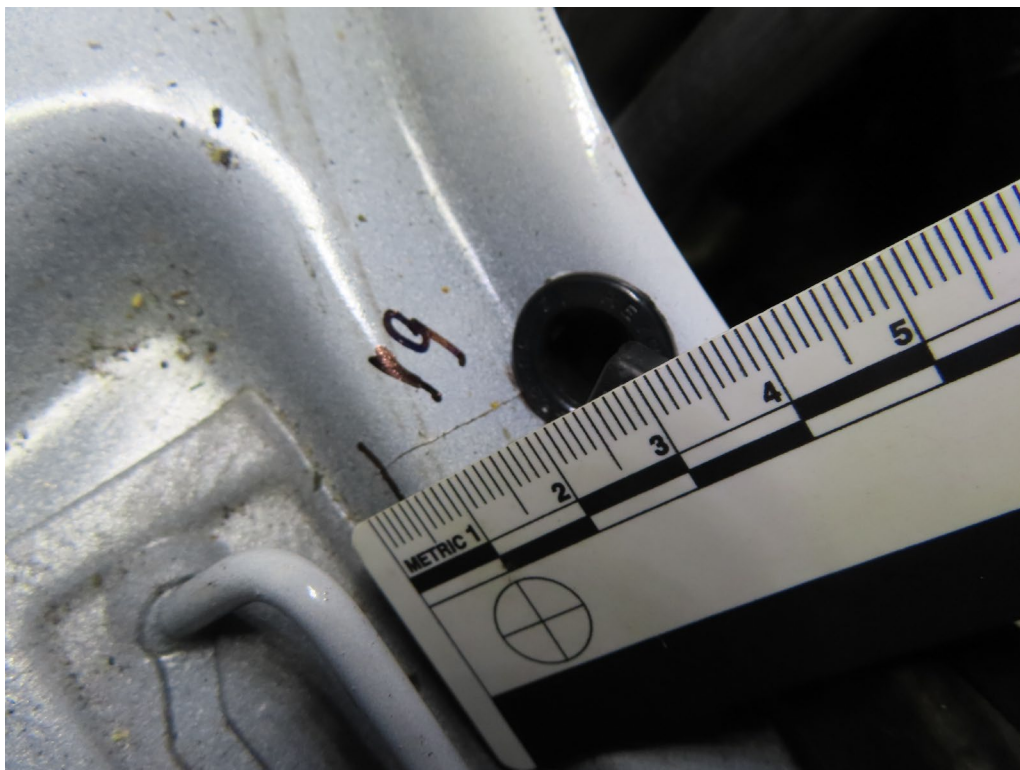
**CRACK #19; CRACK UNDER THE DOG BOX**

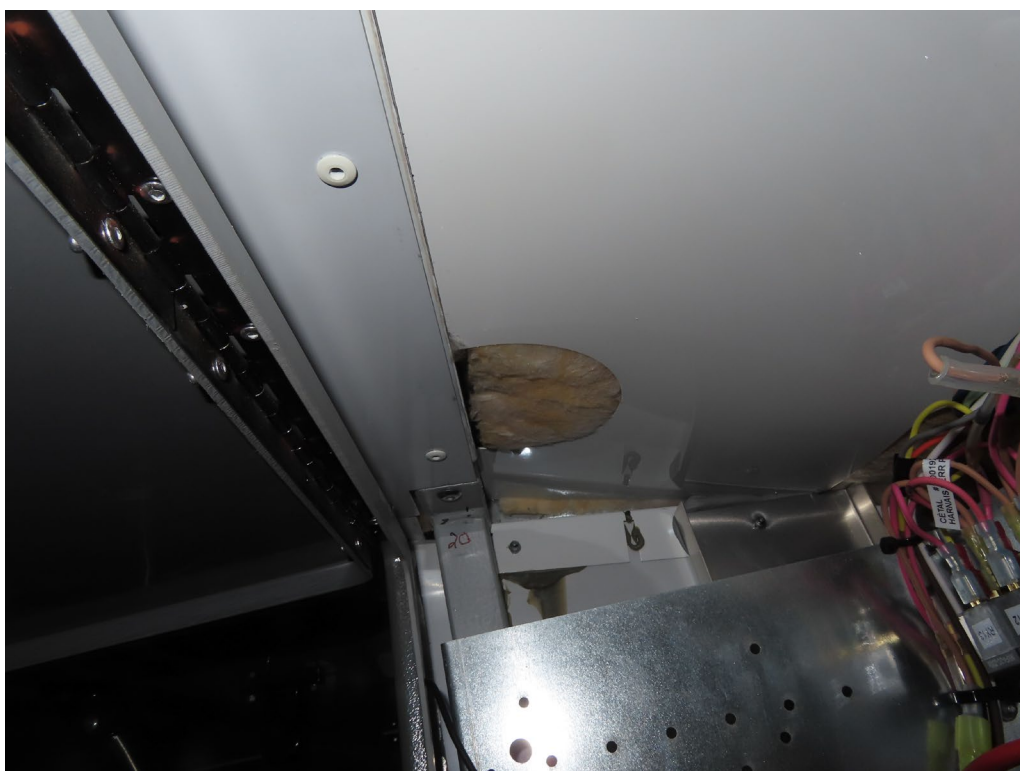
**CRACK #20; CRACK IN THE FUSE BOX ABOVE THE DRIVER**

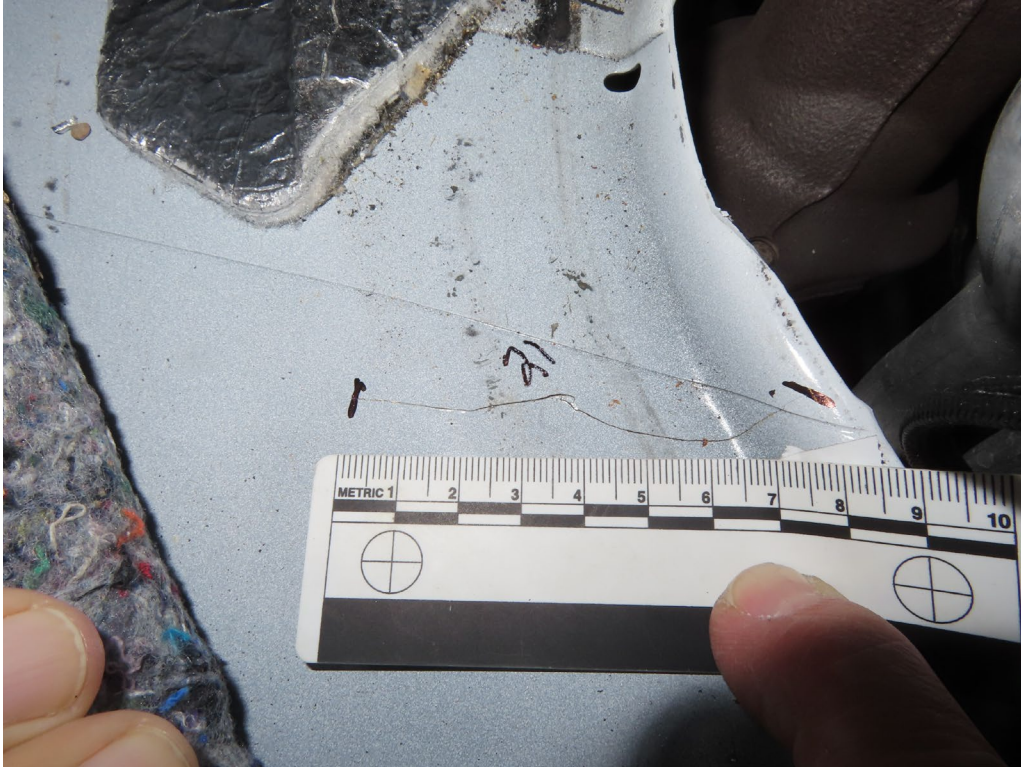
**CRACK #21; CRACK ON THE STREETSIDE DRIVER FLOOR AREA**

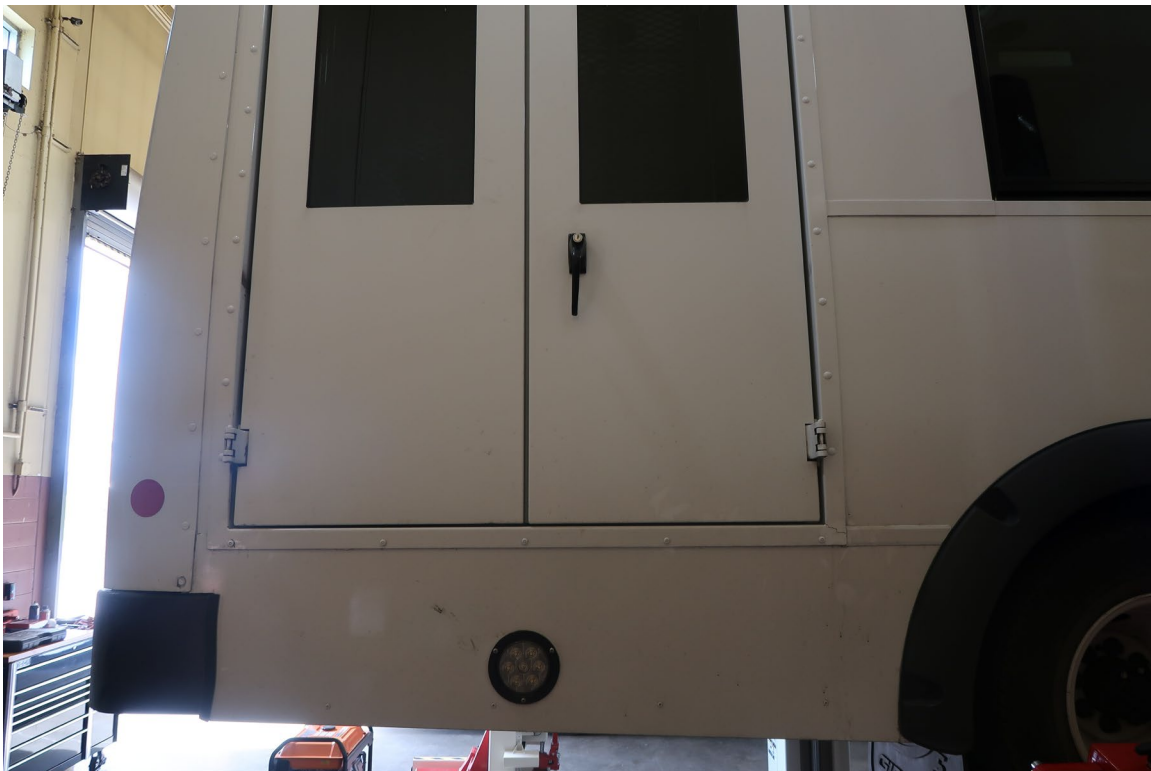
**CRACK IN THE ADA LIFT DOOR FRAME**

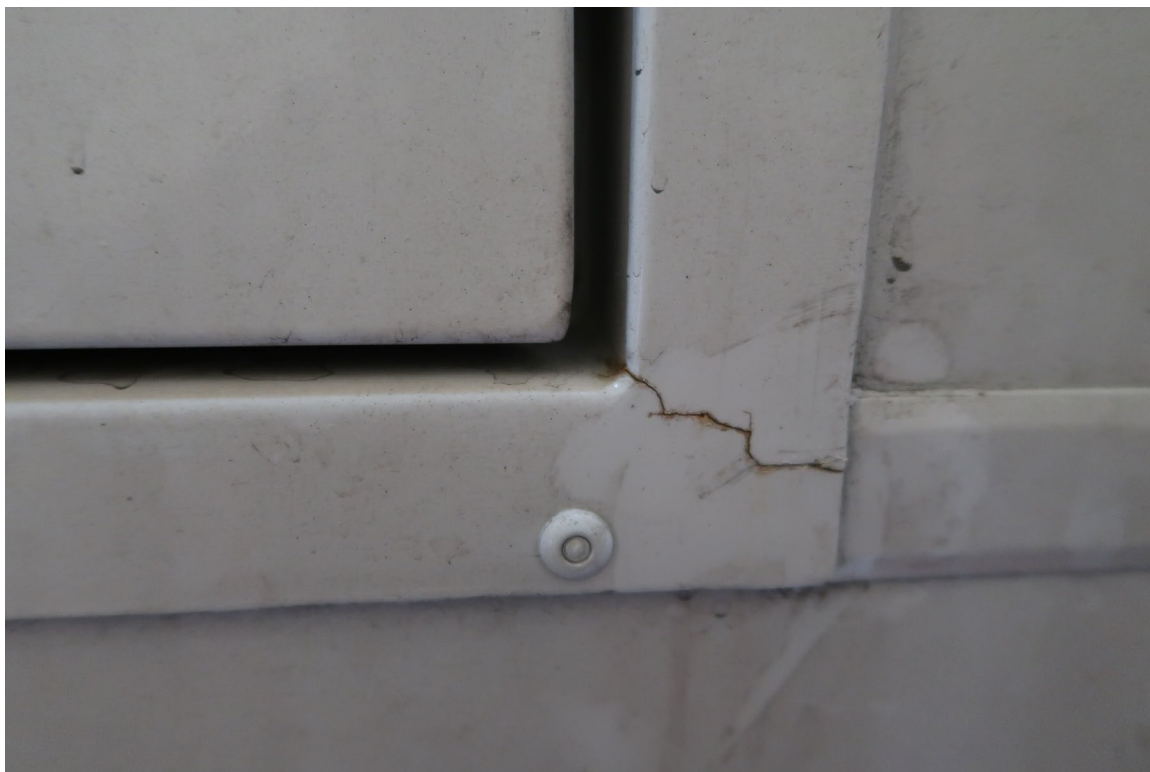
**CLOSE UP OF CRACK IN THE ADA LIFT DOOR FRAME**
