The following image illustrates the summary for NPA airspace with SA ON and no barometric aiding (refer to Figure 10-3, RAIM Summary — NPA Airspace, with SA On and No Baro-aiding).

Displaying TSO-C129, no barometric aiding, RAIM NPA airspace,
Selective Availability ON, mask angle: 5.0°

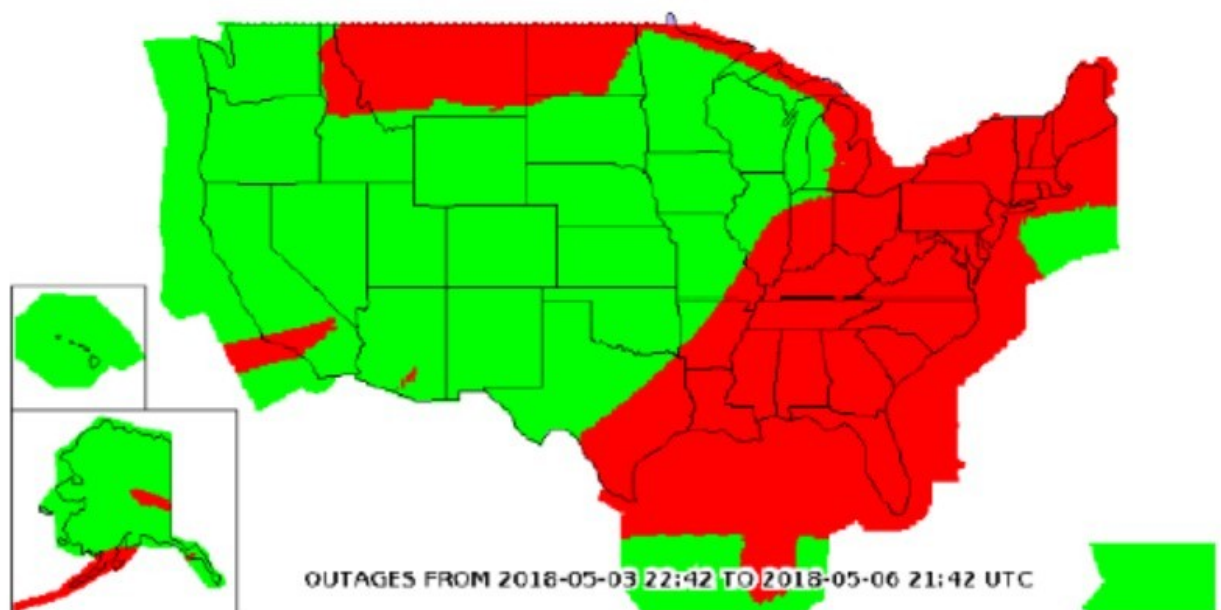
Outage Summaries available for 2018/05/03 22:42 - 2018/05/06 21:42
UTC
