2022 California Battery Energy Storage System Disturbances

California Events: March 9 and April 6, 2022
Joint NERC and WECC Staff Report

September 2023

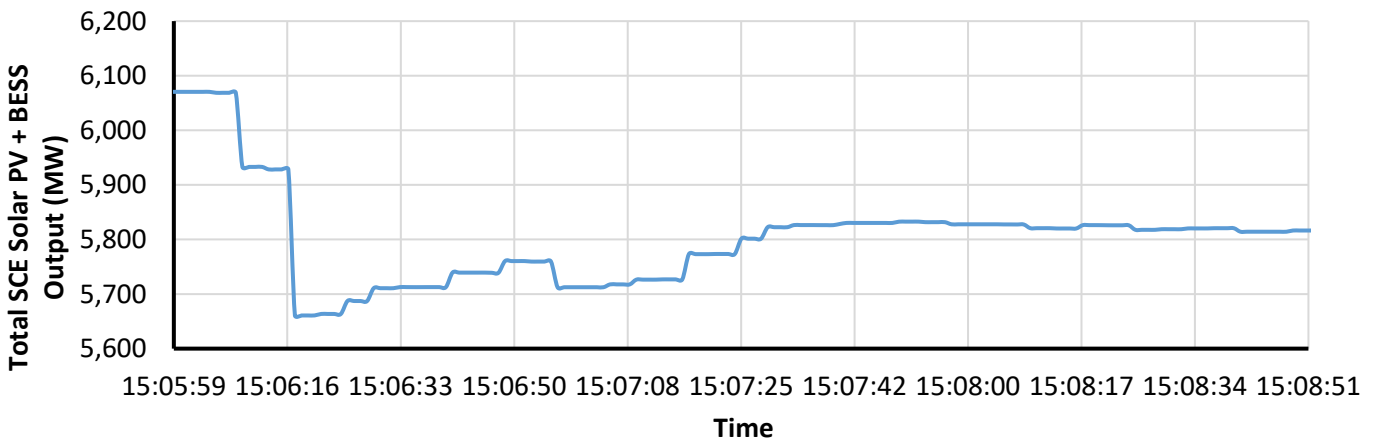
[Figure 1.3](#) and [Figure 1.4](#) show the reduction in solar PV and BESS resources reported by Southern California Edison (SCE) Operations for each disturbance. [Figure 1.5](#) shows the Western Interconnection frequency from PMU data at nearby 500 kV substation for both disturbances.

Figure 1.4: SCE BPS-Connected Solar PV + BESS during Disturbance on April 6 [Source: SCE]
