# 2022 California Battery Energy Storage System Disturbances

California Events: March 9 and April 6, 2022  
Joint NERC and WECC Staff Report

September 2023

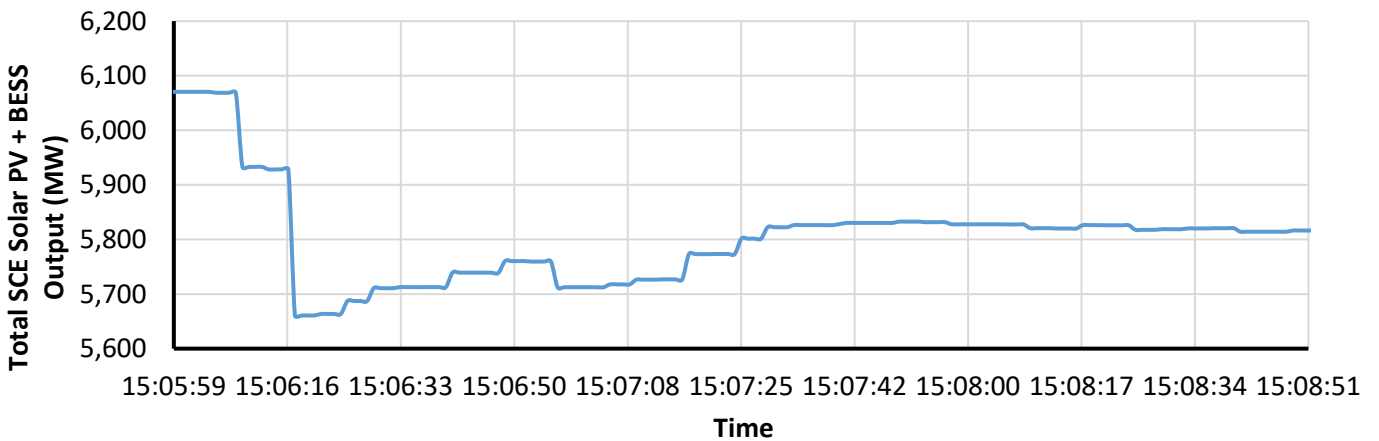
**Figure 1.4: SCE BPS-Connected Solar PV + BESS during Disturbance on April 6 [Source: SCE]**

[Figure 1.3](#) and [Figure 1.4](#) show the reduction in solar PV and BESS resources reported by Southern California Edison (SCE) Operations for each disturbance. [Figure 1.5](#) shows the Western Interconnection frequency from PMU data at nearby 500 kV substation for both disturbances.
