# **FEDERAL TRANSIT BUS TEST**

**Manufacturer: Micro Bird Inc. / Micro Bird USA LLC  
Model: Micro Bird G5**

**December 2025**

**Report Number: LTI-BT-R2025-03**

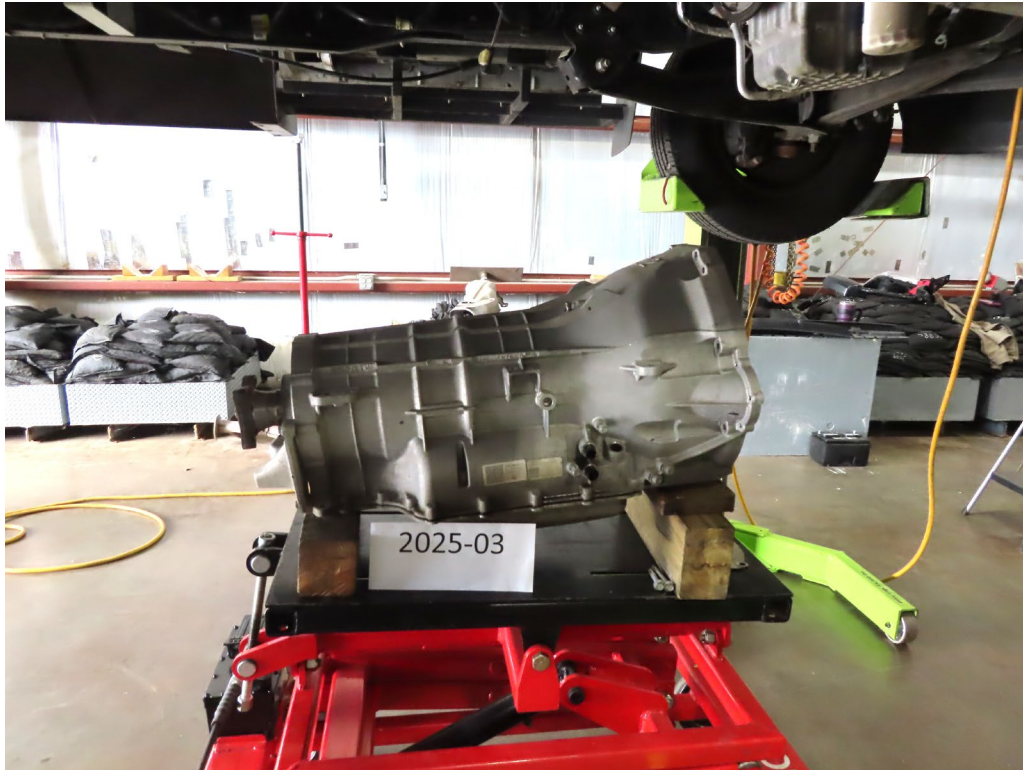
**TRANSMISSION REMOVAL AND REPLACEMENT  
(6.50 LABOR HOURS)**

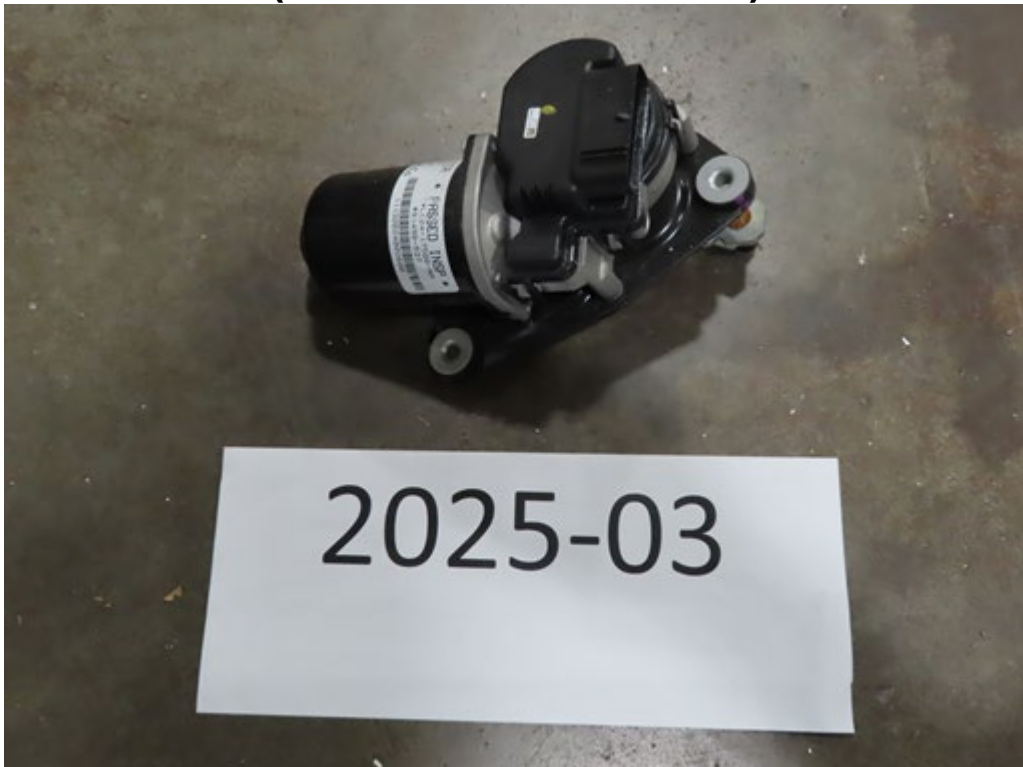
**WIPER MOTOR REMOVAL AND REPLACEMENT  
(0.50 LABOR HOURS)**
