INVESTIGATION GUIDELINE

**Revised 2004
Appendix 101**

PORTABLE LP GAS GRILLS

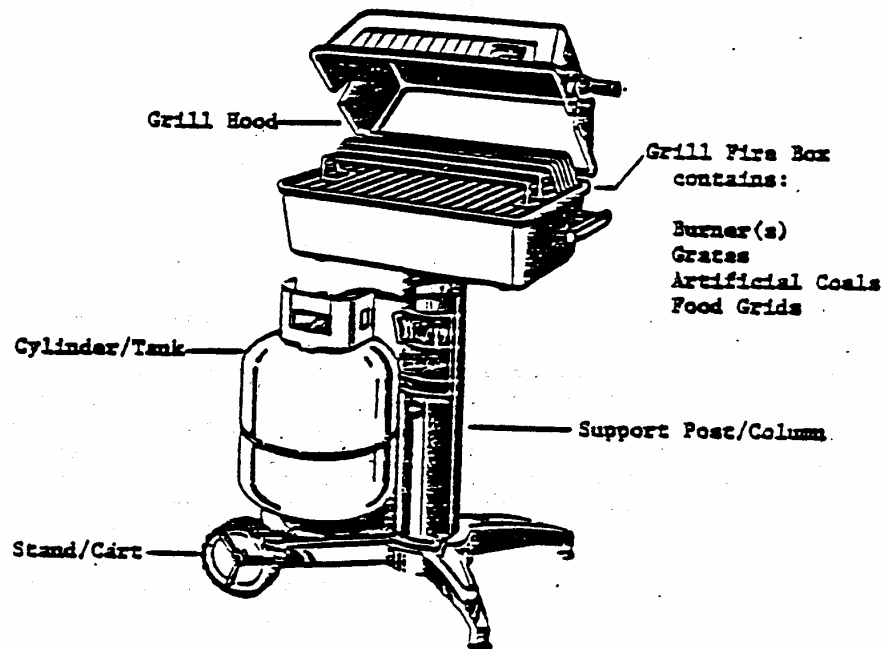
Figure 1

The typical portable LP grill system is shown in Figure 1. It usually consists of a user-owned exchangeable twenty-pound cylinder, a stand or cart which supports the grill and on which the cylinder (or cylinders) is secured, fittings and hose to connect the cylinder to the grill (including on/off valve, regulator, fittings, and hoses). The grill itself can include on/off and flame height controls, burner assemblies, artificial coals, supporting grates and grids and the fire box. On many grills the on/off controls may be on a supporting post. Some grills may also be equipped with electrical devices such as ignitors or rotisseries.

TYPICAL PORTABLE L.P. GRILL

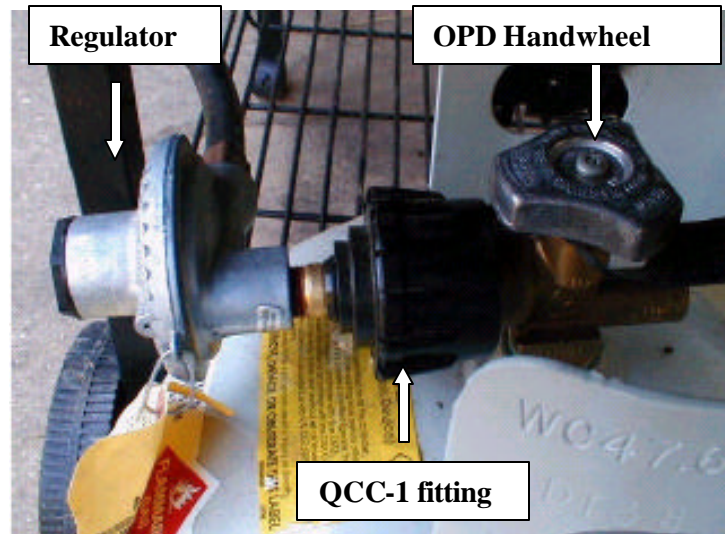
Twenty pound LP gas cylinders generally measure approximately twelve inches in diameter by nineteen inches high. A regulator is usually attached to the cylinder valve by a quick-connect (QCC-1) fitting that consists of a plastic “knob” that connects to the cylinder valve outlet. The QCC-1 has right-handed threads that should hand tighten. The QCC-1 fitting should be marked with the manufacturer’s name. Using a tool to tighten the connection can damage the system. Figure 2 shows the connection between the regulator and the cylinder valve on an OPD-equipped cylinder (note three-lobed handle on top of valve and marked OPD). In some instances this fitting might be a spring-loaded "quick disconnect" device. Figure 3 shows the outlet of the cylinder’s pressure relief valve.

Figure 2 Connection between tank and regulator

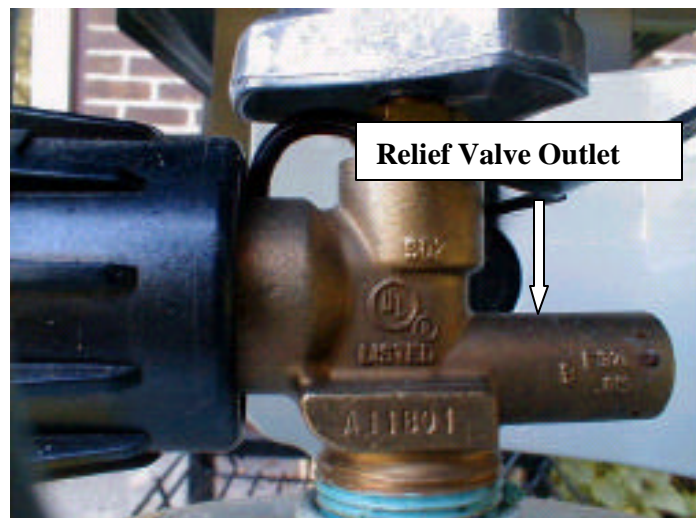
Figure 3 Relief Valve Outlet

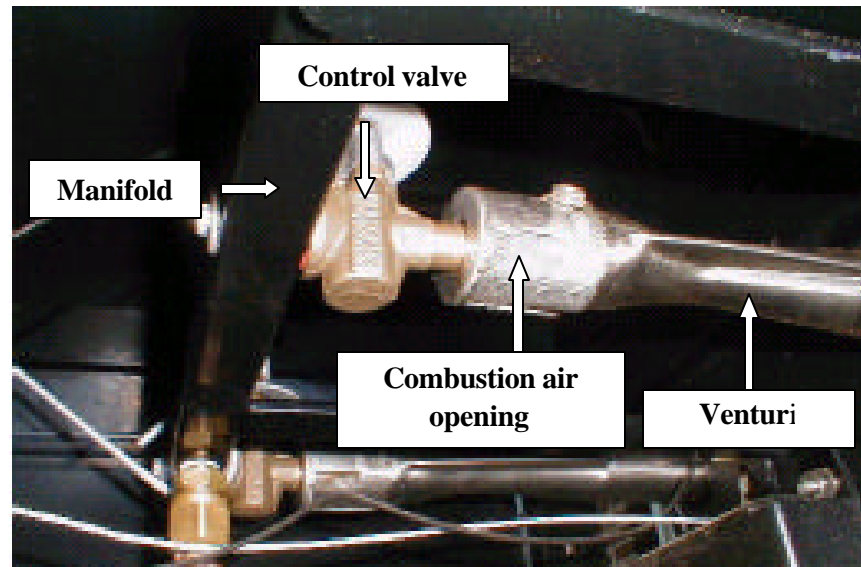
LP-gas from the regulator is supplied to the grill through hosing that connects to the gas manifold and control valves. From the control valves the gas flows through the venturi that is designed to pull in combustion air. The fuel then goes to the burners inside the grill firebox. Figure 4 shows a gas manifold, control valve, venturi and combustion air inlet on a typical grill.

Figure 4 Control valve, manifold and venturi

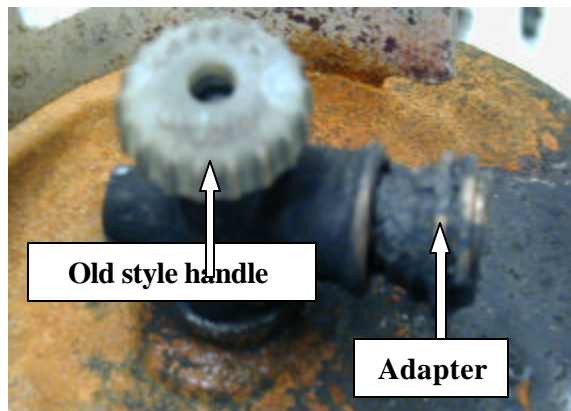
Provide a brief description of the events, in chronological order, leading to the incident. It is very important to identify if the incident happened the first time the cylinder was used after re-filling. If the incident is the result of the pressure relief valve opening, the initial flame will be like a huge blowtorch directed horizontally. Did the consumer hear a loud “popping” sound prior to the fire? Did the incident start with a small fire and suddenly grow in size? Estimate the size of the initial flames. Where did the consumer first notice flames? Did the initial flames originate at the connection between the regulator and the cylinder? Did the initial flames originate from under the grill in the area of the control valves or venturi? Some older cylinders have been retrofitted for the QCC-1 with adapters as shown in Figure 5. These adapters may be marked as LP adapters. The old style handle will not have the three-lobed handle, which is indicative of an OPD handwheel.

Figure 5 Cylinder with adapter

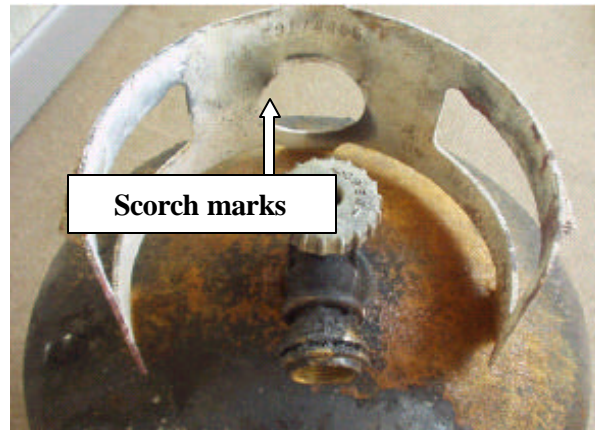
**Figure 6 Cylinder collar
with scorch marks**
