INVESTIGATION GUIDELINE

**Revised 2004
Appendix 101**

PORTABLE LP GAS GRILLS

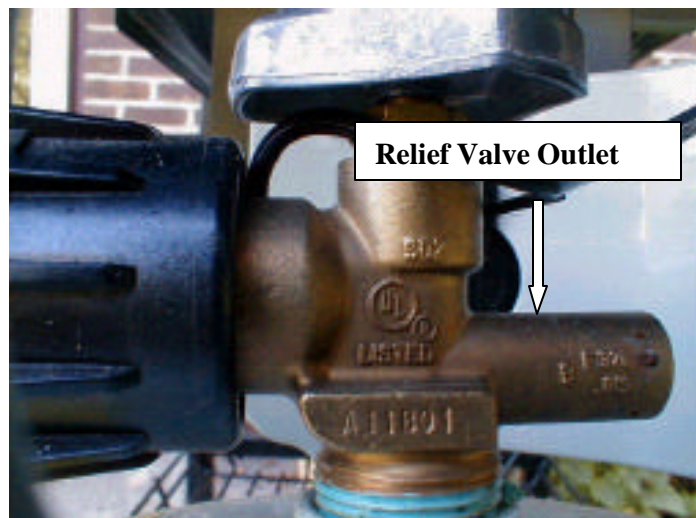
Figure 3 Relief Valve Outlet

Twenty pound LP gas cylinders generally measure approximately twelve inches in diameter by nineteen inches high. A regulator is usually attached to the cylinder valve by a quick-connect (QCC-1) fitting that consists of a plastic “knob” that connects to the cylinder valve outlet. The QCC-1 has right-handed threads that should hand tighten. The QCC-1 fitting should be marked with the manufacturer’s name. Using a tool to tighten the connection can damage the system. Figure 2 shows the connection between the regulator and the cylinder valve on an OPD-equipped cylinder (note three-lobed handle on top of valve and marked OPD). In some instances this fitting might be a spring-loaded “quick disconnect” device. Figure 3 shows the outlet of the cylinder’s pressure relief valve.

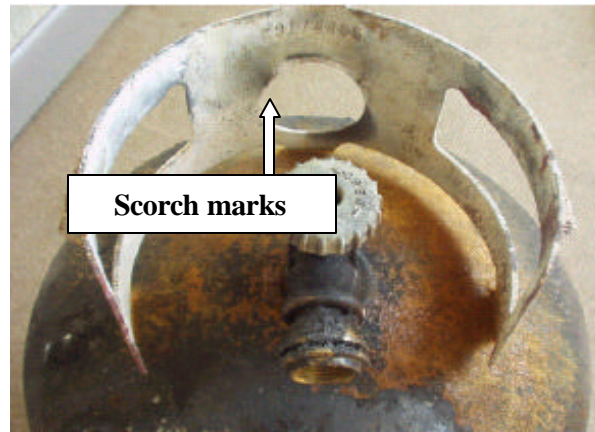
**Figure 6 Cylinder collar
with scorch marks**
