# BOEING SERVICE BULLETIN 727-53A0233

## Appendix B: REPORTING TEMPLATE - AIRPLANES WITH SCRIBE LINES (SHEET 1 OF 2)

**Appendix C: AIRPLANE FUSELAGE SCRIBE LINE MARK SUMMARY TABLES  
(SHEET 1 OF 2)**

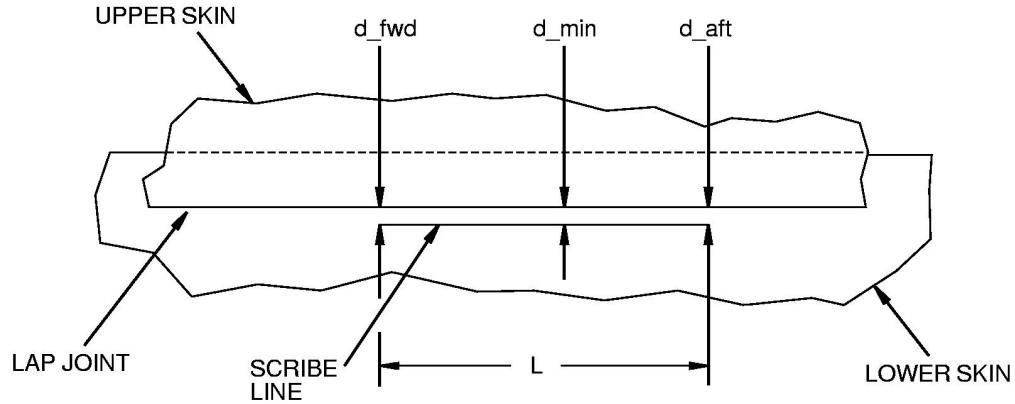
Table 1 - Skin Lap Joints

| Location | | | Length<br>(inches) | Distance From Lap (Inches) | | | Depth<br>(inches) |
|---|---|---|---|---|---|---|---|
| (a) $d_{fwd}$ = Distance from the edge of the upper skin of the forward end of the scribe line. | | | | | | | |
| (b) $d_{min}$ = Minimum distance of the scribe line at any point along the entire length of the scribe line from the edge of the upper skin. | | | | | | | |
| (c) $d_{aft}$ = Distance from the edge of the upper skin of the aft end of the scribe line. | | | | | | | |

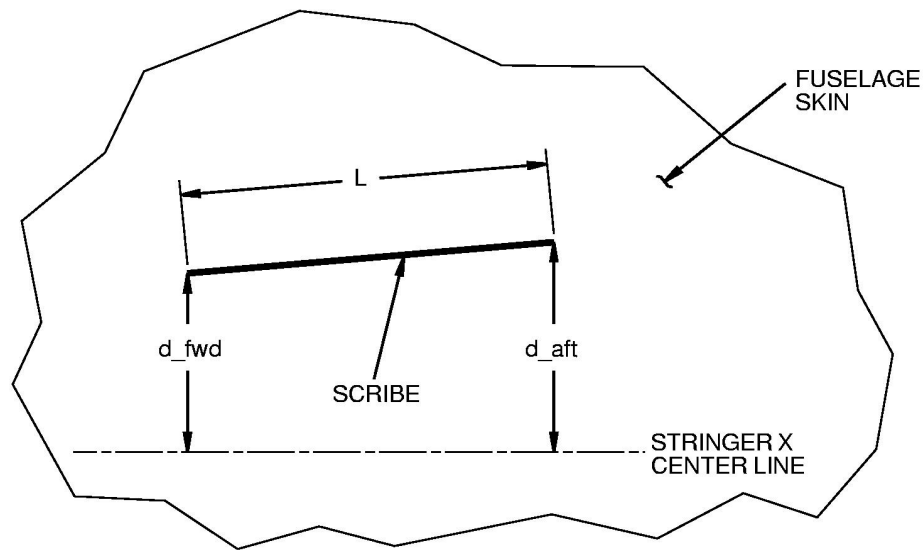
Table 2 - Locations other than Skin Lap Joints

| Forward Body Station | Aft Body Station | Stringer | Length (inches) | Distance From Stringer (Inches) | | Depth (inches) |
|---|---|---|---|---|---|---|
| (a) d_fwd = Distance of the forward end of the scribe from the stringer. | | | | | | |
| (b) d_aft = Distance of the aft end of the scribe from the stringer. | | | | | | |
