INVESTIGATION GUIDELINE

**Revised 2004
Appendix 101**

PORTABLE LP GAS GRILLS

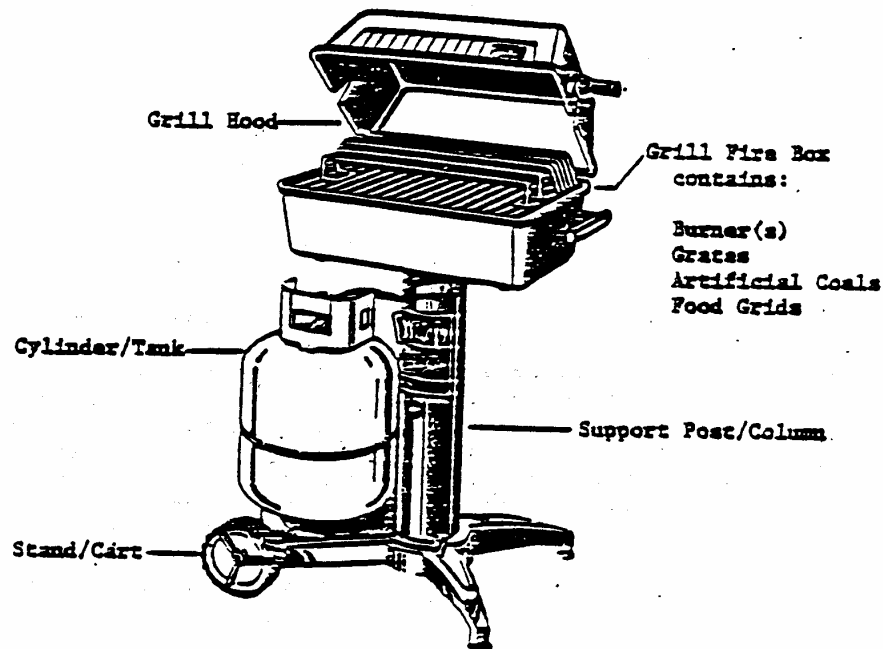
Figure 1

The typical portable LP grill system is shown in Figure 1. It usually consists of a user-owned exchangeable twenty-pound cylinder, a stand or cart which supports the grill and on which the cylinder (or cylinders) is secured, fittings and hose to connect the cylinder to the grill (including on/off valve, regulator, fittings, and hoses). The grill itself can include on/off and flame height controls, burner assemblies, artificial coals, supporting grates and grids and the fire box. On many grills the on/off controls may be on a supporting post. Some grills may also be equipped with electrical devices such as ignitors or rotisseries.

TYPICAL PORTABLE L.P. GRILL

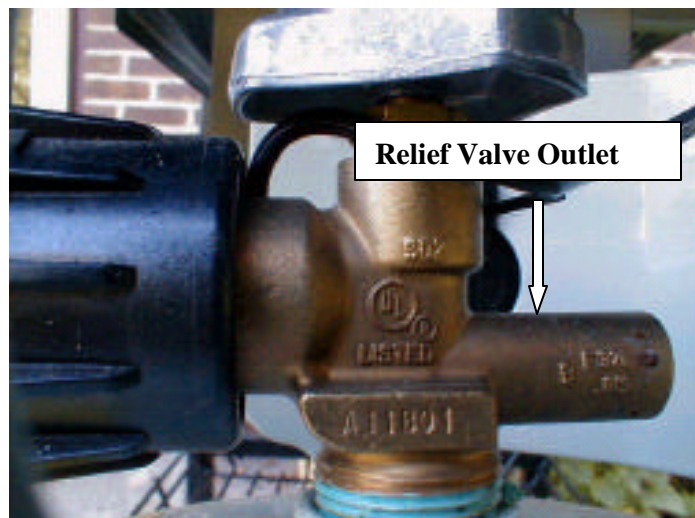
Figure 3 Relief Valve Outlet

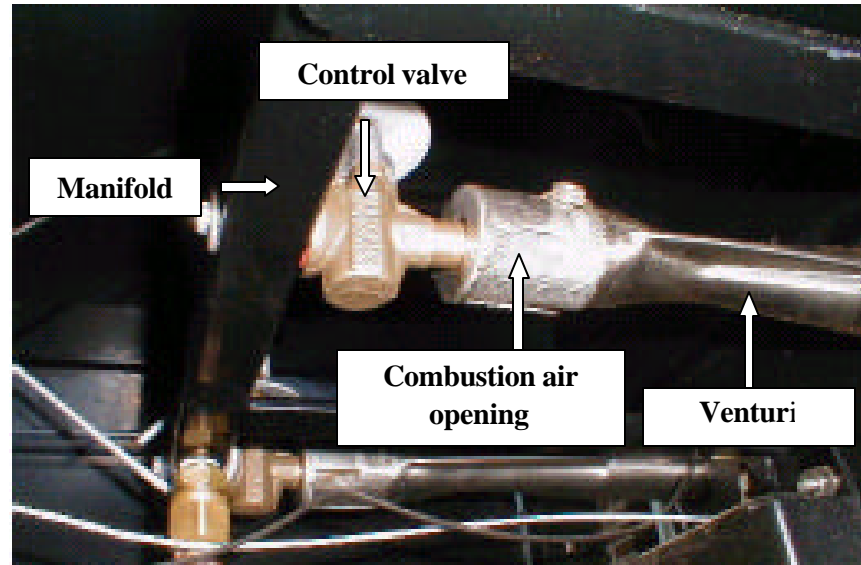
LP-gas from the regulator is supplied to the grill through hosing that connects to the gas manifold and control valves. From the control valves the gas flows through the venturi that is designed to pull in combustion air. The fuel then goes to the burners inside the grill firebox. Figure 4 shows a gas manifold, control valve, venturi and combustion air inlet on a typical grill.

Figure 4 Control valve, manifold and venturi

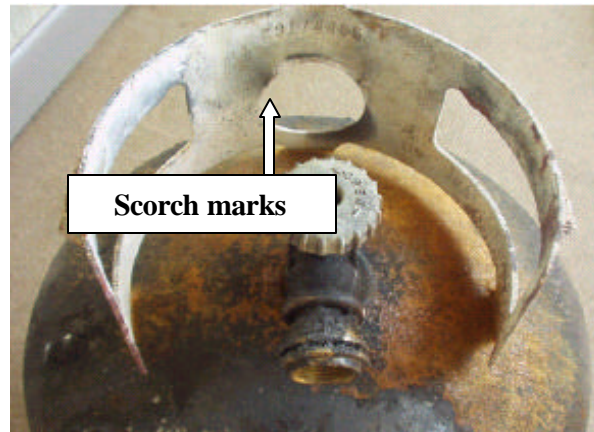
**Figure 6 Cylinder collar
with scorch marks**
