The Landslide Reporter's Guide

Landslide Identification Training

Training Instructions

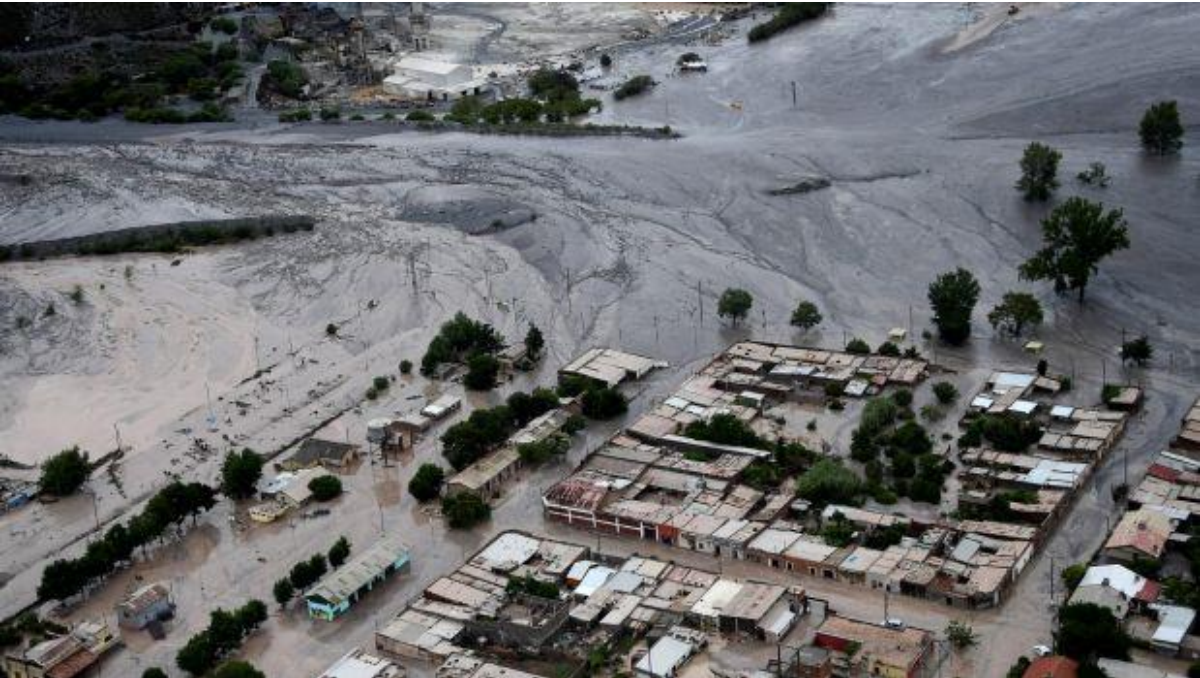
January 2017, Volcán, Jujuy, Argentina (Source: AP/ La Nacion)

- After extremely heavy rains falling over the course of the past week, the largest landslide since 1978 has ravaged the Argentinean province of Jujuy. The landslide claimed two victims as a couple were trapped within their car in the town of Volcán. About 1000 people were evacuated. (Source: The Bubble)

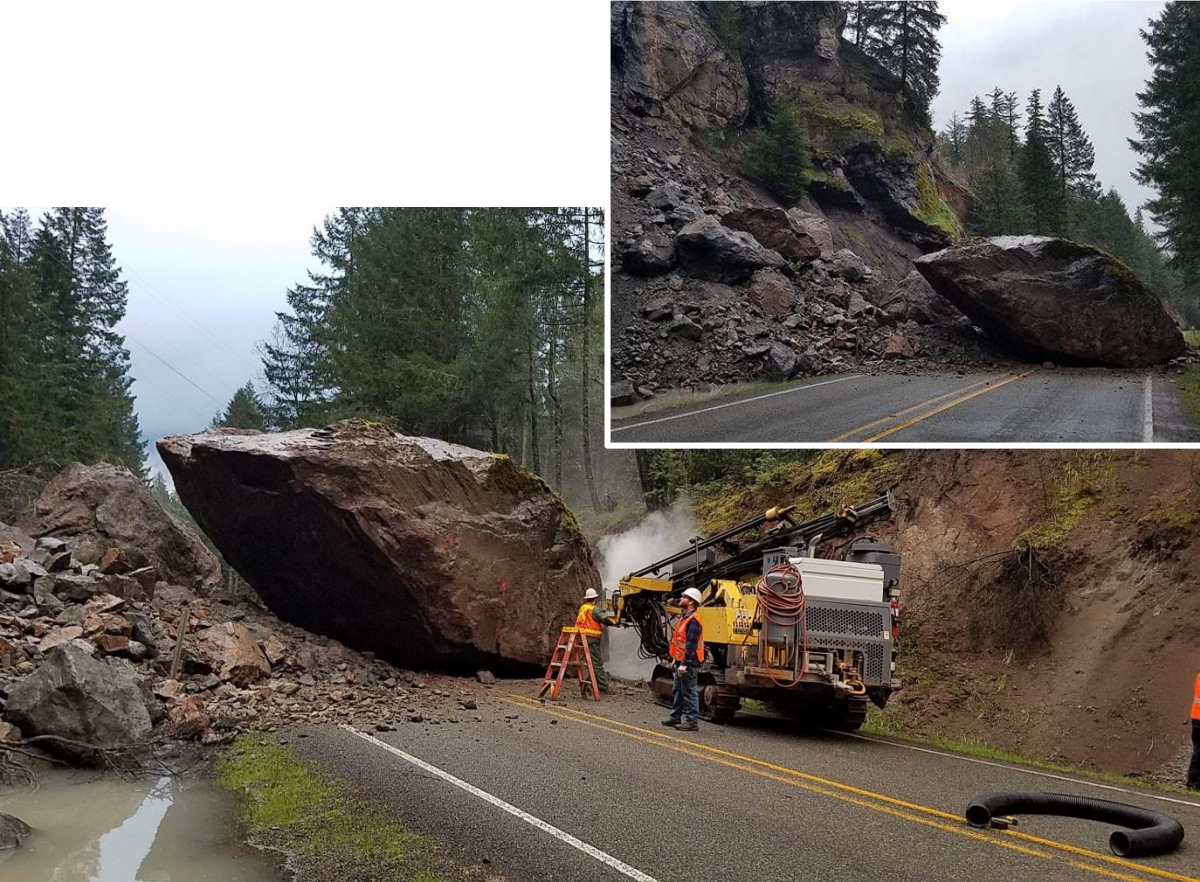
March 2017, Highway 138, Glide, OR, USA
(Source: Oregon DOT)

- A rock the size of a cottage, about 200 tons, fell onto Oregon Highway 138 east of Glide and blocked both lanes of traffic. The rock crashed sometime after midnight. (Source: Mail Tribune)

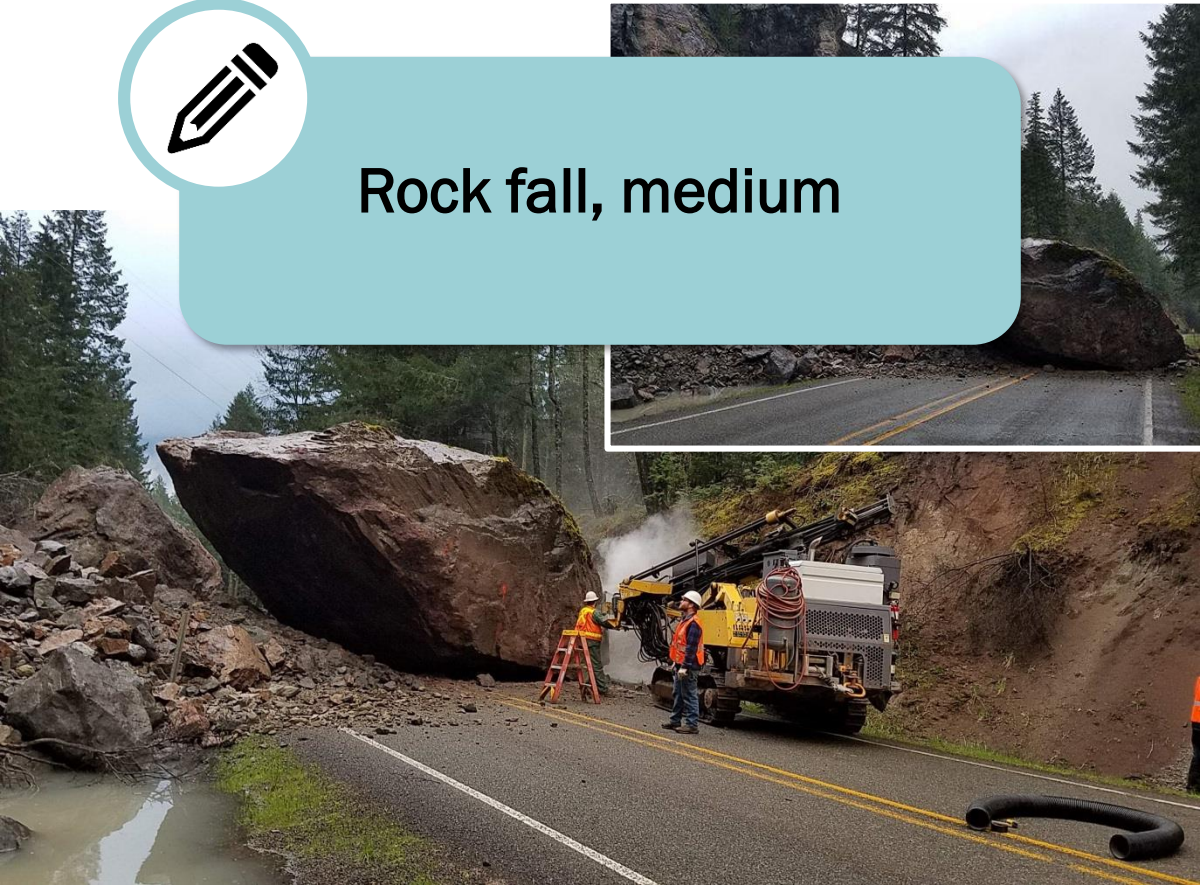
March 2017, Highway 138, Glide, OR, USA
(Source: Oregon DOT)

Rock fall, medium

- A rock the size of a cottage, about 200 tons, fell onto Oregon Highway 138 east of Glide and blocked both lanes of traffic. The rock crashed sometime after midnight. (Source: Mail Tribune)

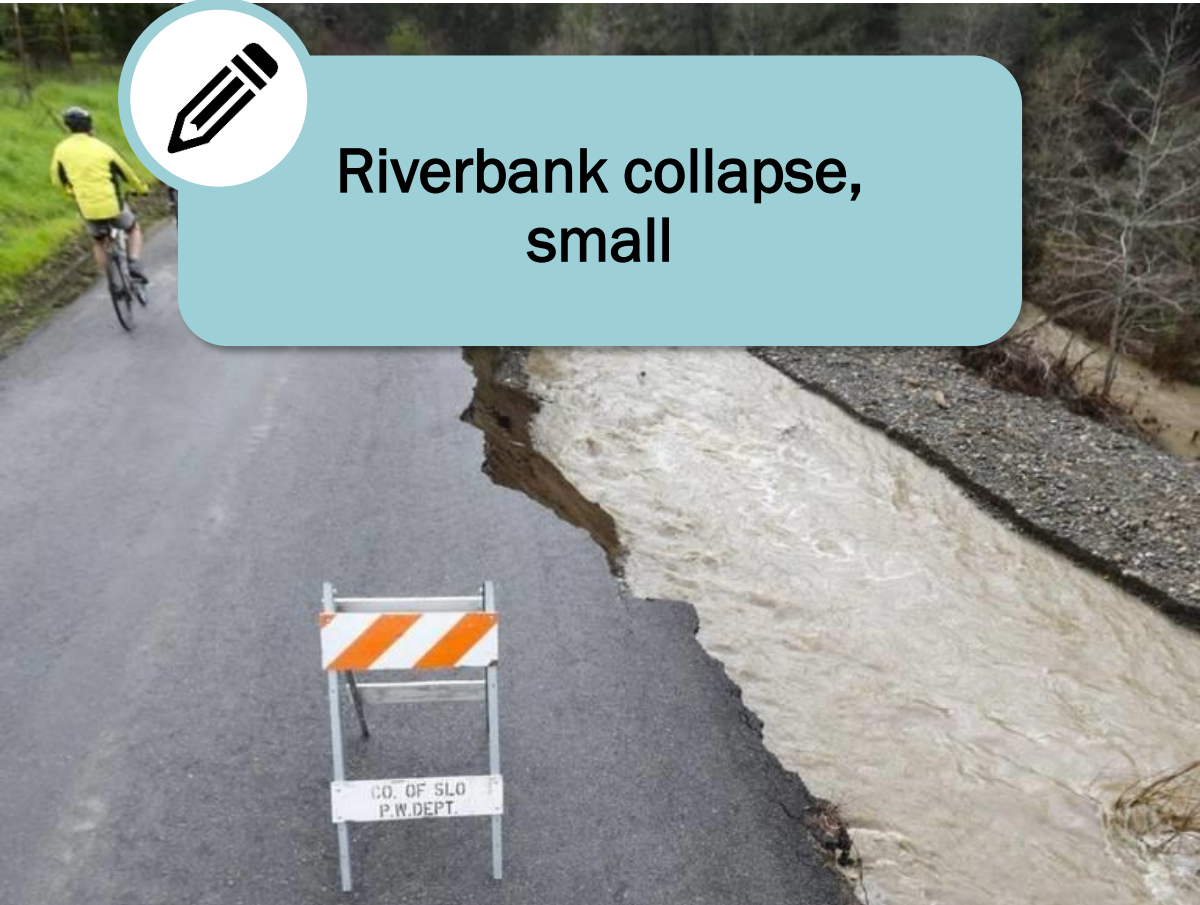
January 2017, Cambria, CA, USA (Source: David Middlecamp, The Tribune News)

Riverbank collapse,
small

- Continuous and heavy rainfall between Jan 3 and Jan 9 have spurred multiple landslides across the North Coast. About five miles upstream from Coast Union High School in Cambria, Santa Rosa Creek undercut Santa Rosa Creek Road. Here, bicyclists check out the damage on Jan. 9. (Source: The Tribune News)

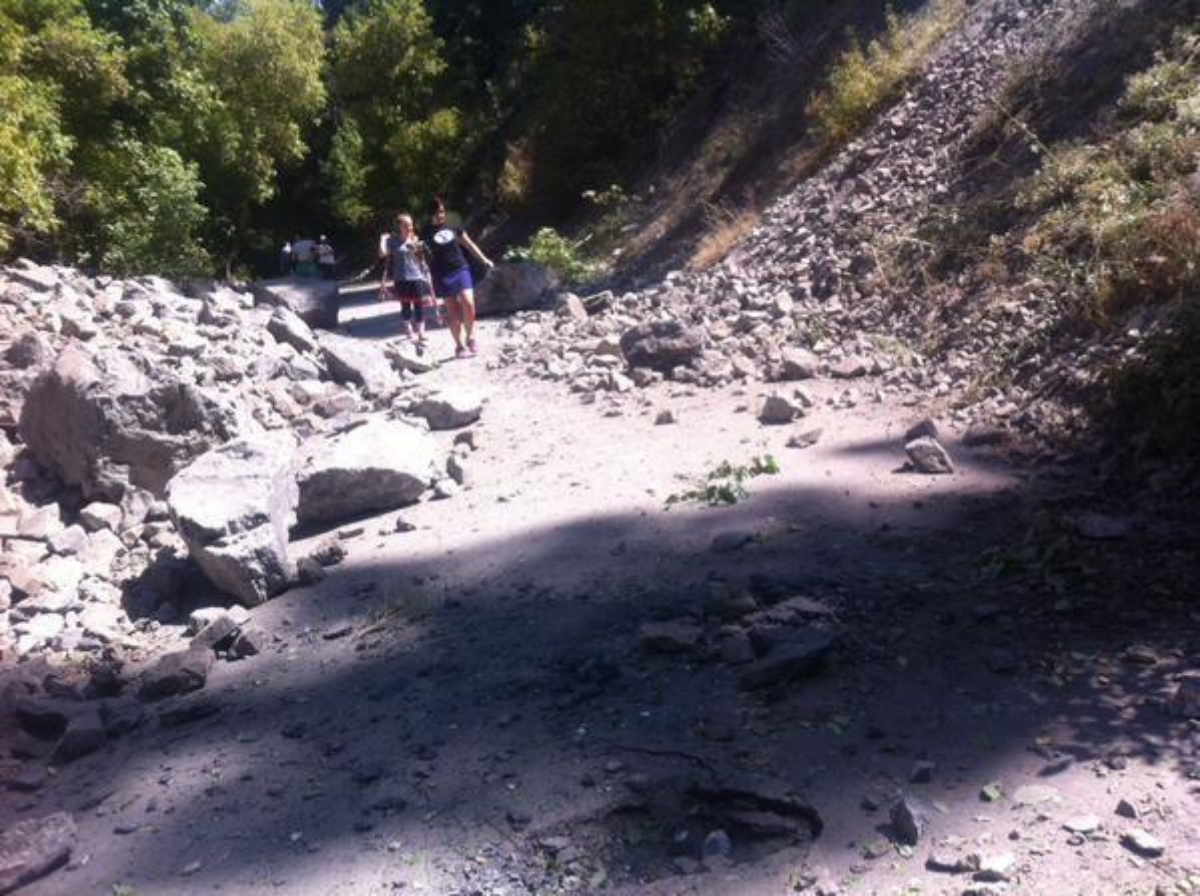
September 2015, Provo River Parkway, Provo Canyon, Utah, USA (Source: Sgt. Spencer Cannon)

- On Monday afternoon, a _____ occurred on the Provo River Parkway trail approximately 1 mile northeast of the popular Bridal Veil Falls recreation area. No one was injured and those walking or jogging along the parkway trail were not seriously hindered from the slide. (Source: Daily Herald)

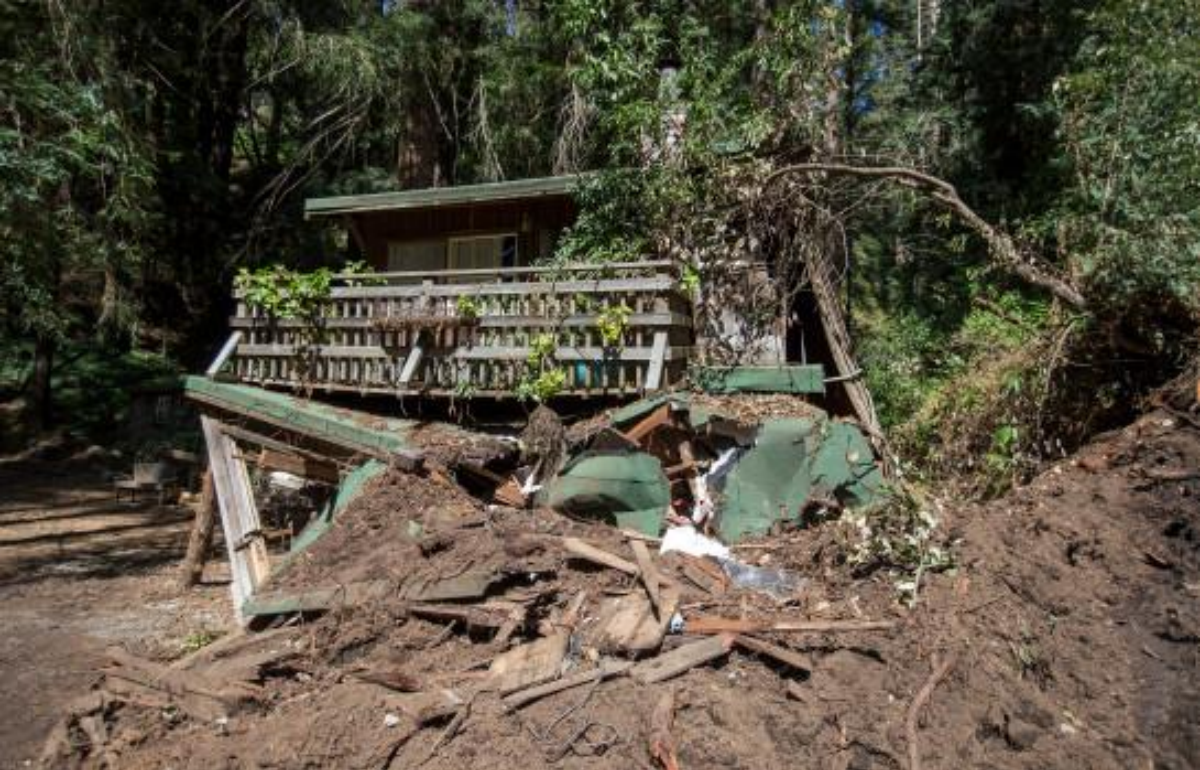
March 2017, The Creek House at Deetjen's Big Sur Inn, Big Sur, CA, USA (Source: LiPo Ching, Bay Area News Group)

- The Creek House at Deetjen's Big Sur Inn was damaged from a _____ during recent storms in Big Sur. Landslides have destroyed four of its 20 cabins and compromised its other historic structures and all the internal roadways. (Source: The Mercury News)
