The Landslide Reporter's Guide

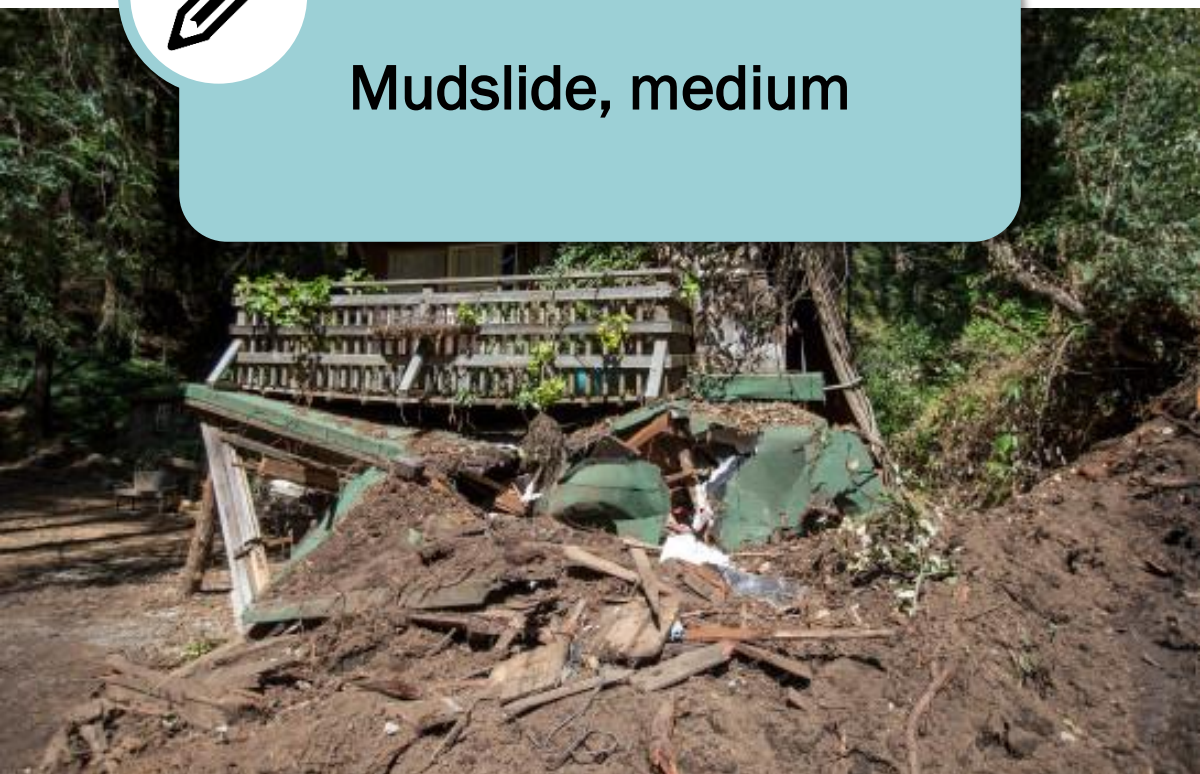
March 2017, The Creek House at Deetjen's Big Sur Inn, Big Sur, CA, USA (Source: LiPo Ching, Bay Area News Group)
