The Landslide Reporter's Guide

Landslide Identification Training

Training Instructions

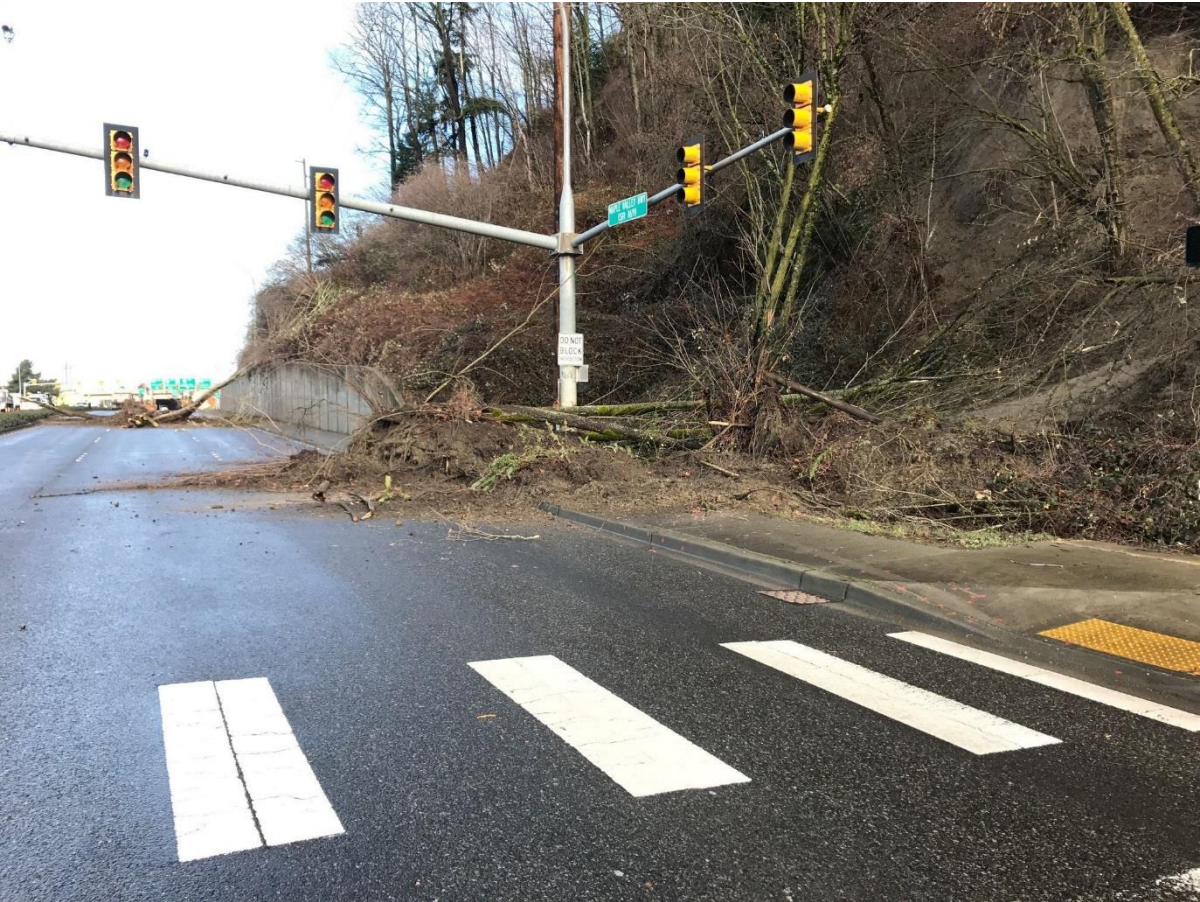
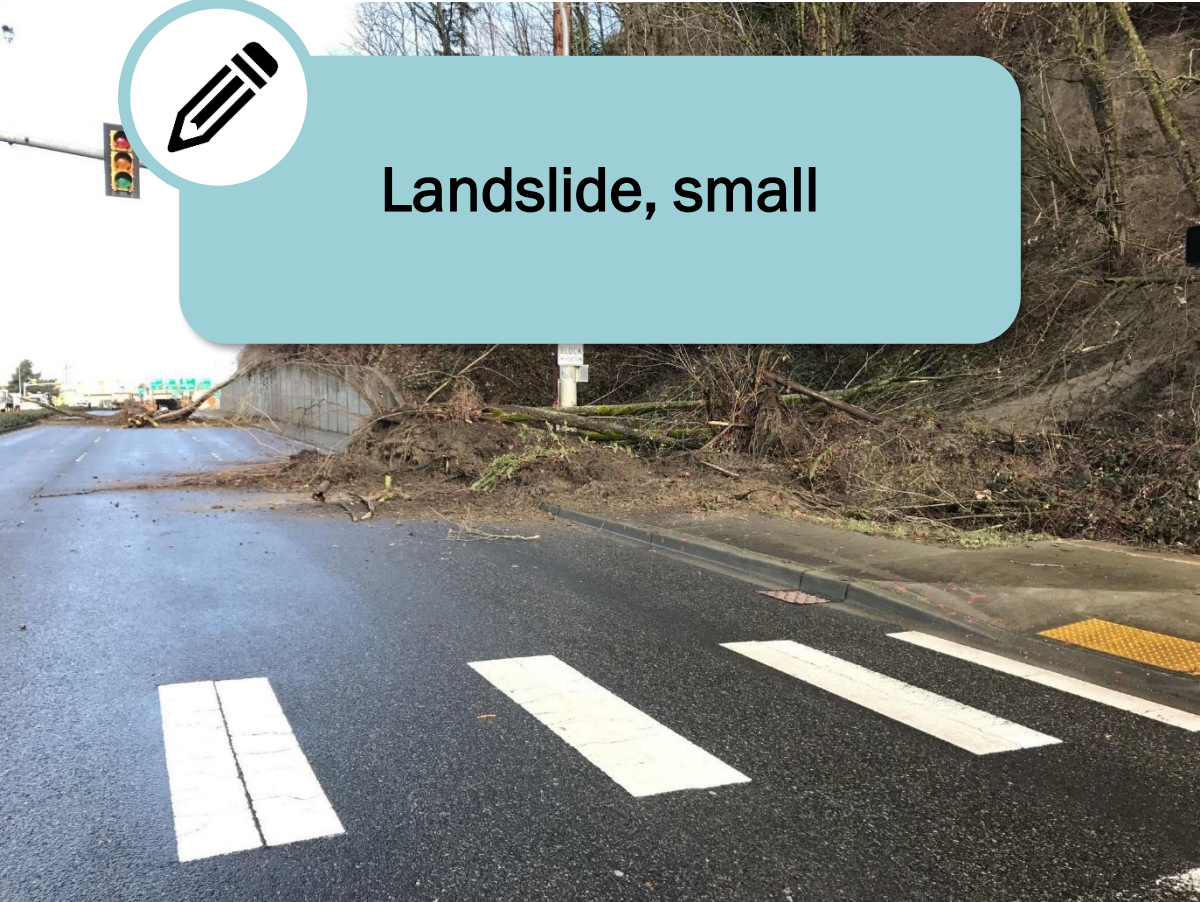
February 2017, Maple Valley Highway, Renton, WA, USA (Source: Renton Reporter)

Landslide, small

- Maple Valley Highway (SR 169) is shut down for westbound traffic due to a landslide. Traffic is shut down at 140th Way Southeast and and Maple Valley Highway. Eastbound traffic is limited to one lane east of I-405 and Maple Valley Highway. (Source: Renton Reporter)

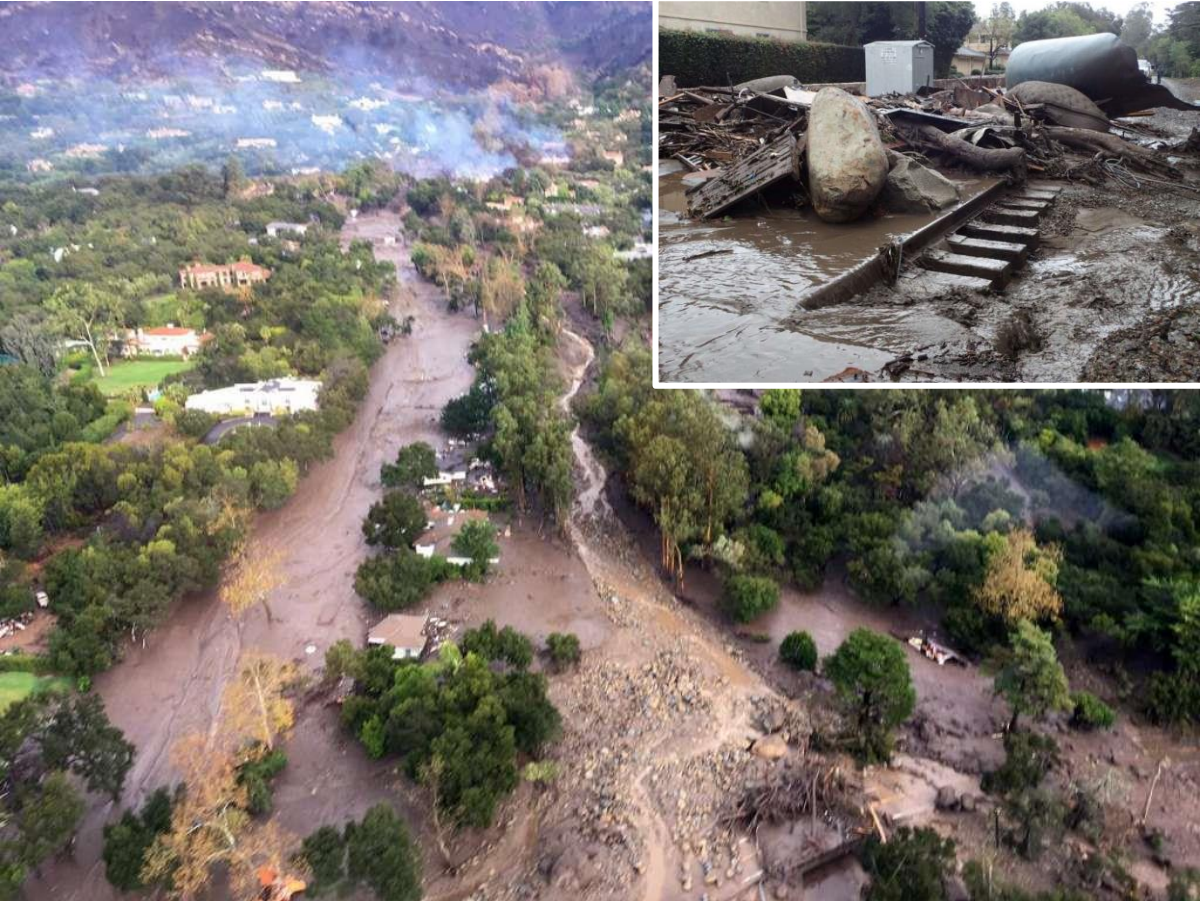
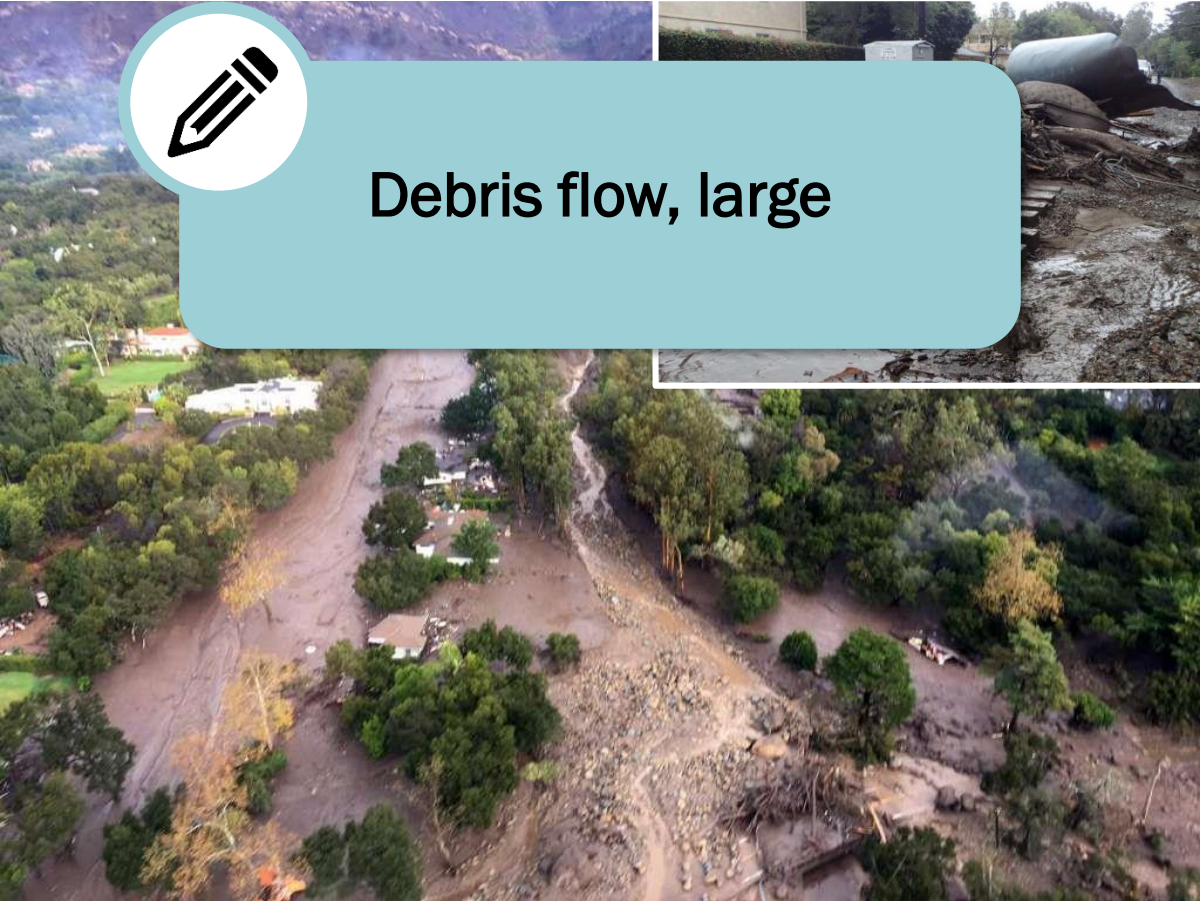
January 2017, Santa Barbara County, CA, USA
(Source: Mike Eliason, AP)

Debris flow, large

- Parts of Santa Barbara and Ventura counties, near the Thomas Fire burn area, were hard-hit with mud and debris on January 9, leading to multiple deaths and injuries. Rain rates of up to 1.5 inches per hour were recorded in the Thomas Fire burn area. (Source: The Weather Company)

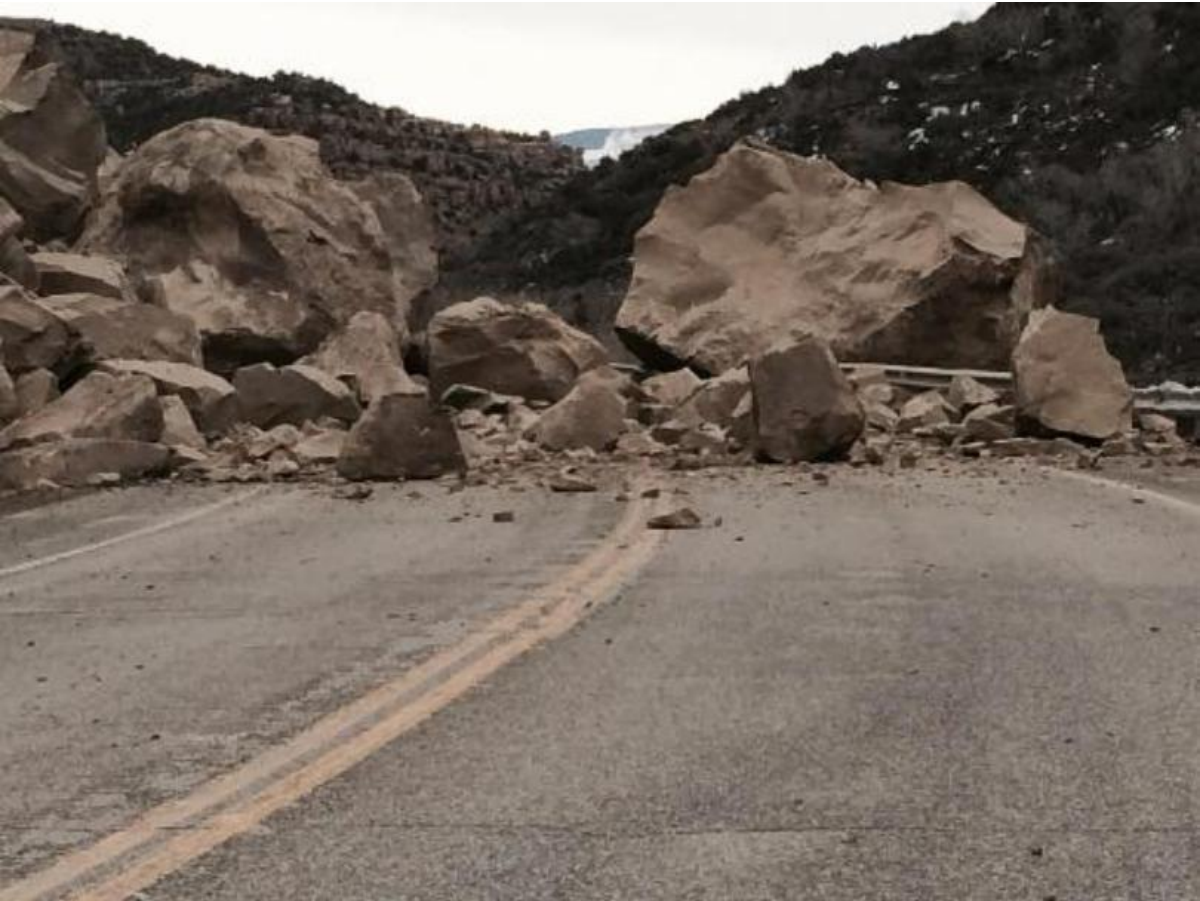
March 2014, Highway 65, Grand Mesa, CO, USA
(Source: NBC / KKCO)

Rock fall, medium

- A 125-foot-wide rockslide has closed the main highway over the Grand Mesa near Interstate-70. According to the Colorado Department of Transportation, Friday morning, crews from Yenter Construction are rock scaling in an effort to bring down remaining rocks and boulders perched on the slope above the roadway.
(Source: NBC / KKCO)

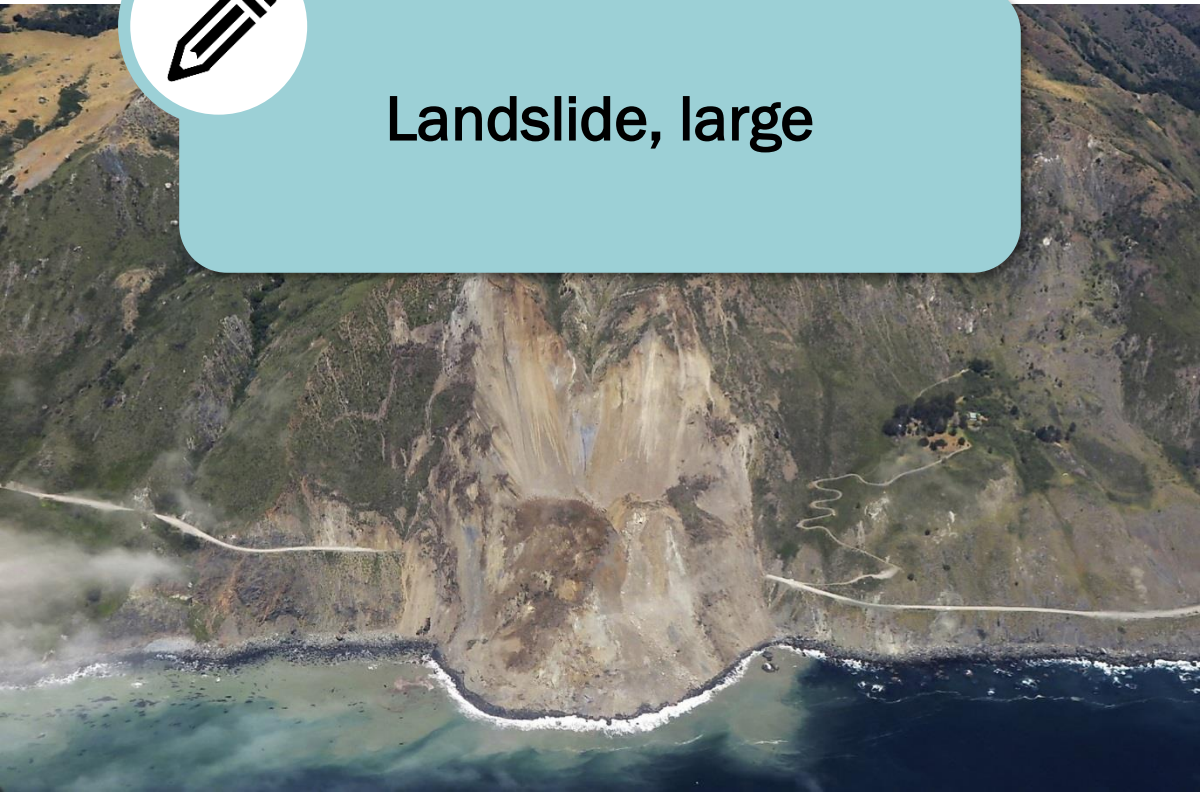
May 2017, Highway 1, Big Sur, CA, USA (Source: John Madonna, AP)

Landslide, large

- A massive landslide along California's coastal Highway 1 has buried the road under a 40-foot layer of rock and dirt. A swath of the hillside gave way in an area called mud creek on Saturday, covering about half a kilometer of road and changing the Big Sur coastline. (Source: SFGate)

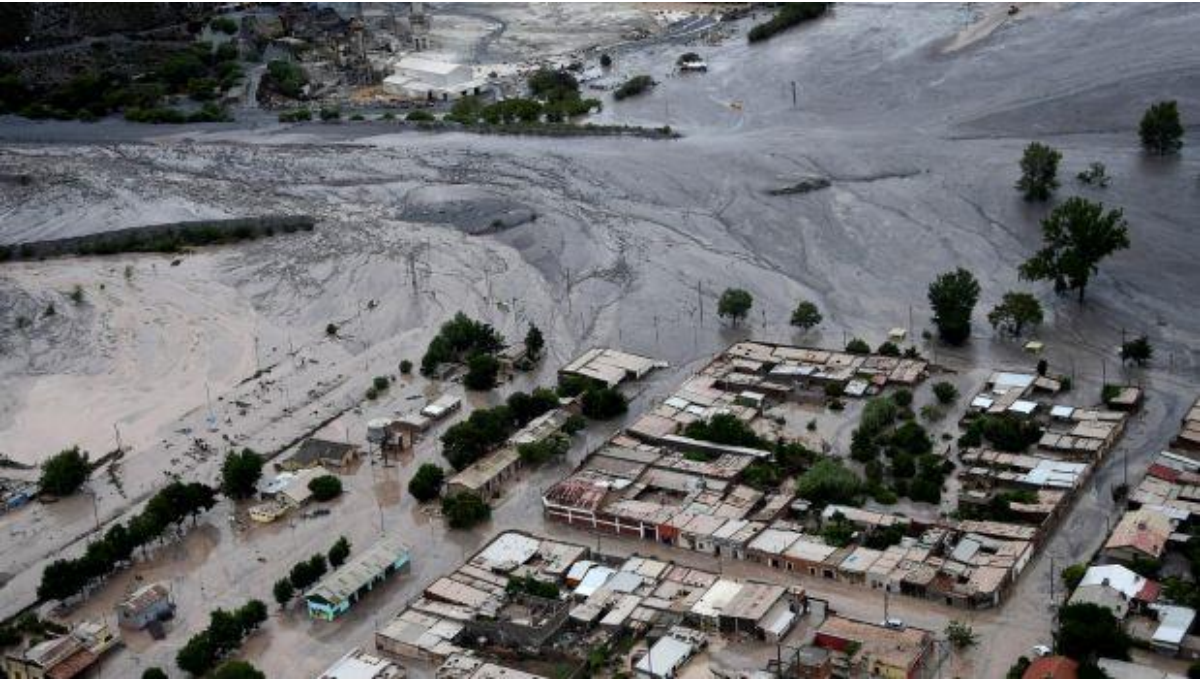
January 2017, Volcán, Jujuy, Argentina (Source: AP/ La Nacion)

Mudslide, very large

- After extremely heavy rains falling over the course of the past week, the largest landslide since 1978 has ravaged the Argentinean province of Jujuy. The landslide claimed two victims as a couple were trapped within their car in the town of Volcán. About 1000 people were evacuated. (Source: The Bubble)

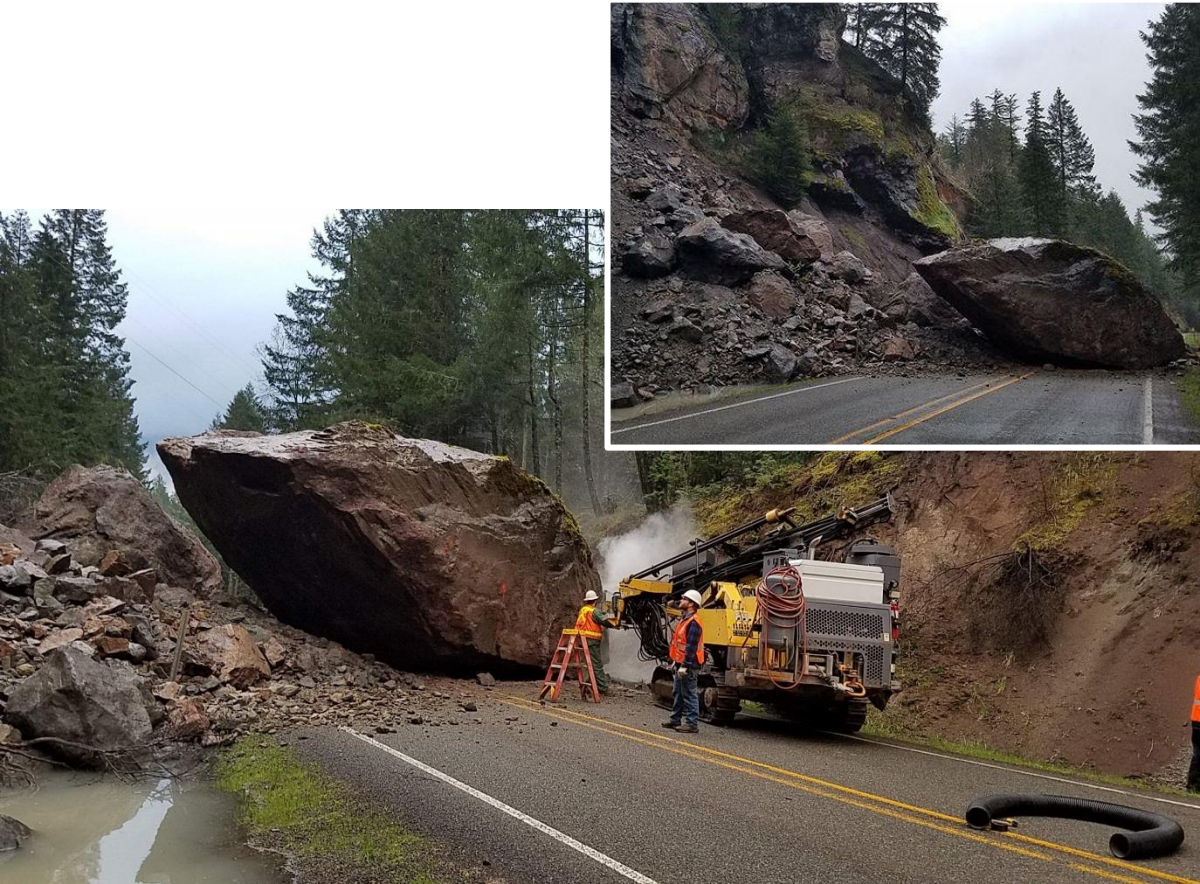
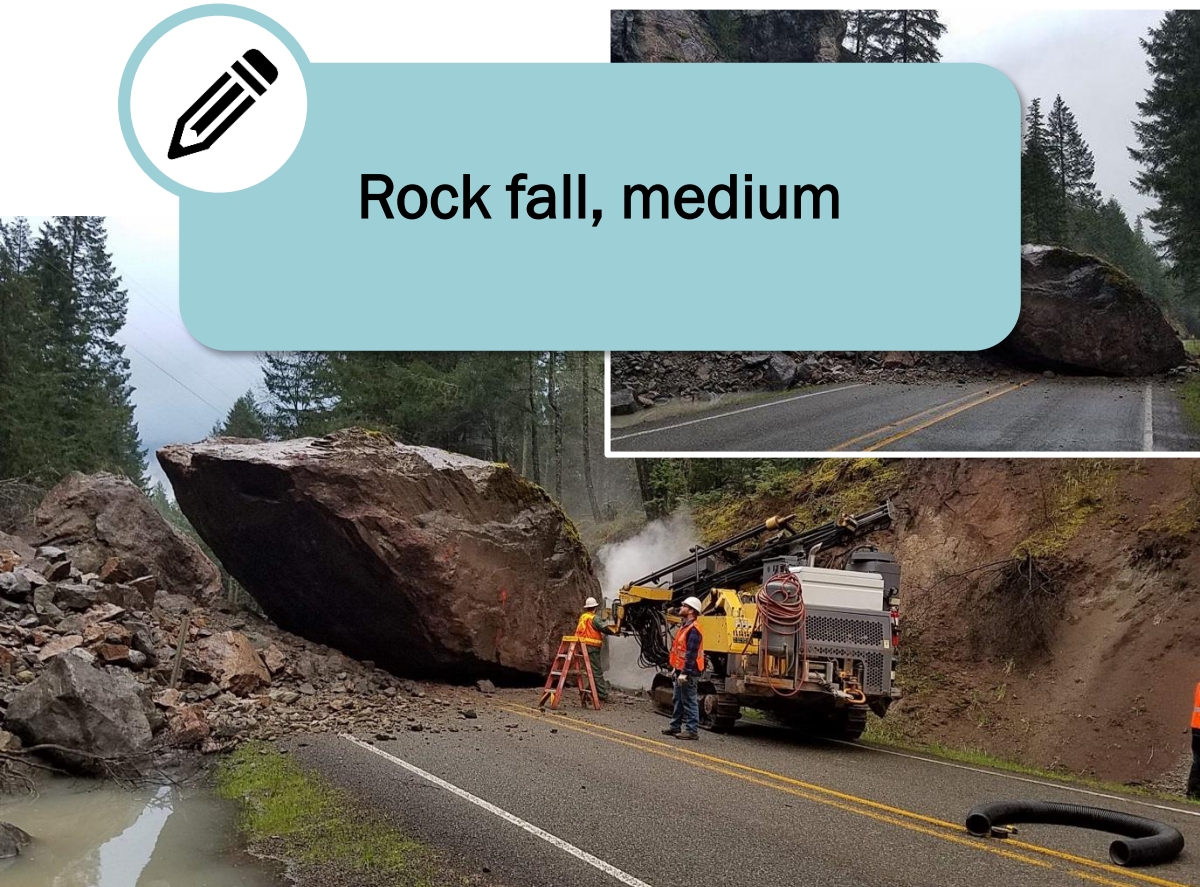
March 2017, Highway 138, Glide, OR, USA
(Source: Oregon DOT)

Rock fall, medium

- A rock the size of a cottage, about 200 tons, fell onto Oregon Highway 138 east of Glide and blocked both lanes of traffic. The rock crashed sometime after midnight. (Source: Mail Tribune)

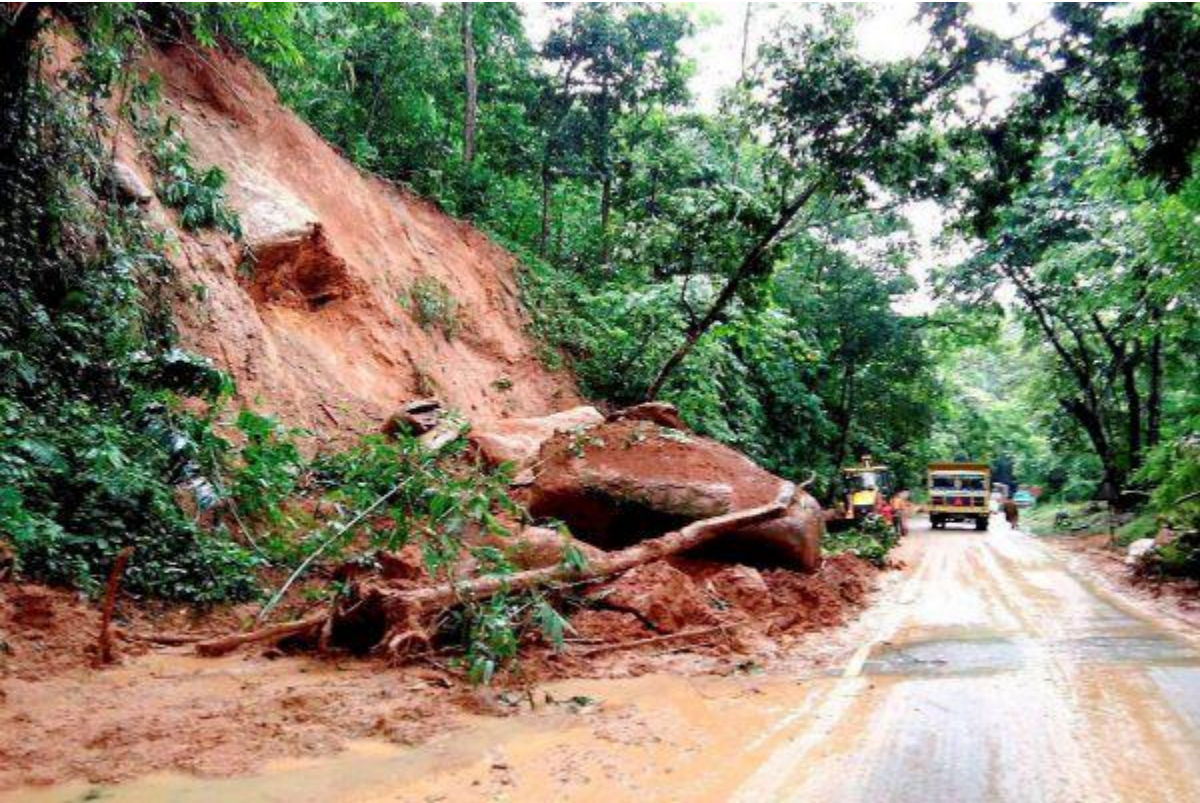
July 2017, NH-37, Burapahar, Nagaon, Assam, India (Source: Daily World)

Landslide, small

- Landslide at National Highway 37 near Burapahar area in Nagaon district of Assam. (Source: Daily World)

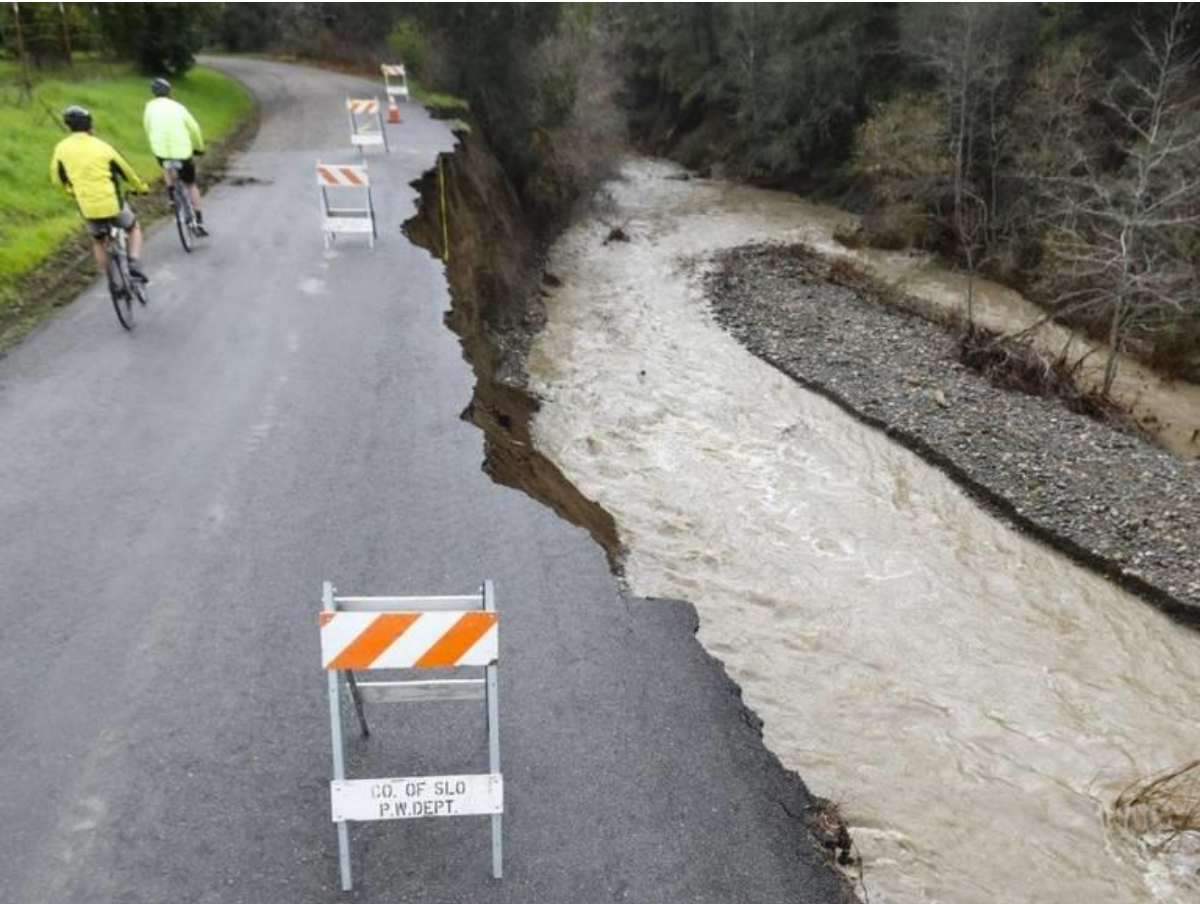
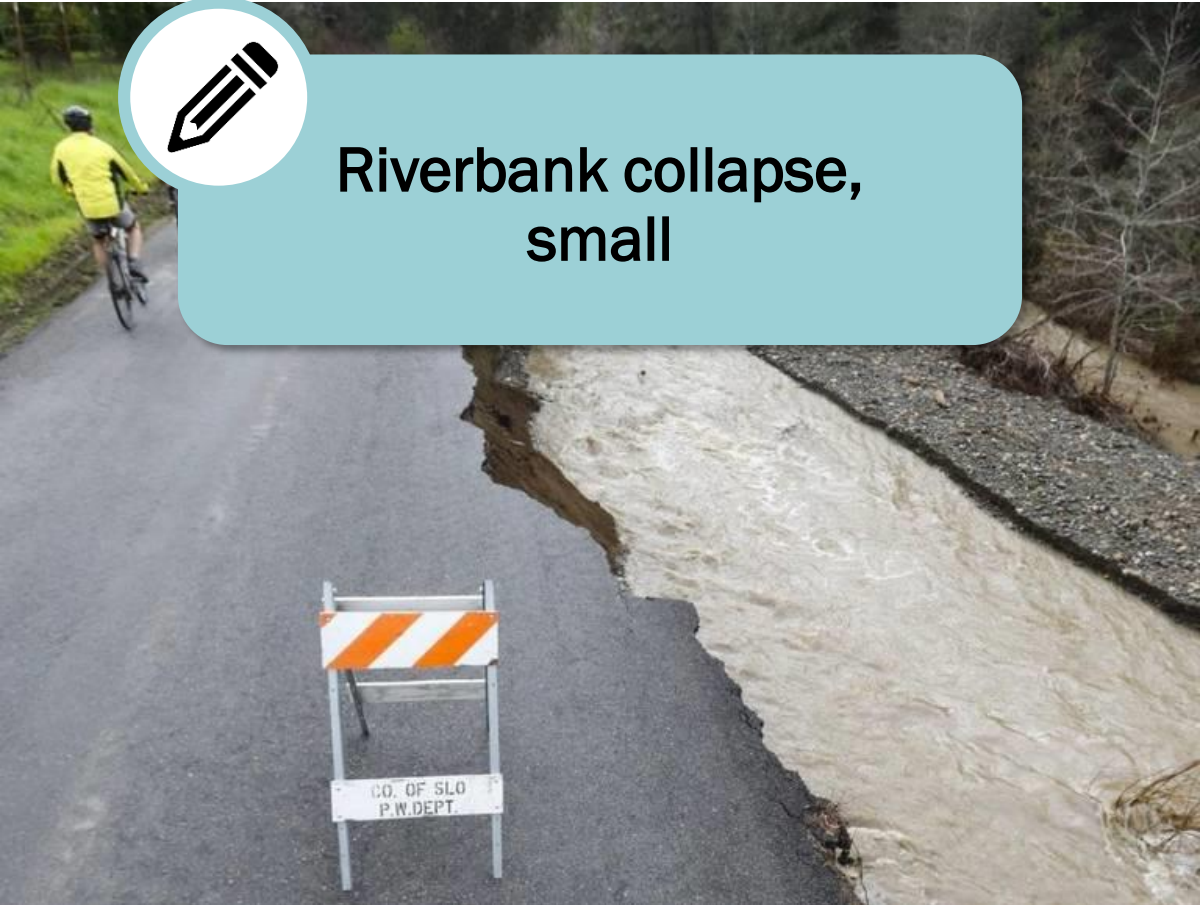
January 2017, Cambria, CA, USA (Source: David Middlecamp, The Tribune News)

**Riverbank collapse,
small**

- Continuous and heavy rainfall between Jan 3 and Jan 9 have spurred multiple landslides across the North Coast. About five miles upstream from Coast Union High School in Cambria, Santa Rosa Creek undercut Santa Rosa Creek Road. Here, bicyclists check out the damage on Jan. 9. (Source: The Tribune News)

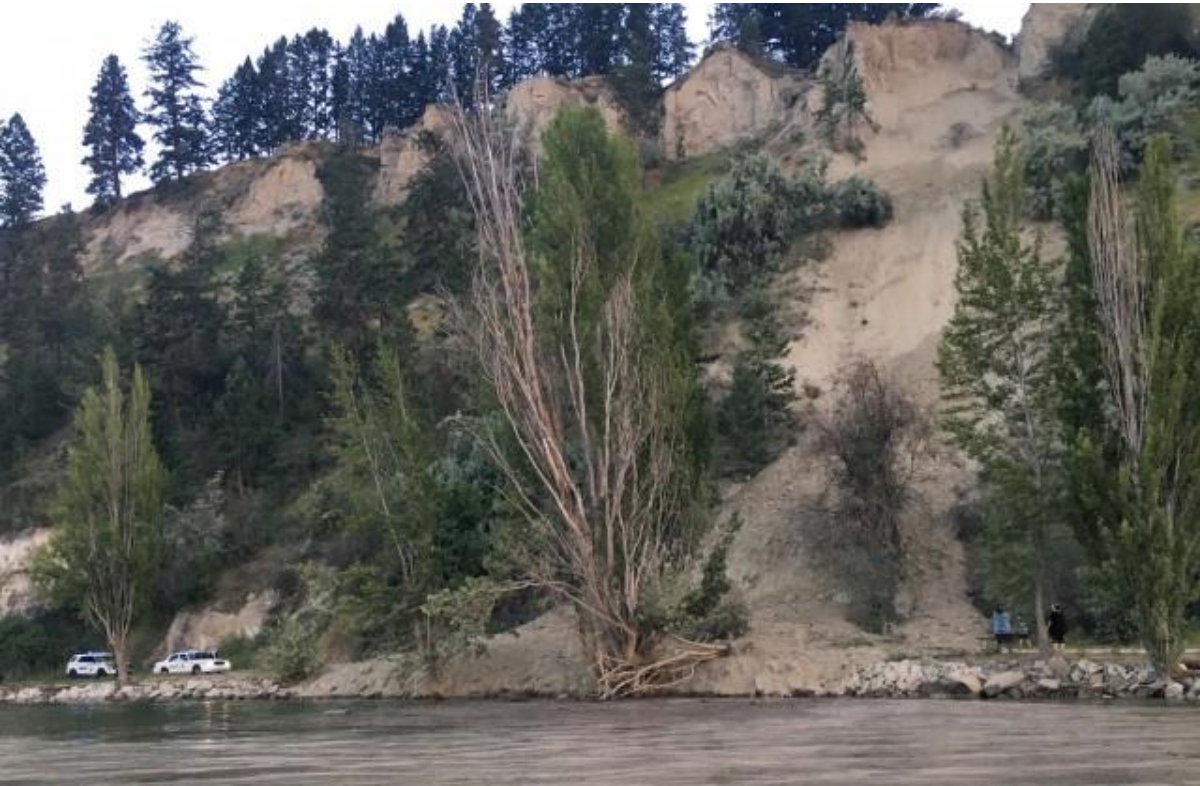
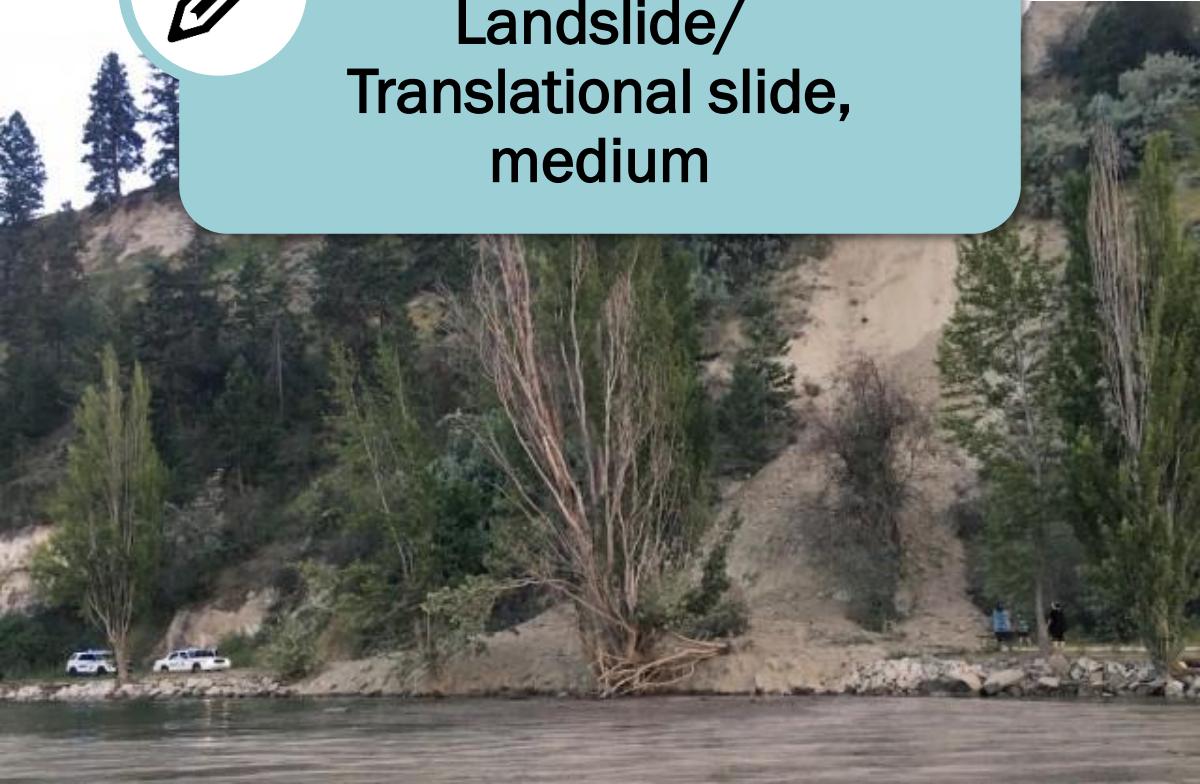
July 2017, Lakeshore Drive North, Summerland, British Columbia, Canada (Source: Kayley Davies)

Landslide/
Translational slide,
medium

- A landslide has washed out a beachfront road in Summerland. The slide occurred Thursday evening, and covered Lakeshore Drive North, just north of Summerland by Crescent Beach. It is unclear if anyone was injured in the slide, but police are on scene. (Source: Castanet)

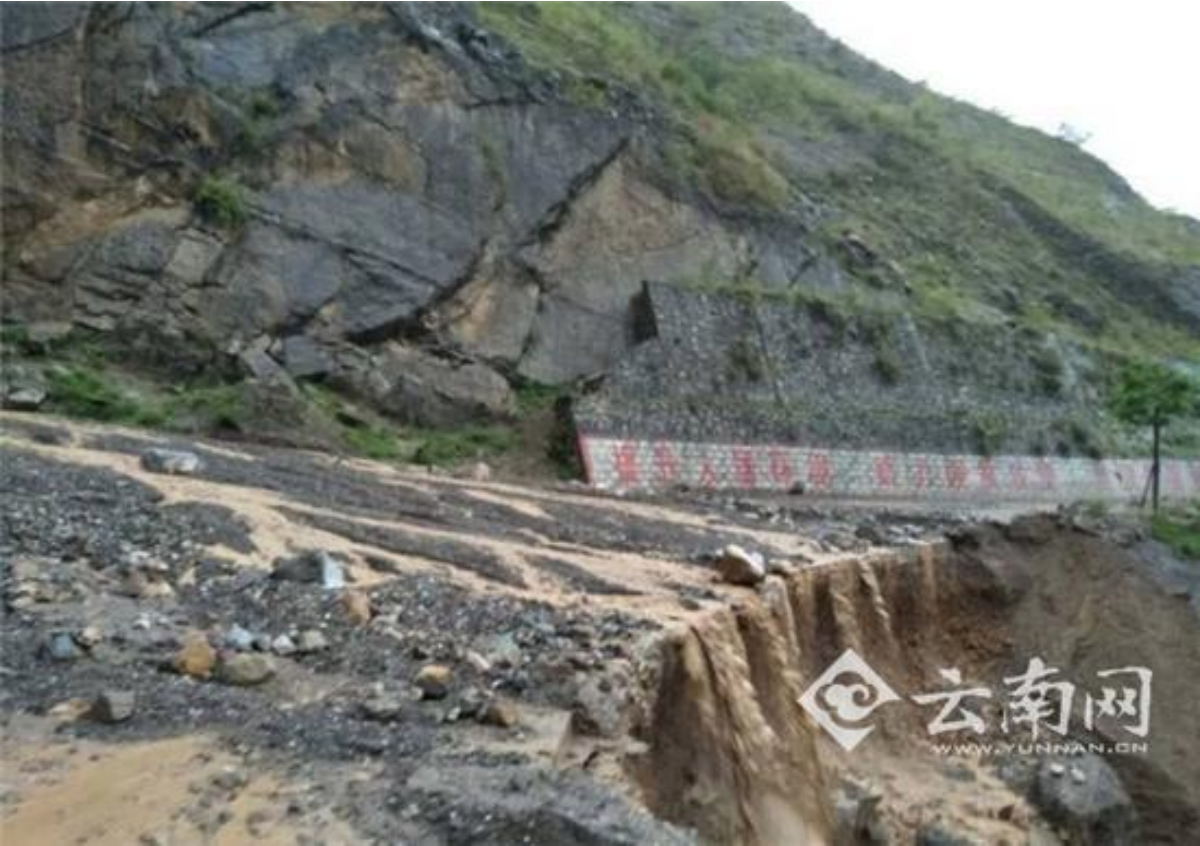
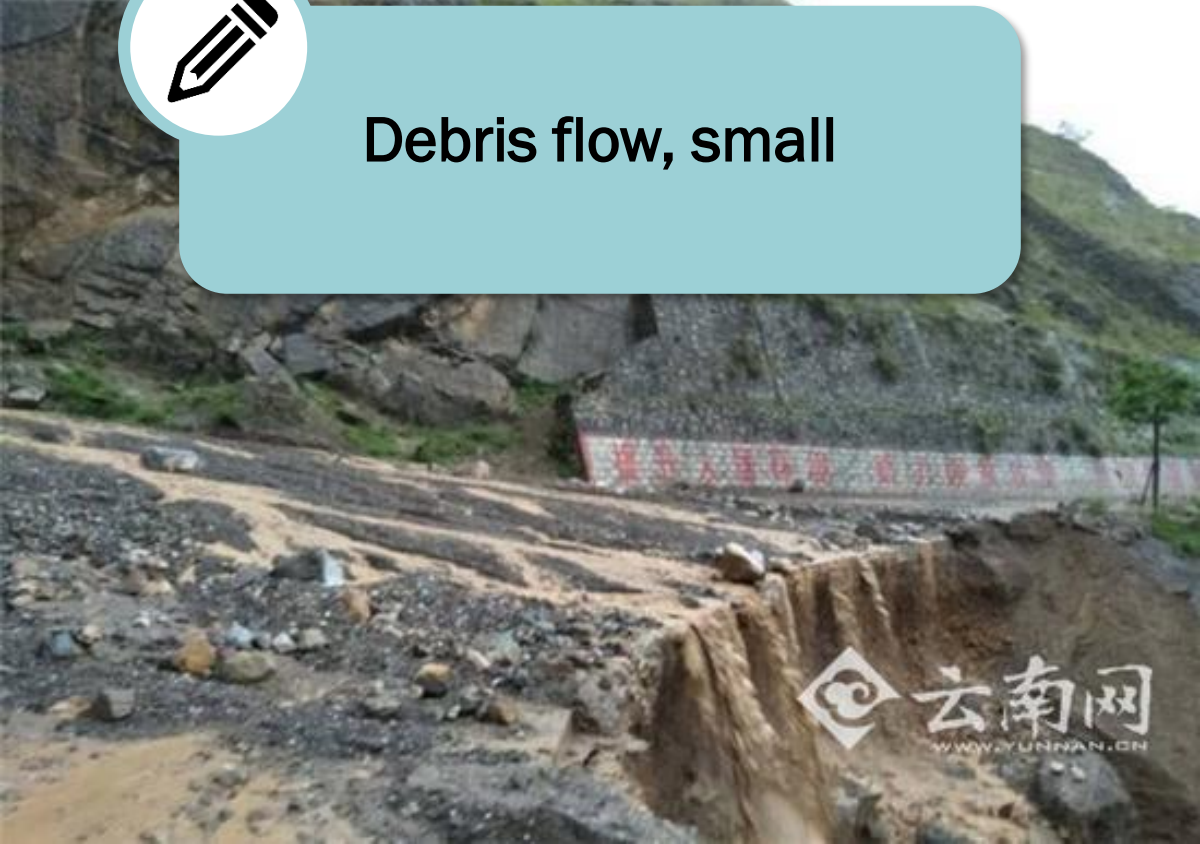
June 2017, Qiao Meng Road, Zhao Qiao, Yunnan Province, China (Source: Yunnan.cn)

Debris flow, small

- Heavy rain on June 30 led to a debris flow, resulting in temporary traffic disruptions. (Source: Top News)

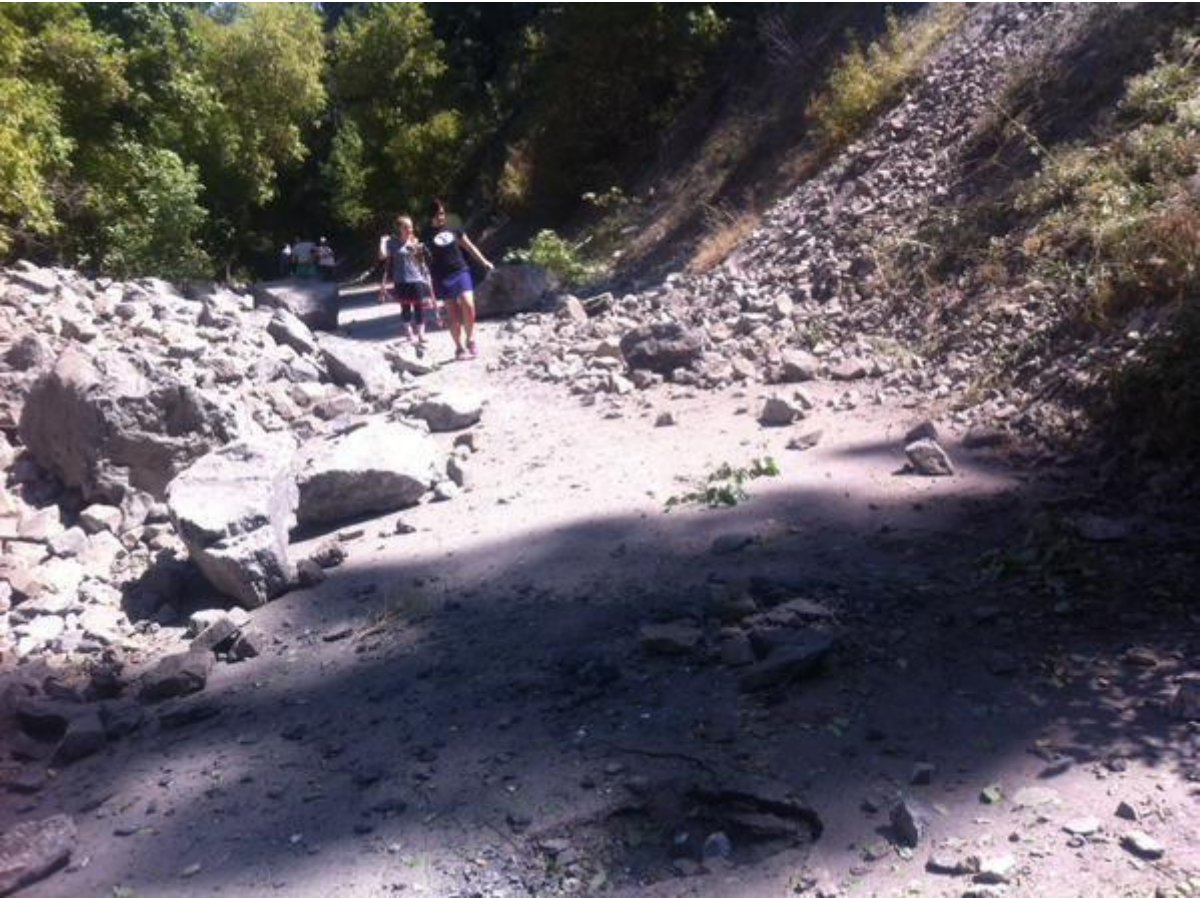
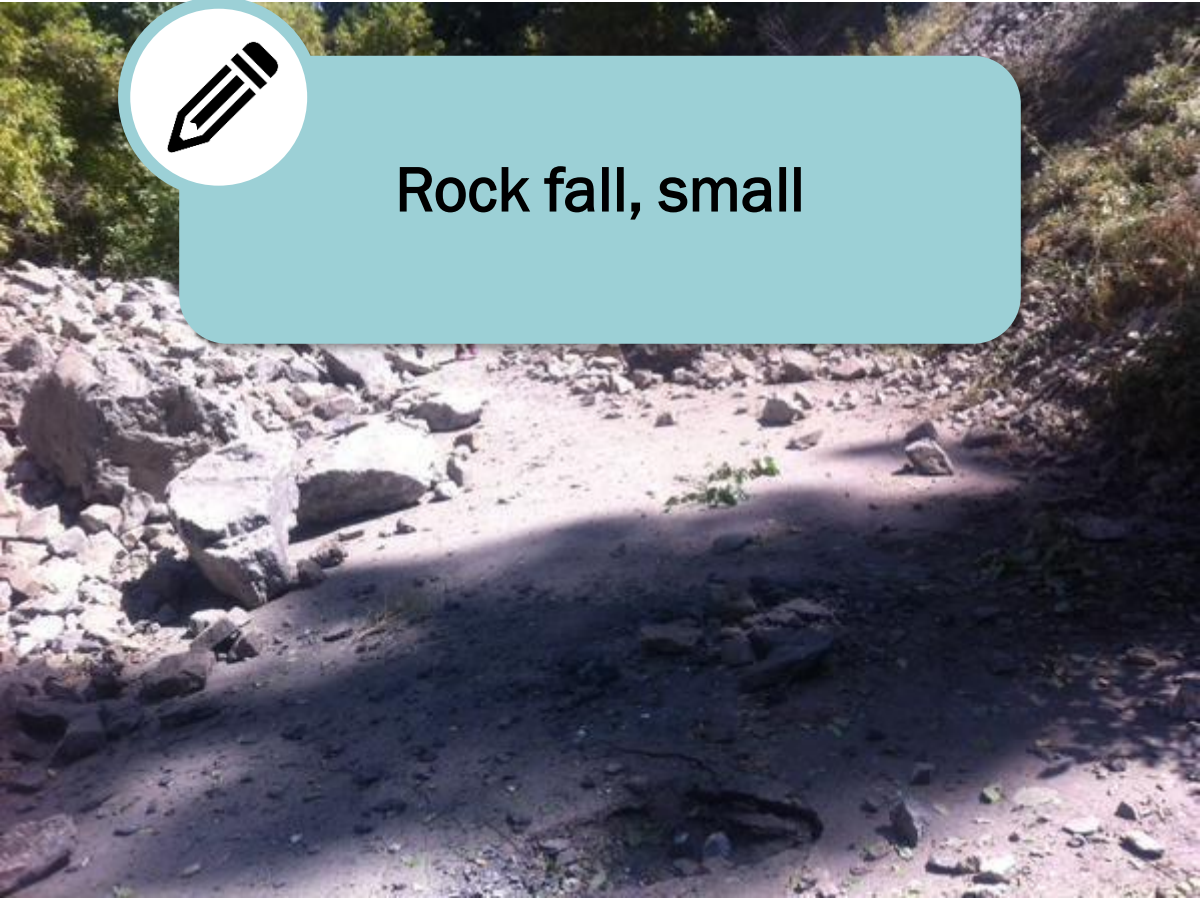
September 2015, Provo River Parkway, Provo Canyon, Utah, USA (Source: Sgt. Spencer Cannon)

Rock fall, small

- On Monday afternoon, a rock slide occurred on the Provo River Parkway trail approximately 1 mile northeast of the popular Bridal Veil Falls recreation area. No one was injured and those walking or jogging along the parkway trail were not seriously hindered from the slide. (Source: Daily Herald)

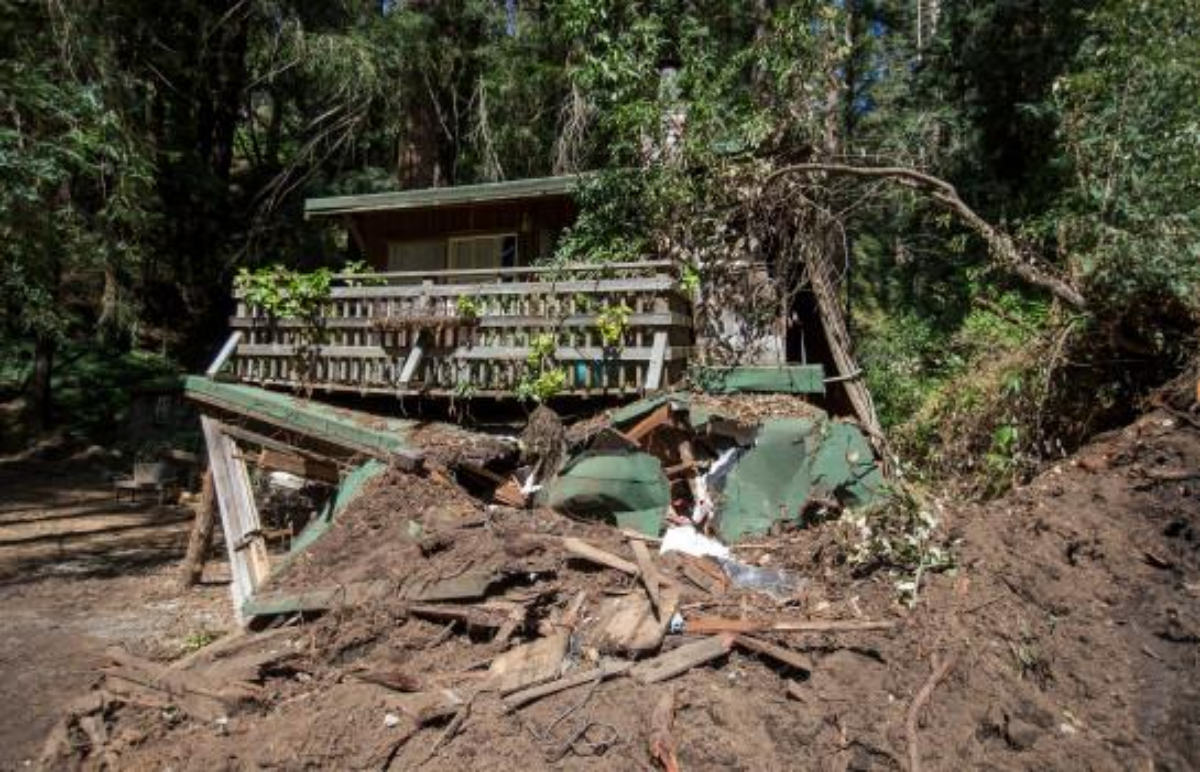
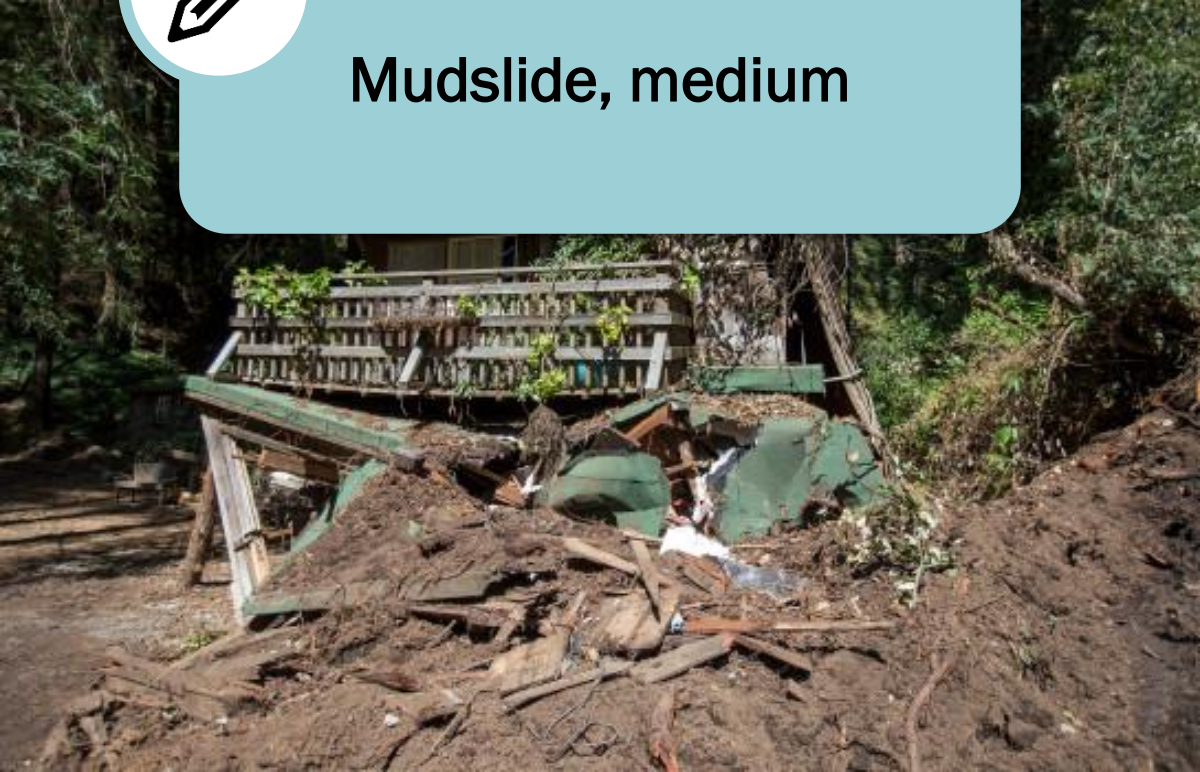
March 2017, The Creek House at Deetjen's Big Sur Inn, Big Sur, CA, USA (Source: LiPo Ching, Bay Area News Group)

Mudslide, medium

- The Creek House at Deetjen's Big Sur Inn was damaged from a mudslide during recent storms in Big Sur. Landslides have destroyed four of its 20 cabins and compromised its other historic structures and all the internal roadways. (Source: The Mercury News)

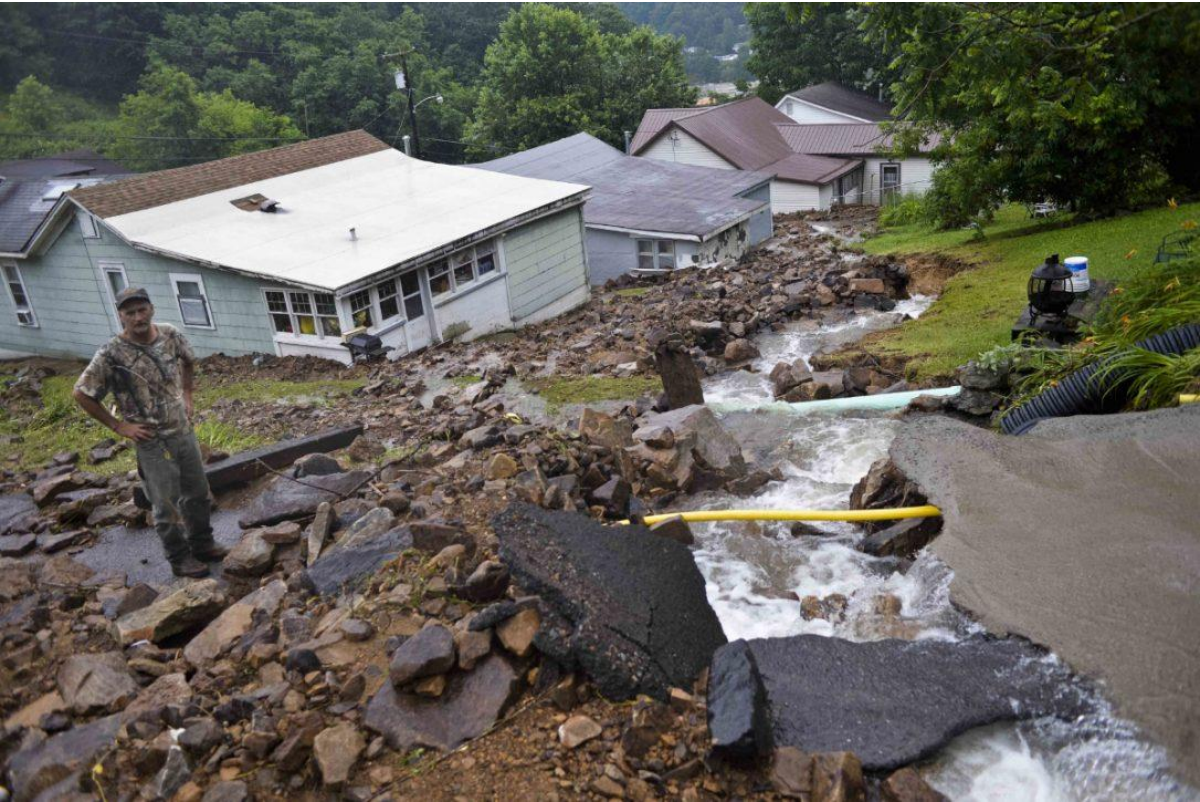
June 2016, Richwood, West Virginia, USA

Debris flow, medium

- A resident of Richwood, W.Va. stands among the aftermath of a rockslide caused by severe flooding that poured into a property owned by his family since the 1930's. West Virginia's governor declared a state of emergency in 44 of 54 counties and has authorized up to 500 soldiers to assist after flooding caused widespread chaos. (Source: The Star)
