The Landslide Reporter's Guide

Landslide Identification Training

Training Instructions

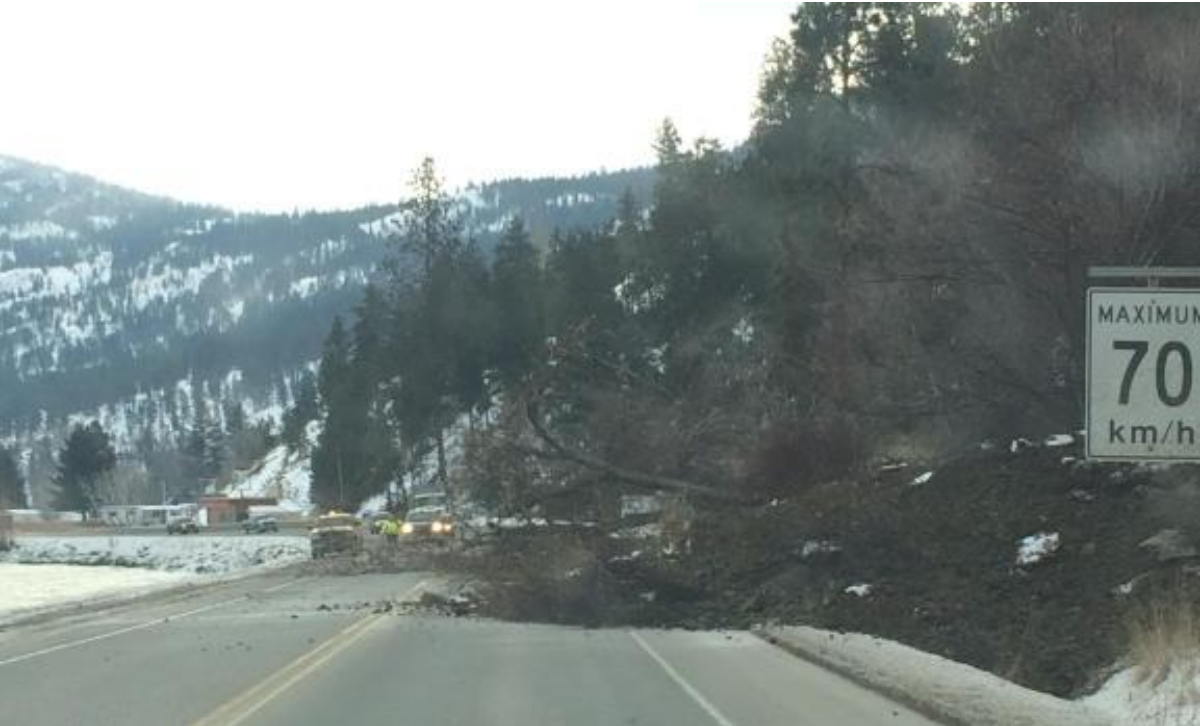
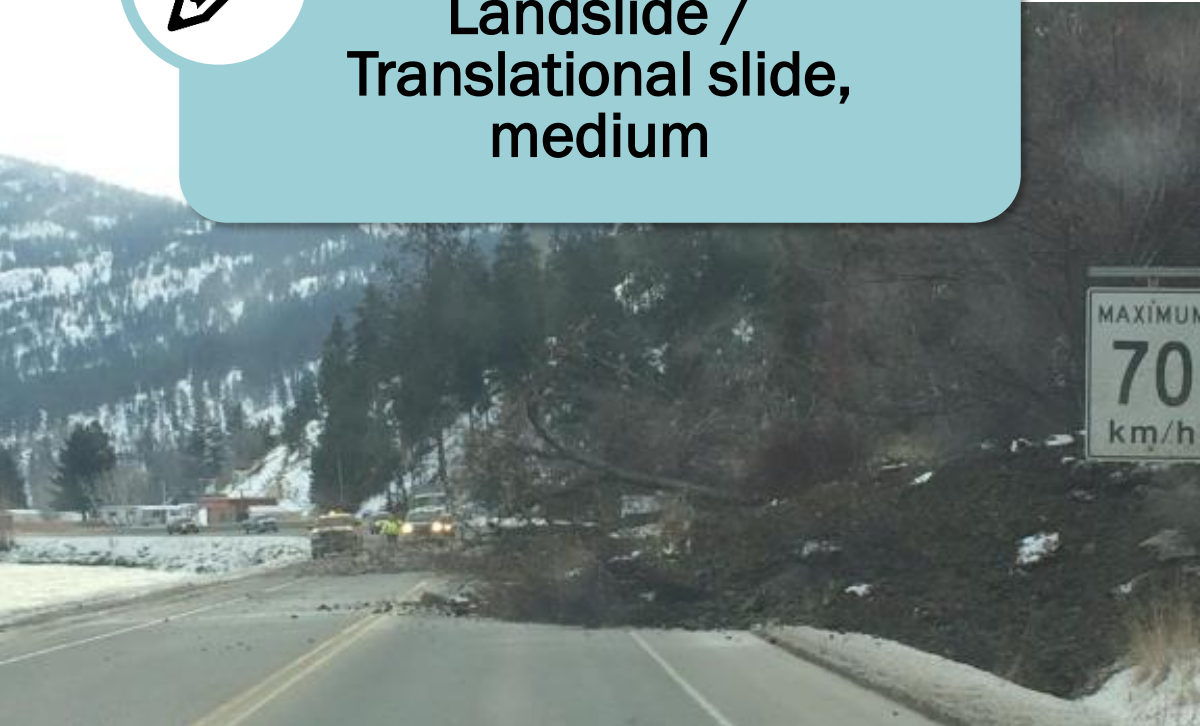
January 2017, Highway 97, Peachland, British Columbia, Canada (Source: Cynthia Coates)

Landslide /
Translational slide,
medium

- A small landslide brought traffic to a standstill when it covered the southbound lane of Highway 97 near Peachland, B.C., on Friday afternoon. The slide happened shortly after 1 p.m. PT about three kilometres south of the small Okanagan community. The slide blocked traffic on Renfrew Road above Highway 97. (Source: CBC News)
