The Landslide Reporter's Guide

Landslide Identification Training

Training Instructions

- The following images are reports made to the Global Landslide Catalog (GLC).
- Flip through these to train your eye to identify some of the common types of landslides from reports.
- In addition to images, keywords in the news articles may help with identifying the appropriate size and category.

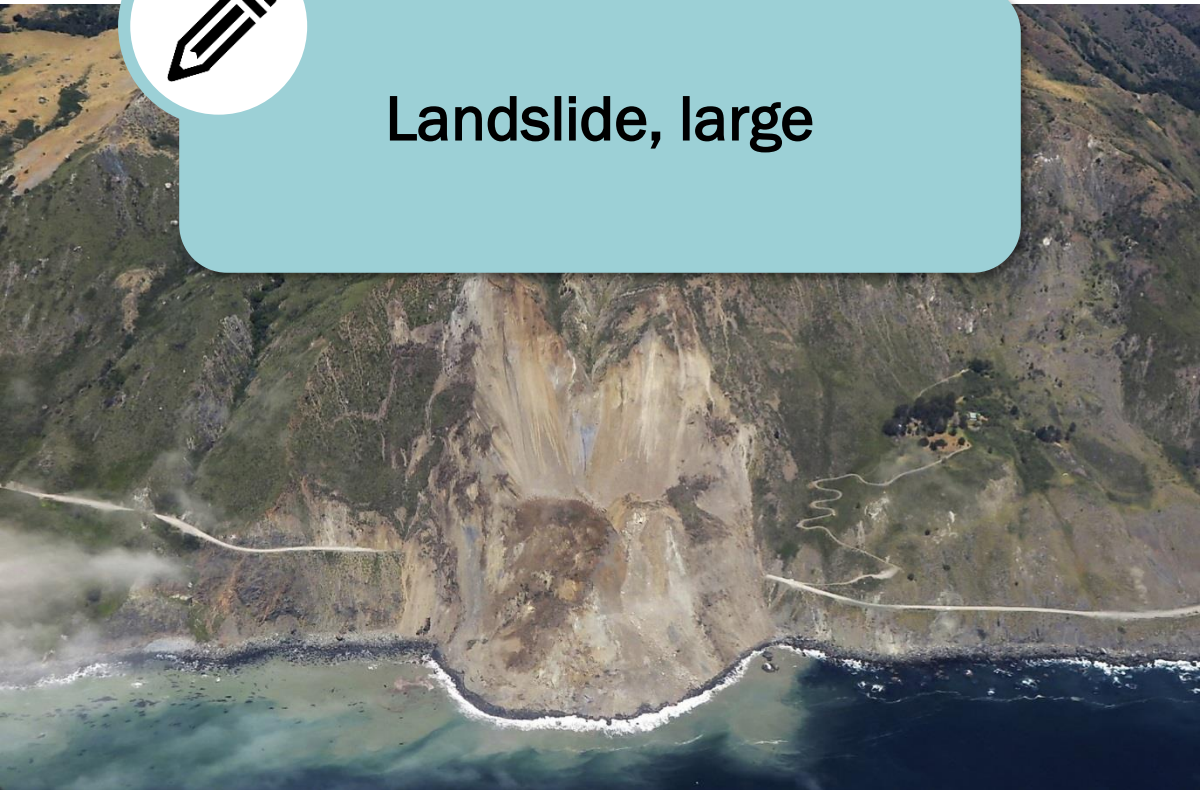
May 2017, Highway 1, Big Sur, CA, USA (Source: John Madonna, AP)

Landslide, large

- A massive landslide along California's coastal Highway 1 has buried the road under a 40-foot layer of rock and dirt. A swath of the hillside gave way in an area called mud creek on Saturday, covering about half a kilometer of road and changing the Big Sur coastline. (Source: SFGate)

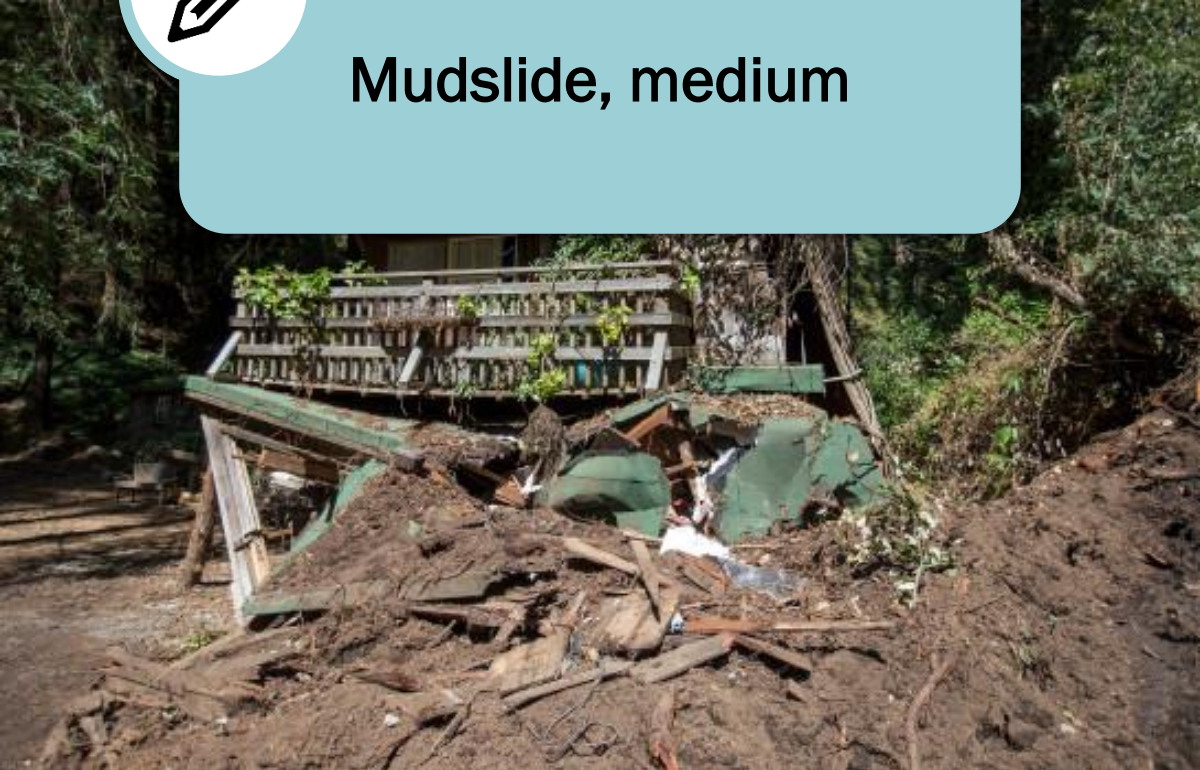
March 2017, The Creek House at Deetjen's Big Sur Inn, Big Sur, CA, USA (Source: LiPo Ching, Bay Area News Group)

Mudslide, medium

- The Creek House at Deetjen's Big Sur Inn was damaged from a mudslide during recent storms in Big Sur. Landslides have destroyed four of its 20 cabins and compromised its other historic structures and all the internal roadways. (Source: The Mercury News)
