# **FEDERAL TRANSIT BUS TEST**

**Manufacturer: Micro Bird Inc. / Micro Bird USA LLC  
Model: Micro Bird G5**

**December 2025**

**Report Number: LTI-BT-R2025-03**

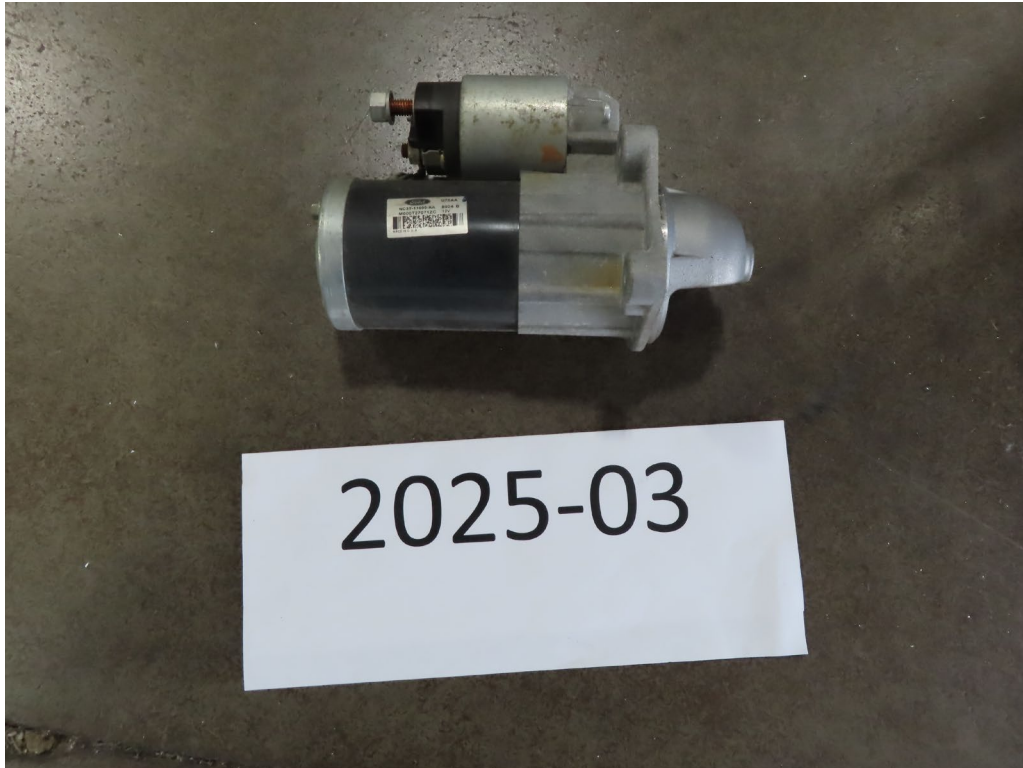
**STARTER REMOVAL AND REPLACEMENT  
(0.67 LABOR HOURS)**
